# 2021 Geotechnical Annual Review

Minto Mine, Yukon  
Minto Explorations Ltd.

SRK Consulting (Canada) Inc. ■ 1CM002.073 ■ October 2021

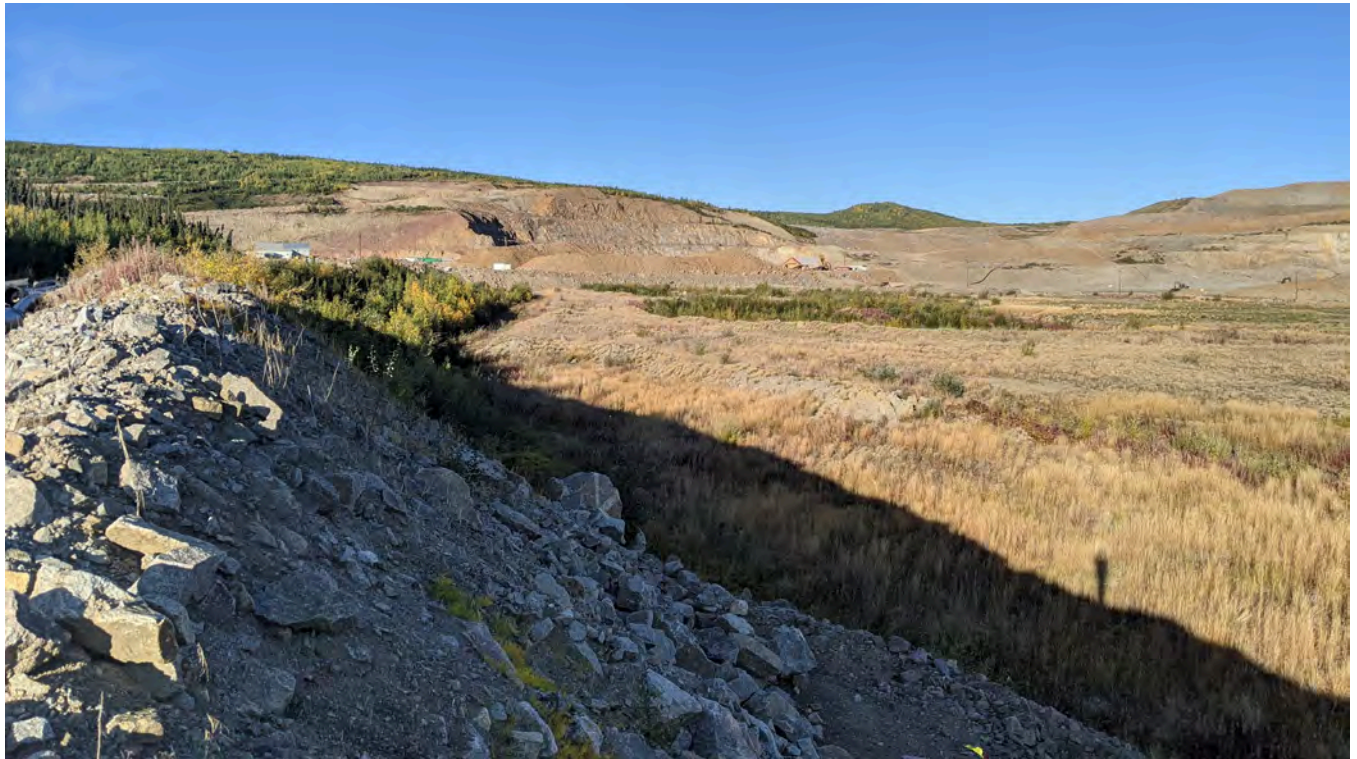
Photo 1-1: Southwest corner of DSTSF (looking west)

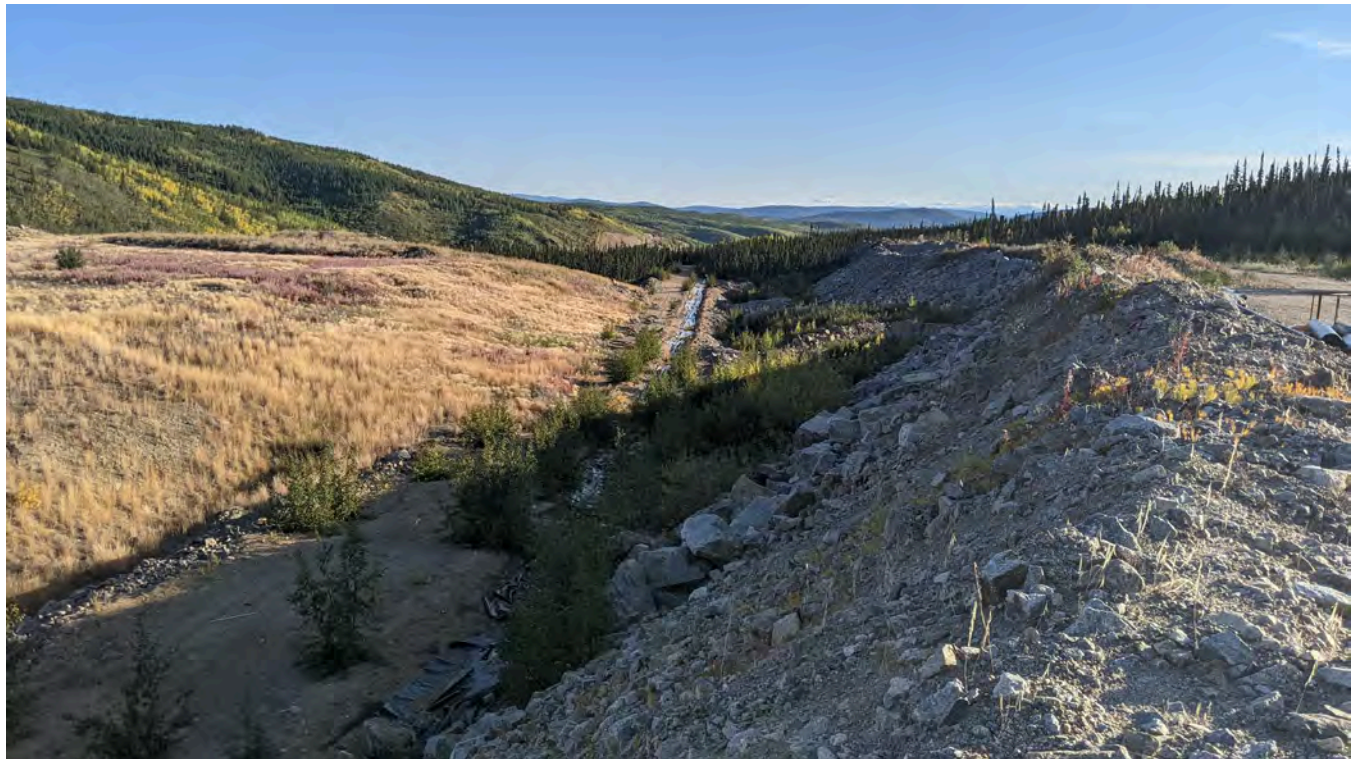
Photo 1-2: Southeast end of the DSTSF from TDD road (looking east)

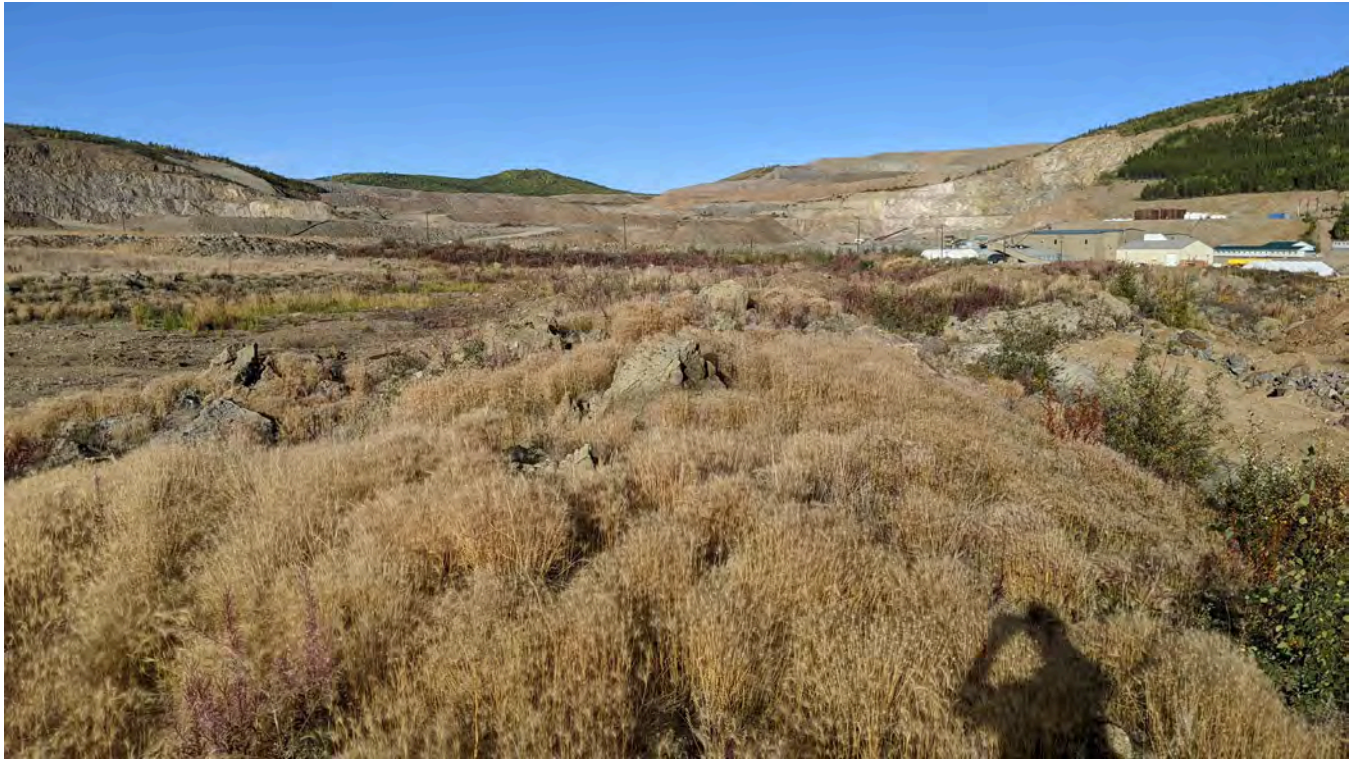
Photo 1-5: Area of stockpiled cover material south of the ungraded waste rock shell.

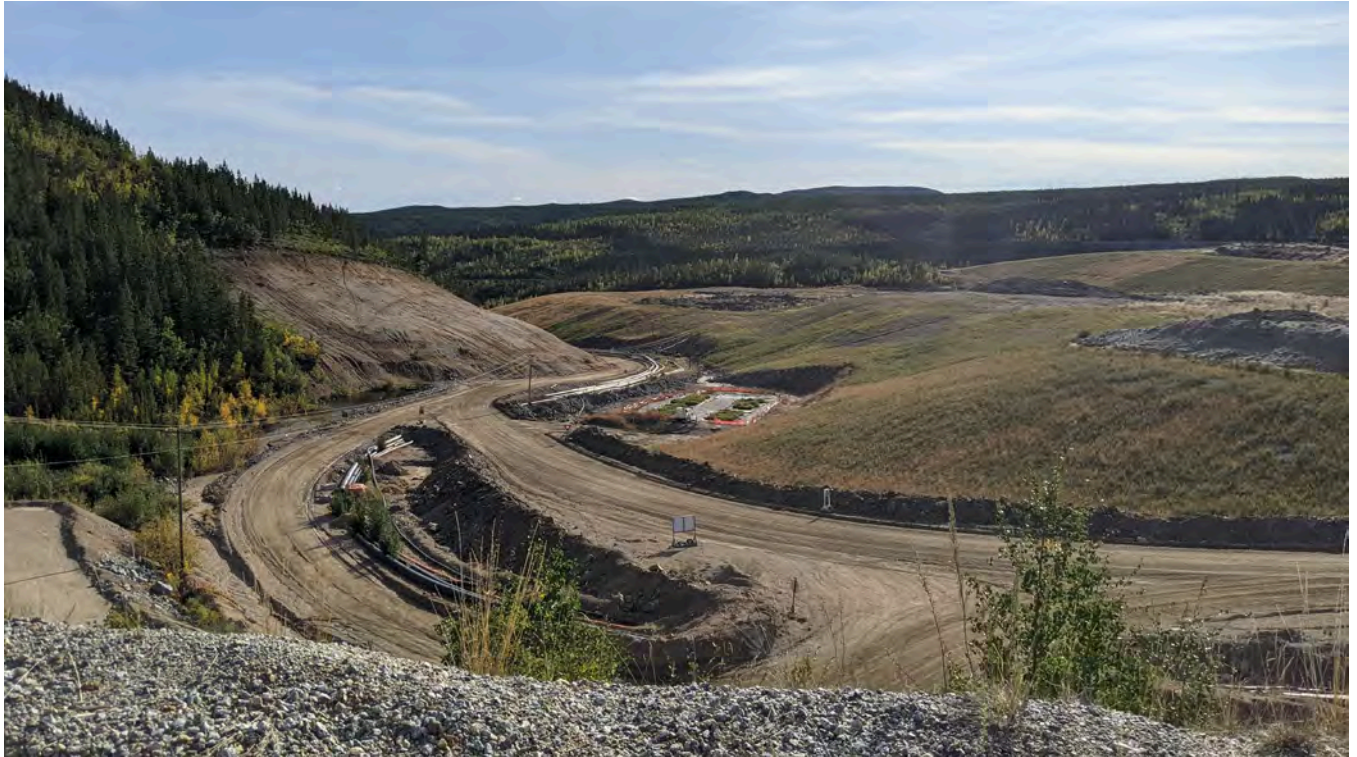
Photo 2-1: Overview of the MVFE from the camp site (looking southeast).

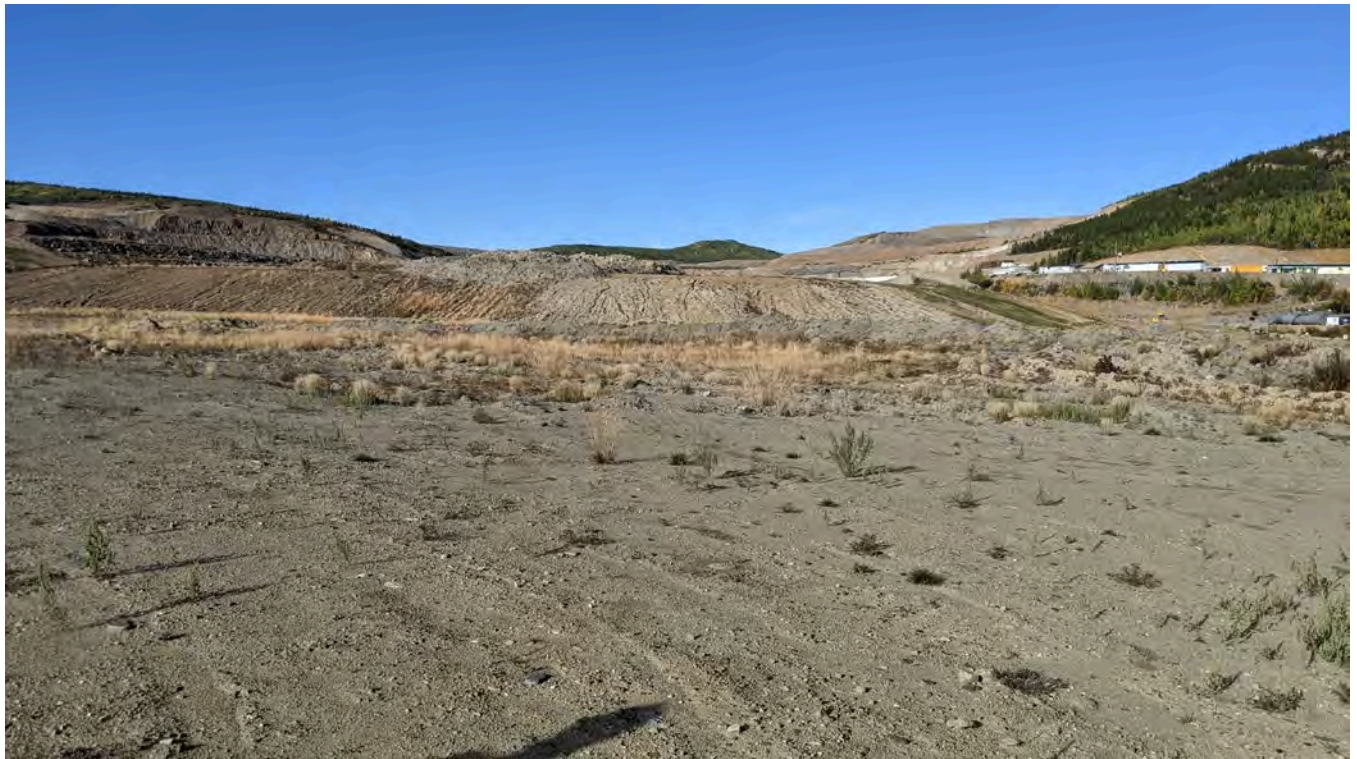
Photo 2-2: Looking west across Tier C, minor erosion gullies visible down Tier B of the MVFE.

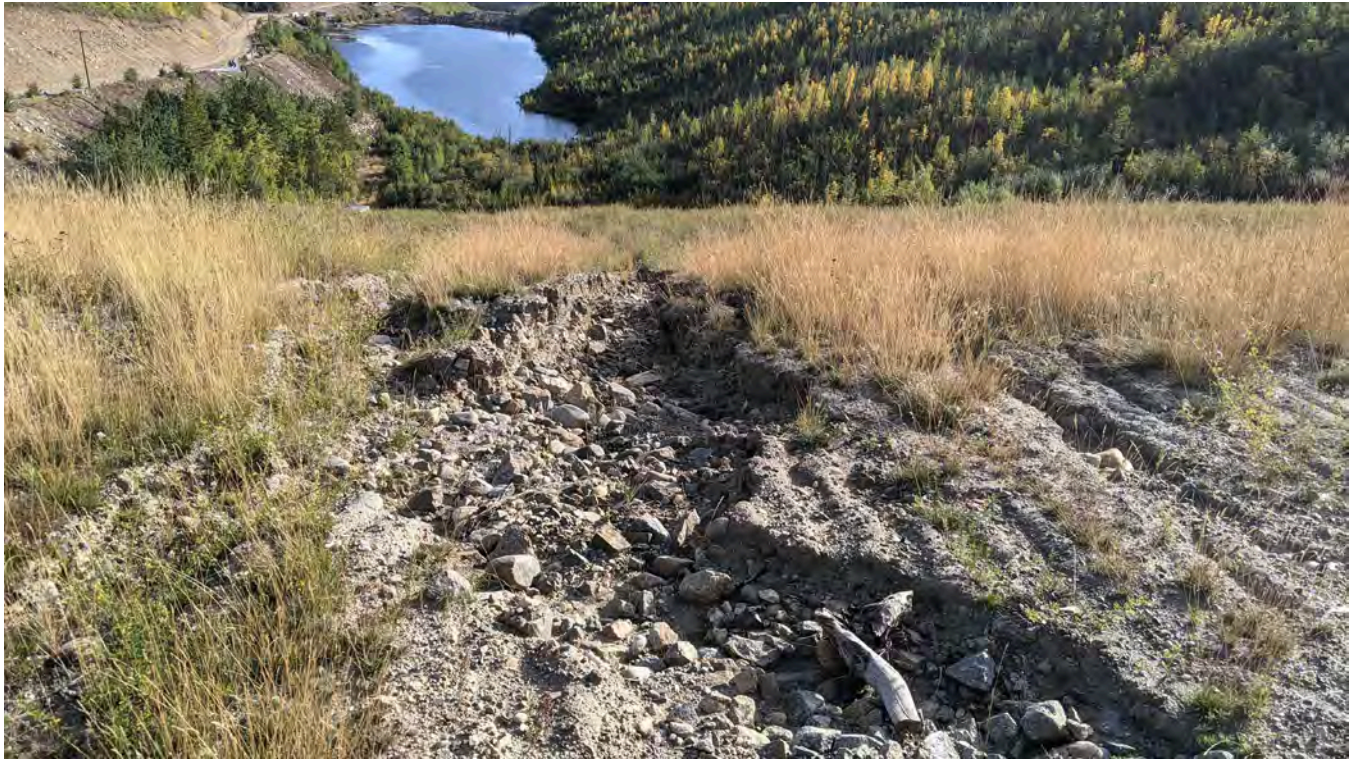
2	Mill Valley Fill Extension (MVFE)	<ul style="list-style-type: none"> <li>■ No observations of global instability.</li> <li>■ Multiple erosion gullies within the cover soil observed on the north and east slopes of the cover where runoff concentrates (see Photos 2-3, 2-4, and 2-5, Appendix A).</li> <li>■ The excavated slope to the south of the Minto Creek Seepage Collection System (MCSCS) that is excavated into permafrost soils has no observable changes compared to the previous years' inspection. The access road headed down to the MCSCS was upgraded in the past year with an armoured ditch constructed to direct surface runoff away from the MCSCS.</li> <li>■ No signs of seepage visible at the toe of the MVFE. The MCSCS appears to be functioning as per design, with no signs of seepage below the system.</li> </ul>
3	Tailings Diversion Ditch (TDD)	<ul style="list-style-type: none"> <li>■ Construction of the TDD Intake Structure and Overflow Spillway into the Area 2 Stage 3 Pit remains incomplete with construction of the intake channel side-slopes and riprap placement remaining.</li> <li>■ Runoff from the Underground Access Road flows into the TDD Intake Structure and has deposited sediments in the basin (Photos 3-1 and 3-2, Appendix A). A berm is also present that prevents use of the overflow spillway into the Area 2 Pit. Any flow that overtops the TDD Intake Structure would be directed down the Underground Access Road to the north. Most of this flow would bypass the DSTSF to the west, but some flow would pass between gaps in the road berm and flow overtop the DSTSF cover.</li> <li>■ Conditions in the TDD remain the same as previous inspections with no major obstructions or signs of instability along the TDD were observed.</li> <li>■ Minor vegetation was observed in the upper portion of the unarmoured ditch (see Photos 3-3 and 3-4, Appendix A). The vegetation growth will be required to be removed within the next year and should continue to be monitored as part of routine inspections.</li> </ul>

Photo 2-3: Erosion gullies – looking east towards the WSP.

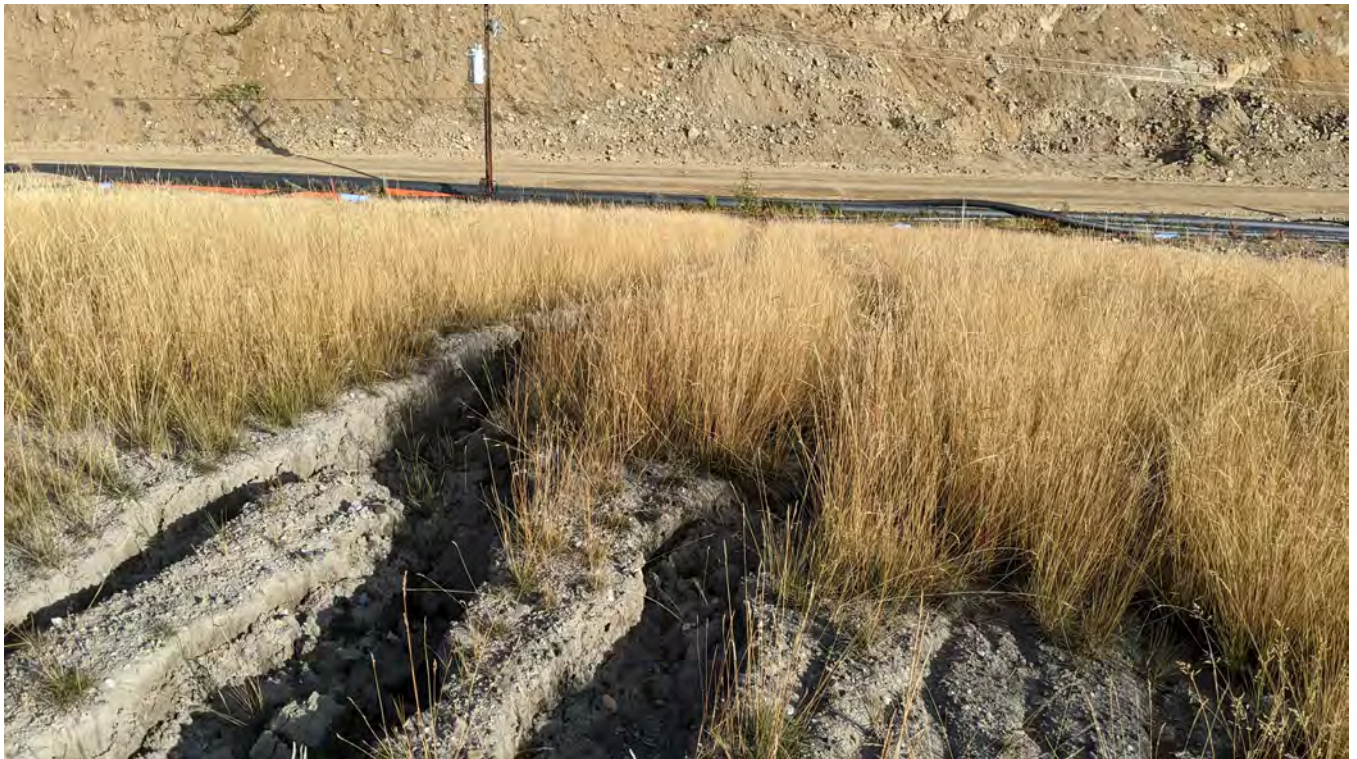
Photo 2-4: Erosion gullies, looking north towards the main access road.

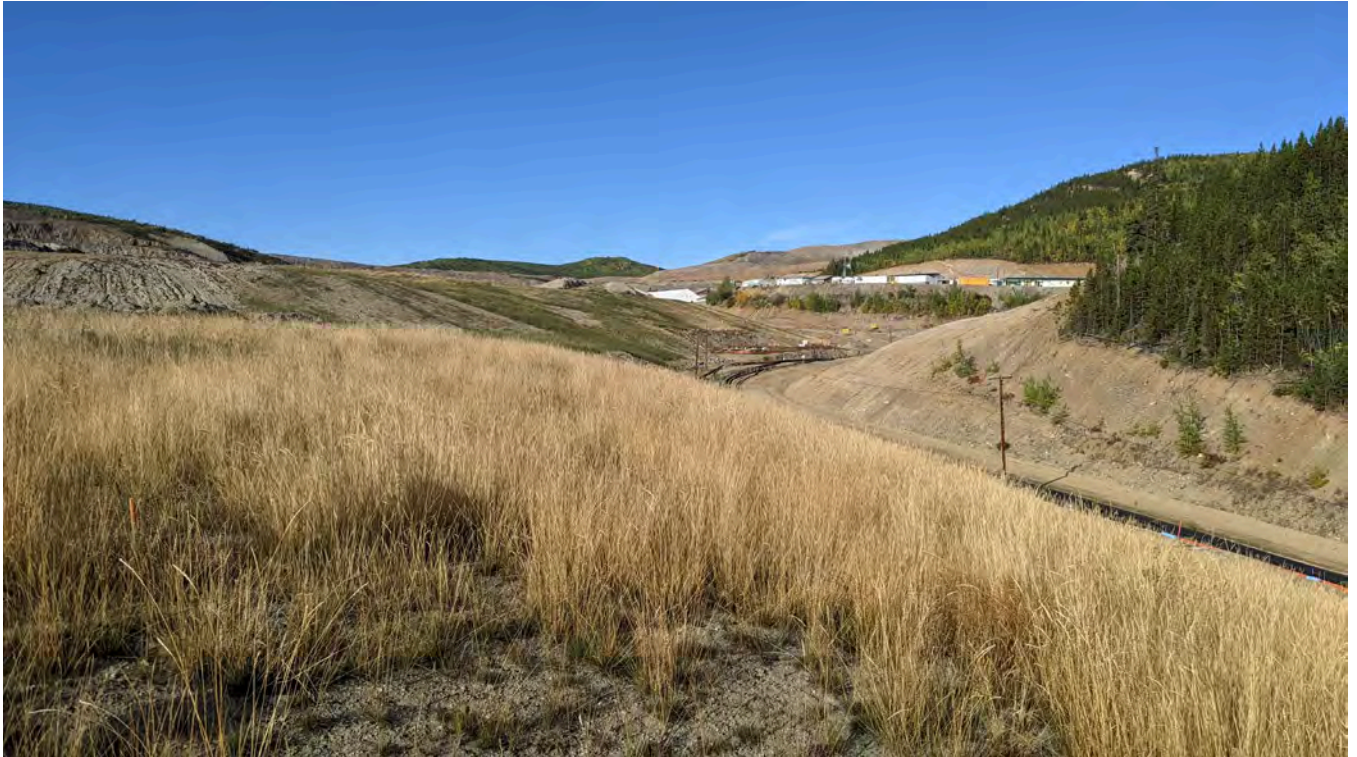
Photo 2-5: View of the north regraded, covered, and vegetated slopes of the MVFE looking towards camp.

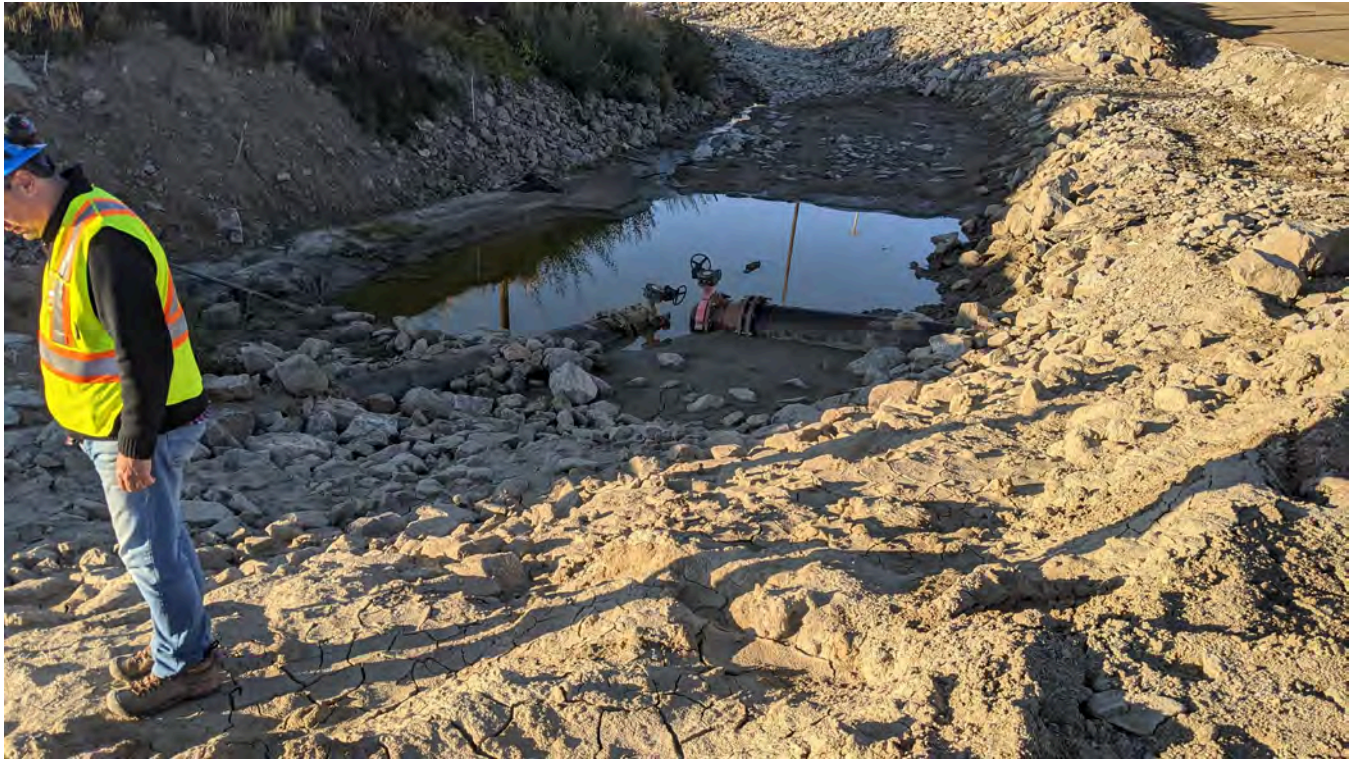
Photo 3-1: TDD Intake Channel. Photo taken from the Airport Access Road looking upstream. Grading of the Underground Access Road results in surface runoff being directed into TDD intake. The intake area was cleaned-out prior to the inspection.

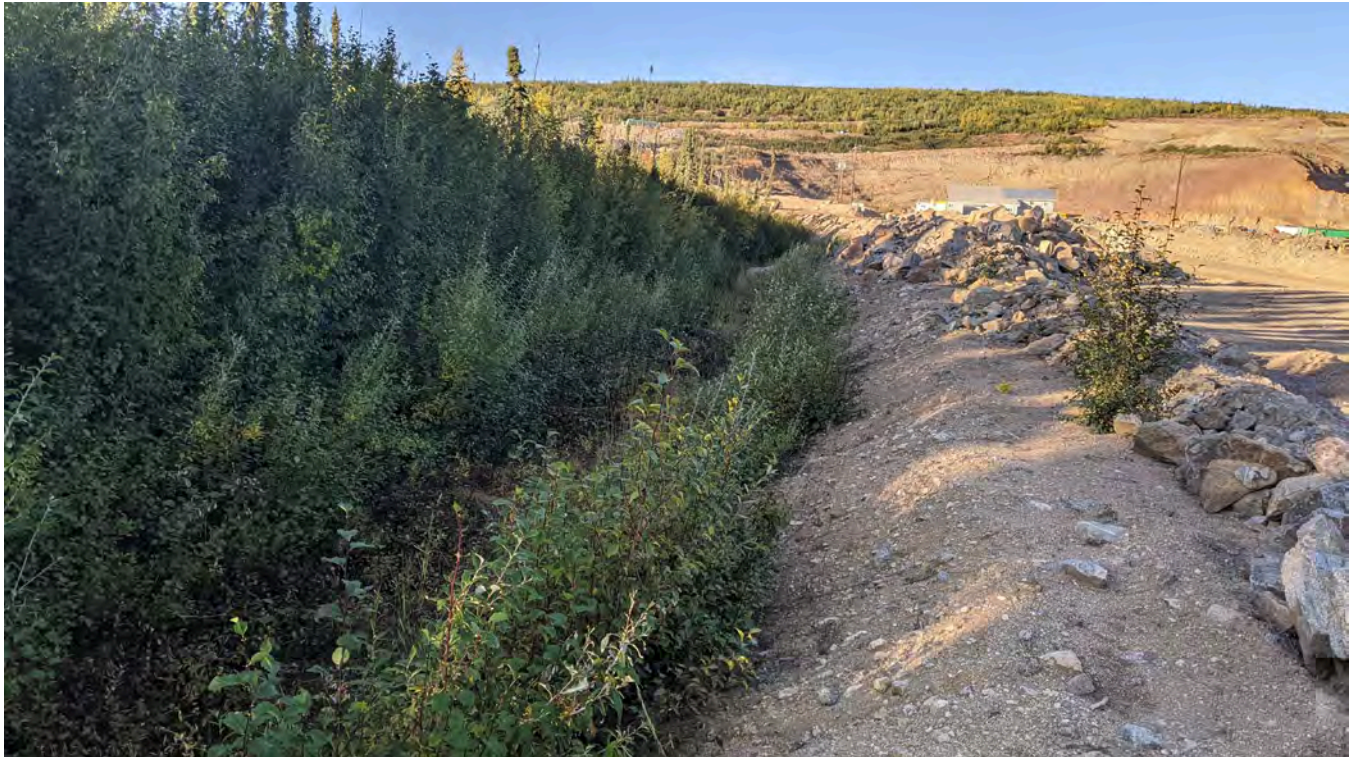
Photo 3-3: Vegetation in the upper portion of the TDD looking upstream.

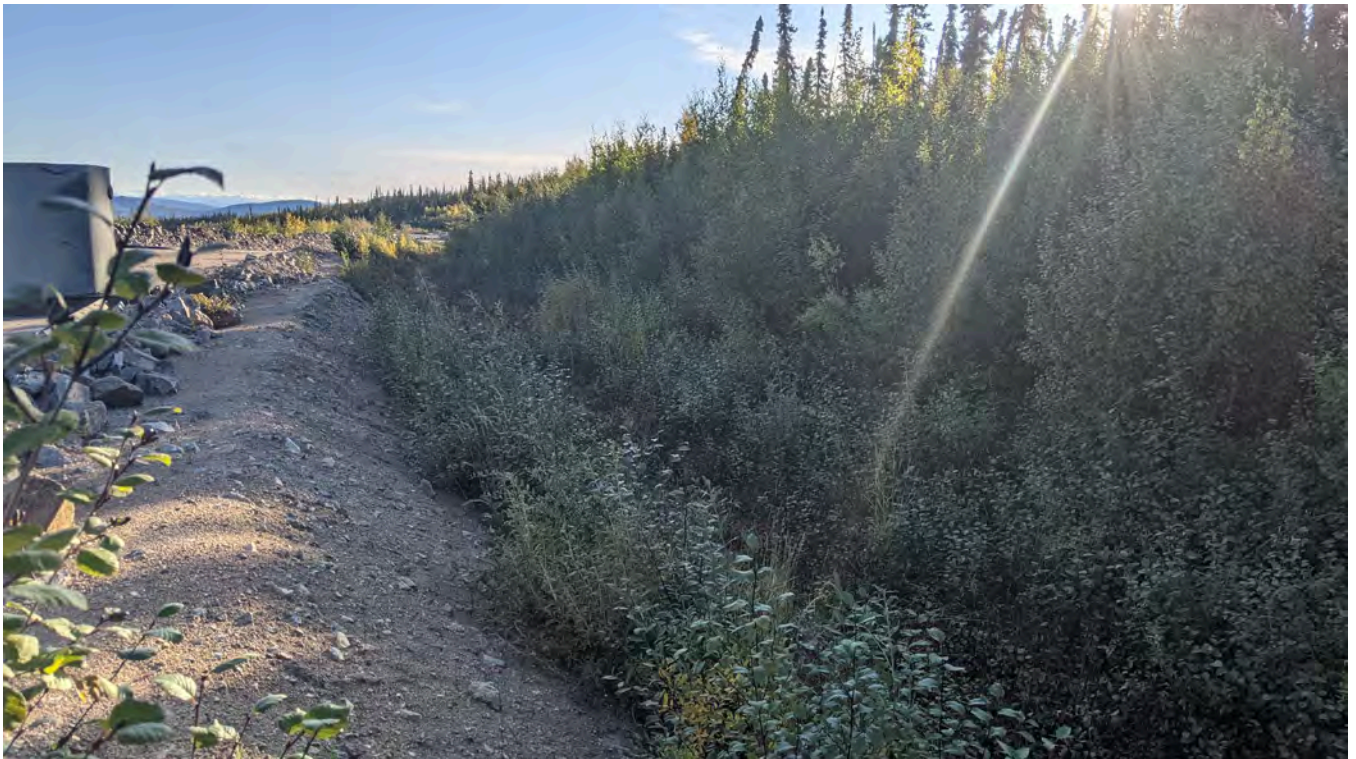
Photo 3-4: Vegetation in the upper portion of the TDD looking downstream.

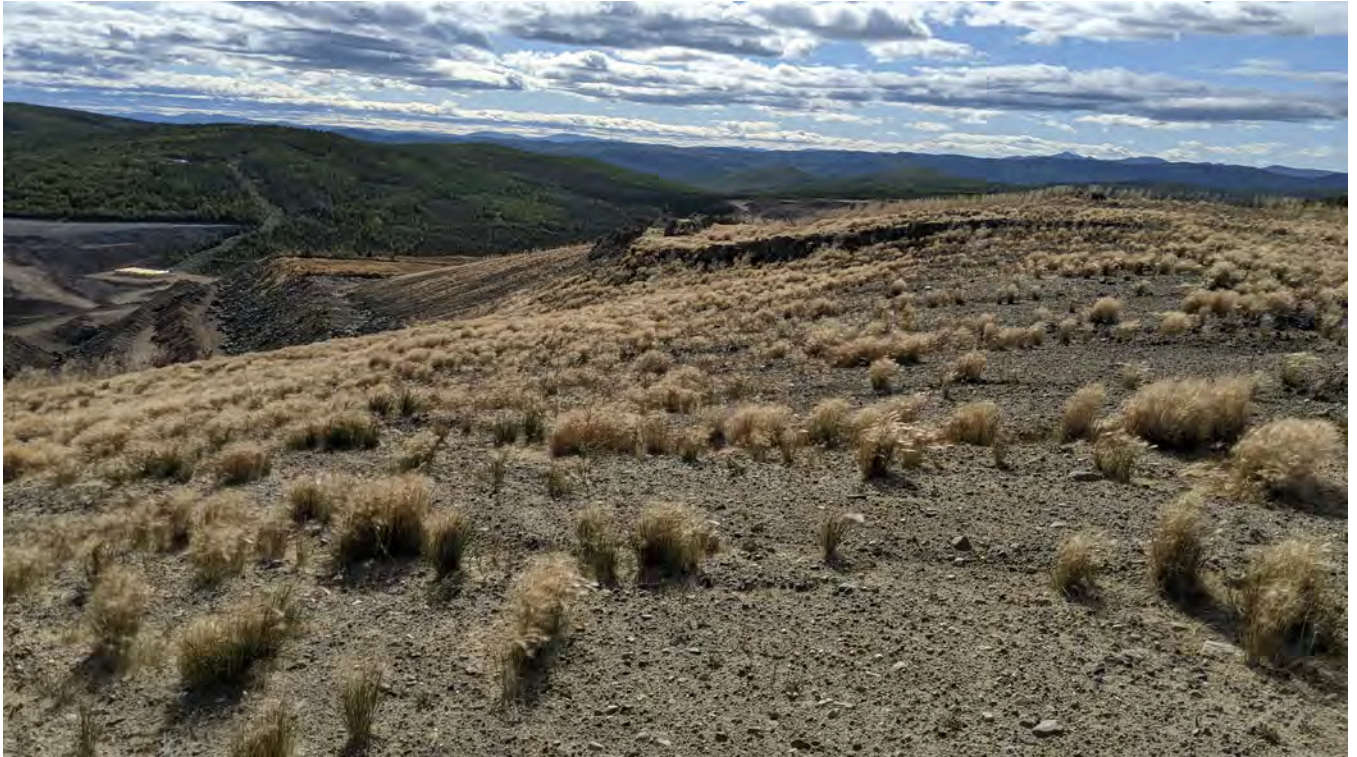
Photo 4-1: MWD regraded slope (looking southeast). A stockpile of cover soil is visible that is located above a portion of the dump that remains to be regraded.

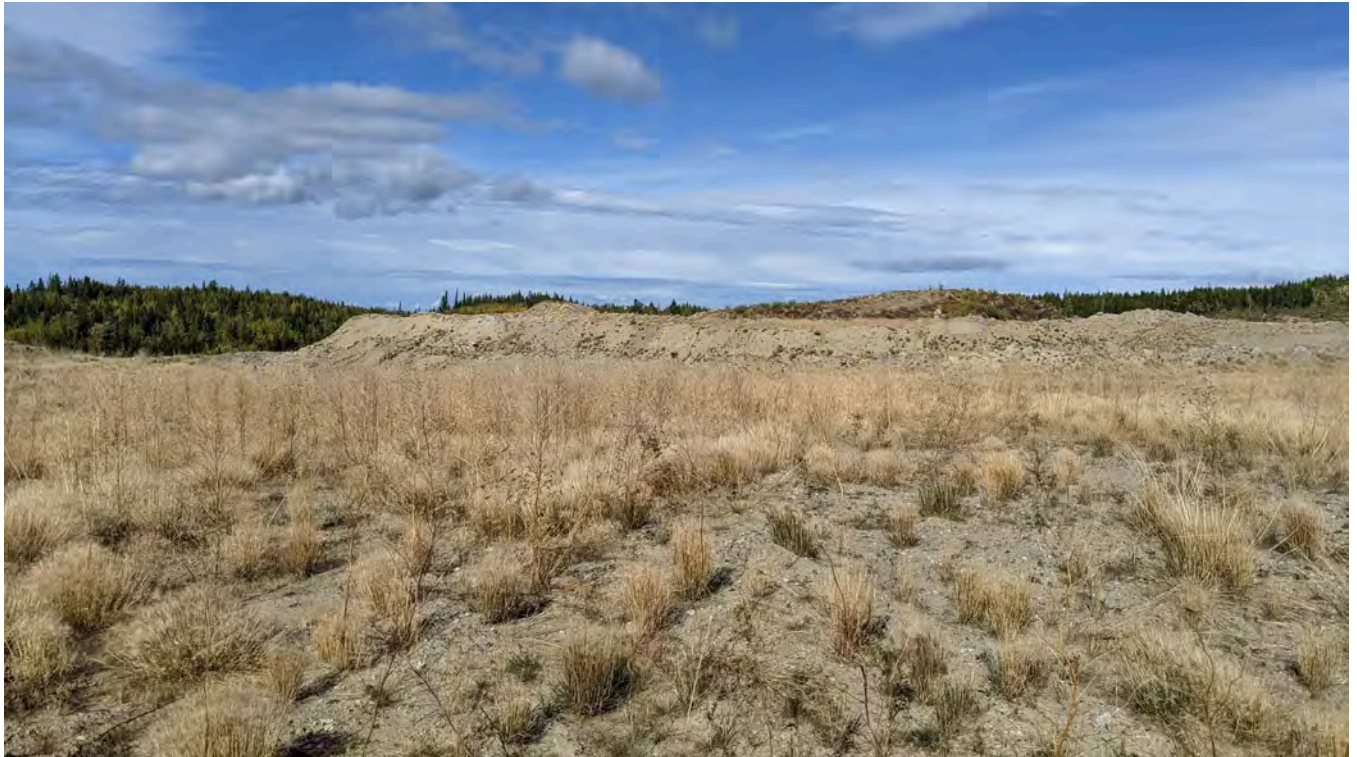
Photo 4-6: Stockpiled cover material at the top of the MWD Expansion.

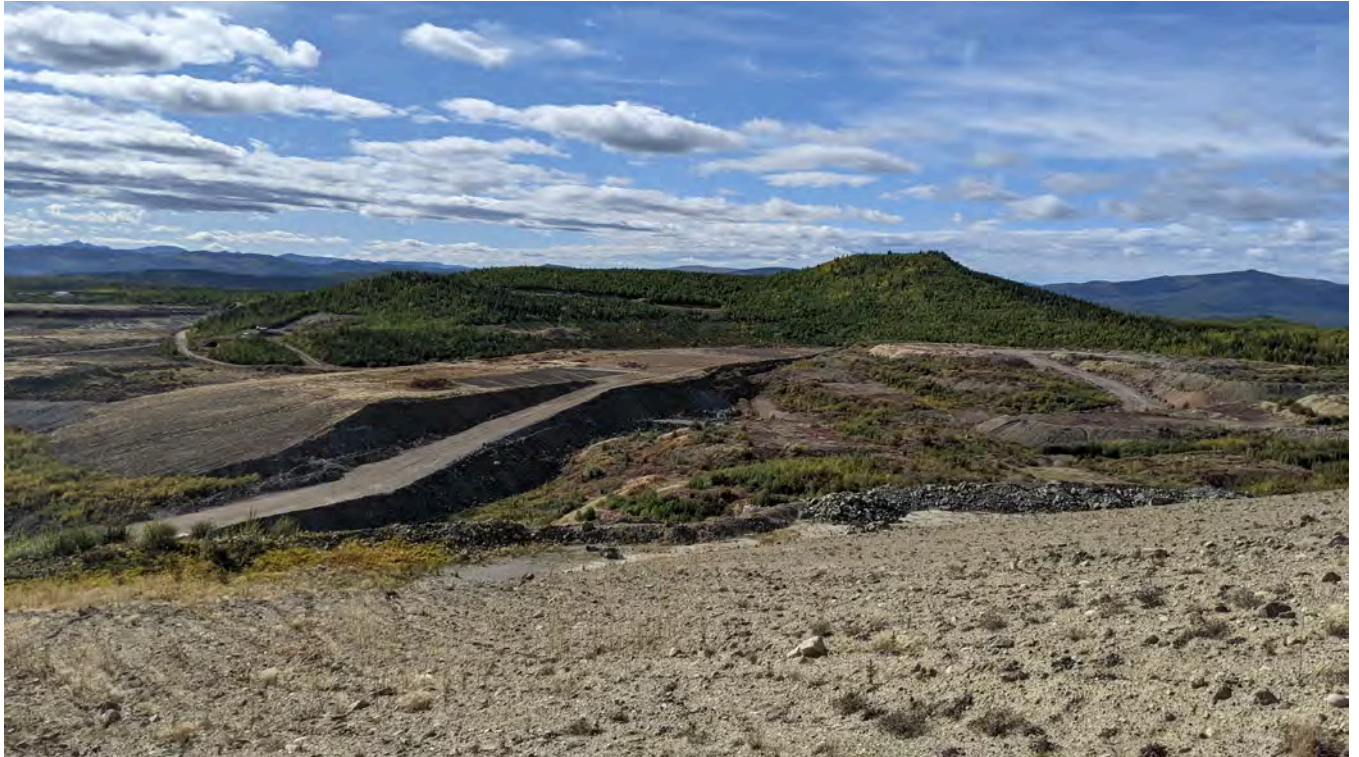
Photo 6-1: Overview of the north end of the SWD and ROD from the Main Waste Dump.

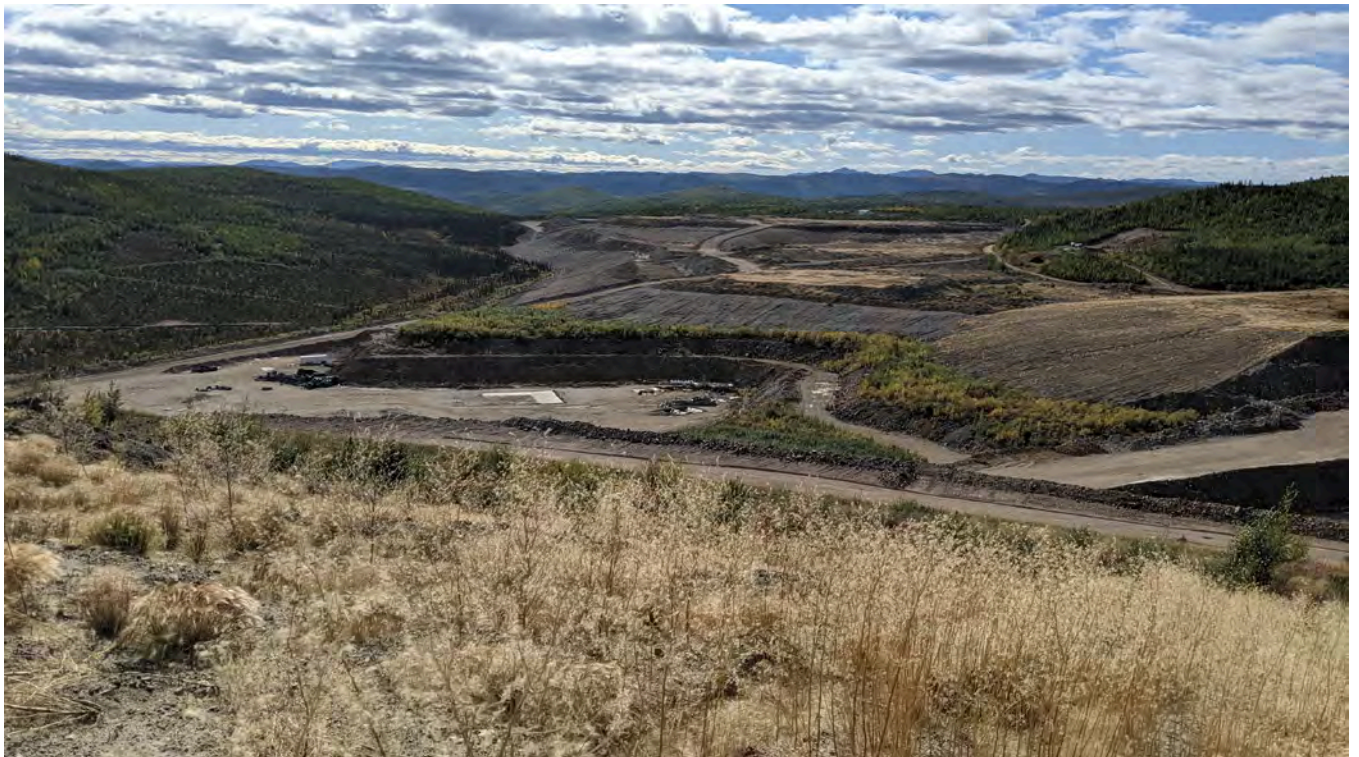
Photo 6-2: Overview of the SWD from the Main Waste Dump.

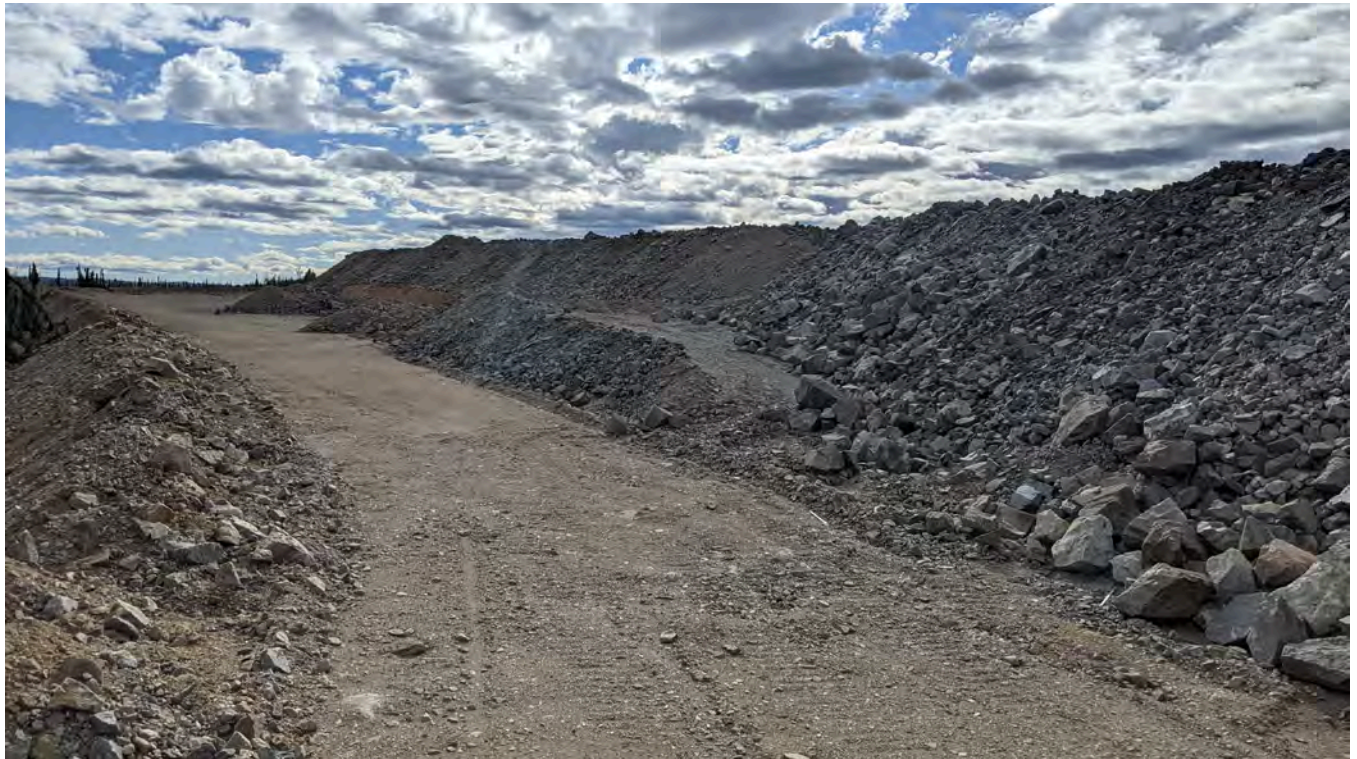
Photo 6-5: HGW Pad at the south end of the SWD

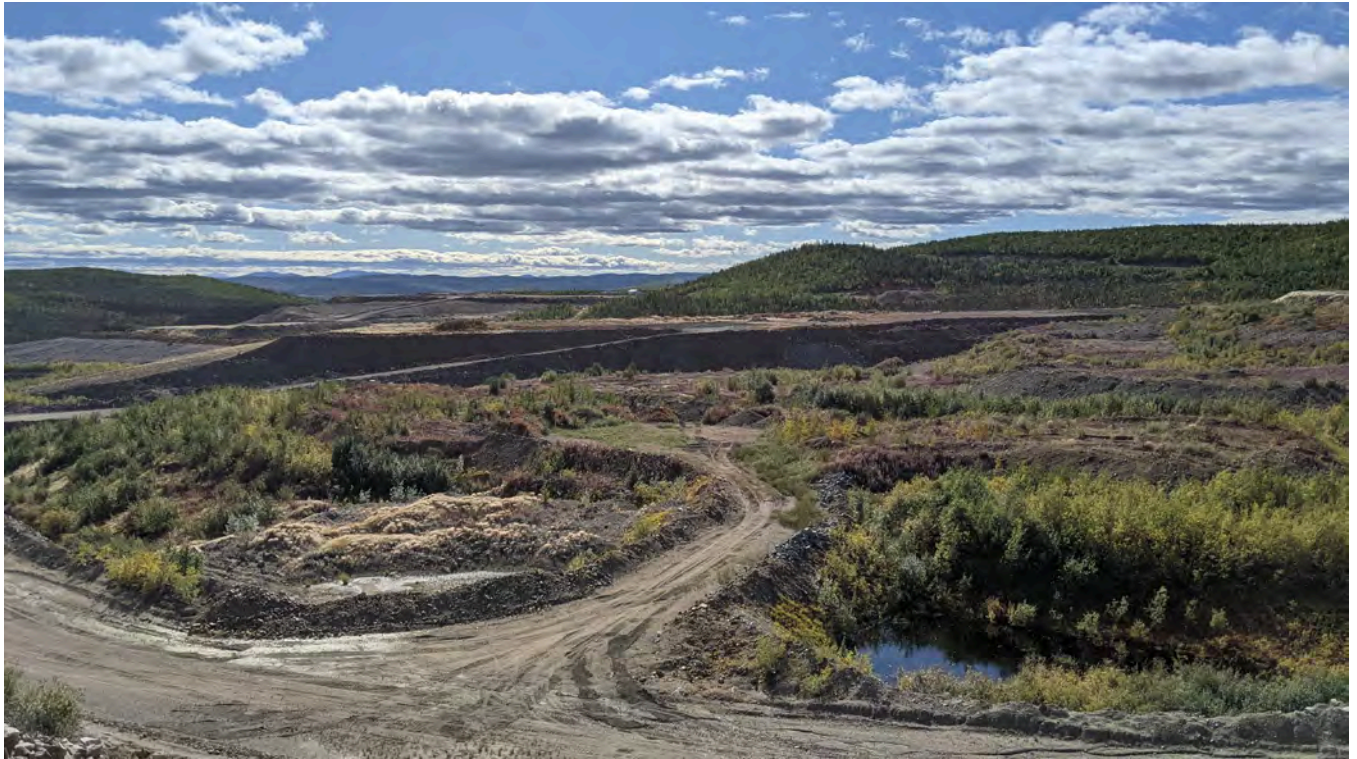
7	Reclamation Overburden Dump (ROD)	<ul style="list-style-type: none"> <li>■ Conditions are the same as noted in previous years' inspections.</li> <li>■ Vegetation has established in many areas the dump area on suitable overburden piles (Photo 7-1 and 7-2, Appendix A).</li> <li>■ Previous notes include:               <ul style="list-style-type: none"> <li>– Slumping, settlement, and tension cracks are expected in the dump as it is constructed with frozen overburden and thawing is expected</li> <li>– Discontinuous tension cracks and differential settlement have been observed along the perimeter crest</li> <li>– Ground undulation is typically 0.3 m and is prevalent throughout the facility</li> </ul> </li> <li>■ This area was not inspected on foot during the 2021 inspection</li> </ul>
8	Ore Stockpiles	<ul style="list-style-type: none"> <li>■ The ore stockpiles were investigated briefly in passing and appeared to be in good condition. No obvious signs of instability were noted.</li> </ul>

Photo 7-1: Reclamation Overburden Dump looking south.

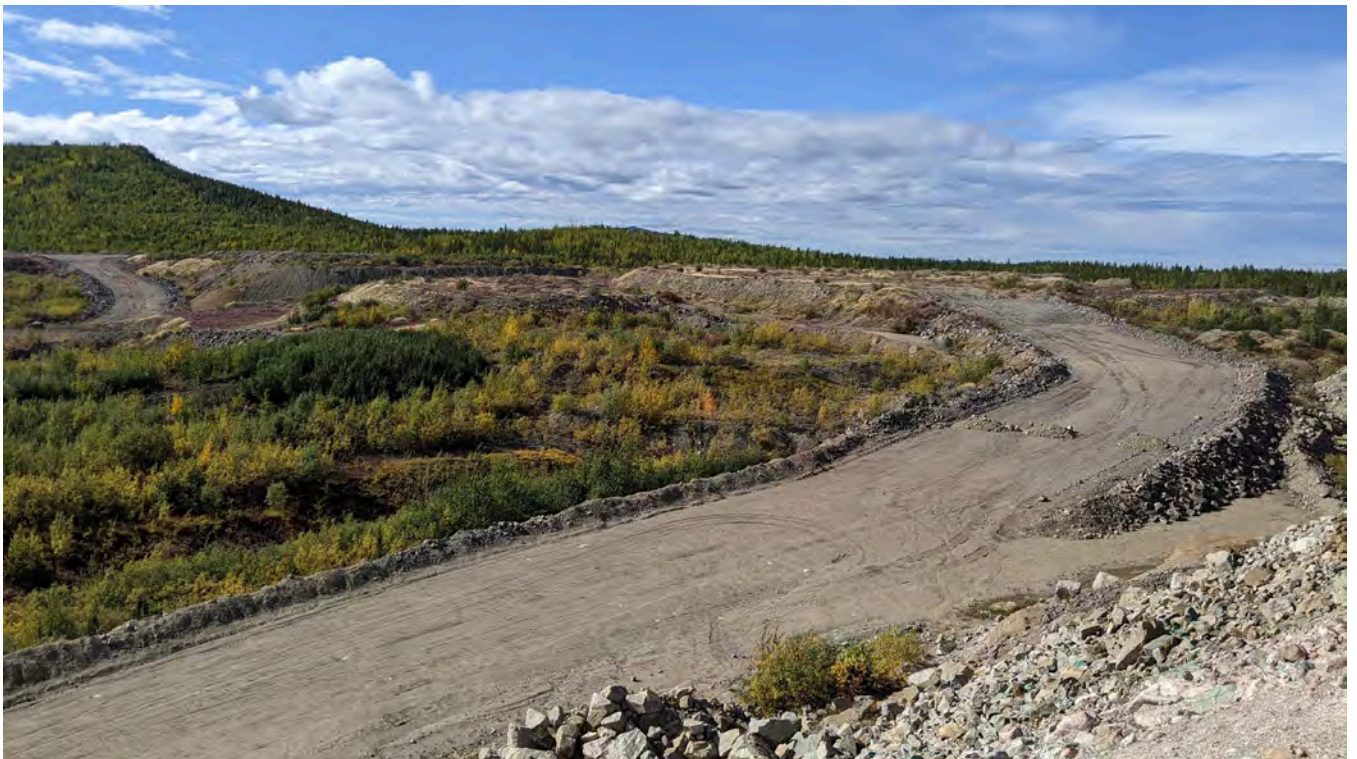
Photo 7-2: Reclamation Overburden Dump looking west.

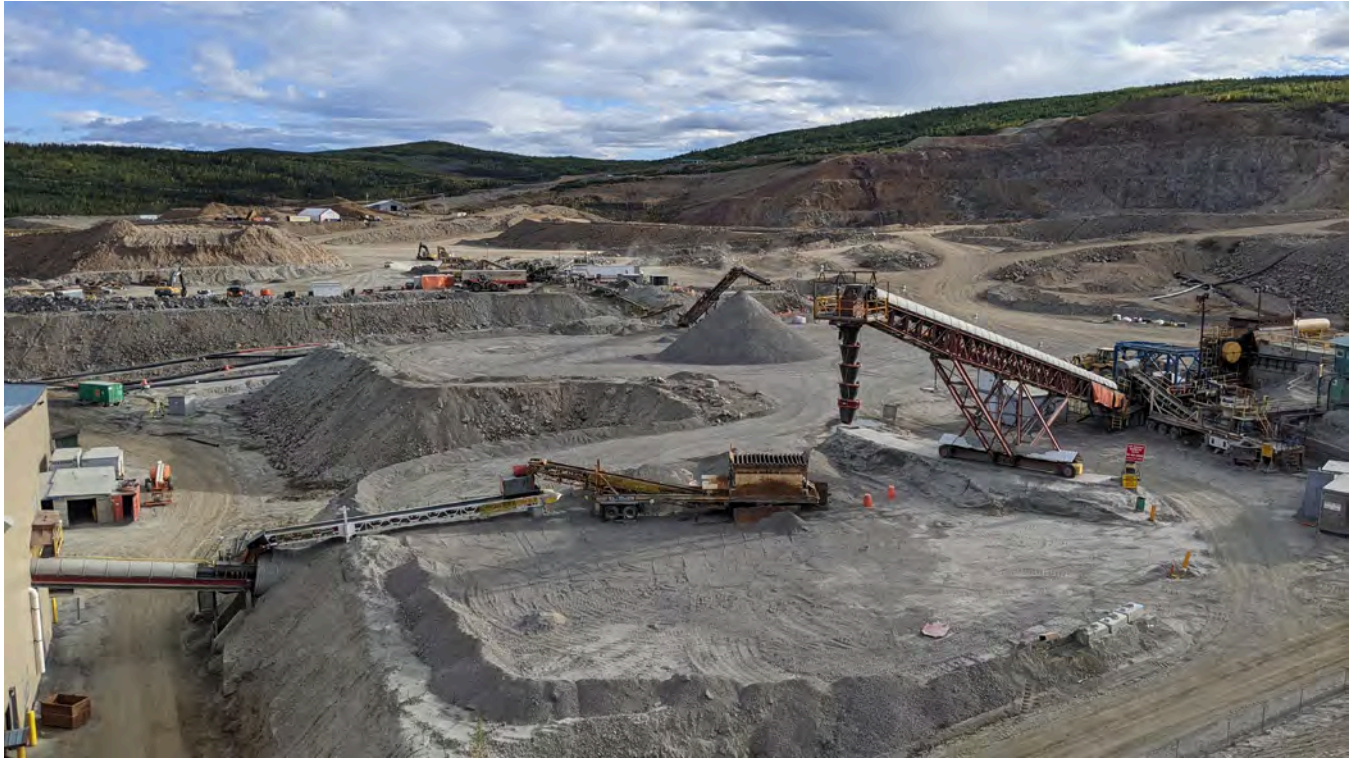
Photo 8-1: Crusher Stockpile west of the mill.

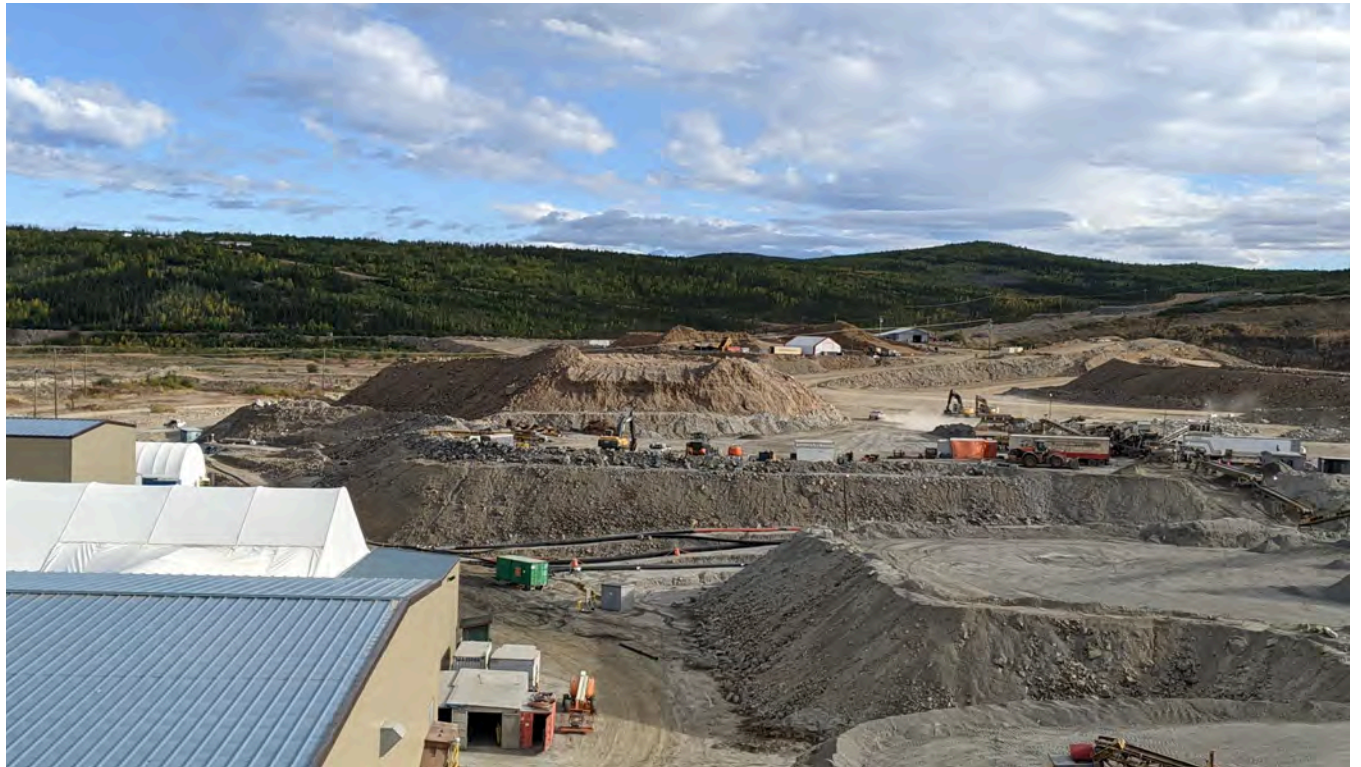
Photo 8-2: Ore Stockpiles south of the mill.

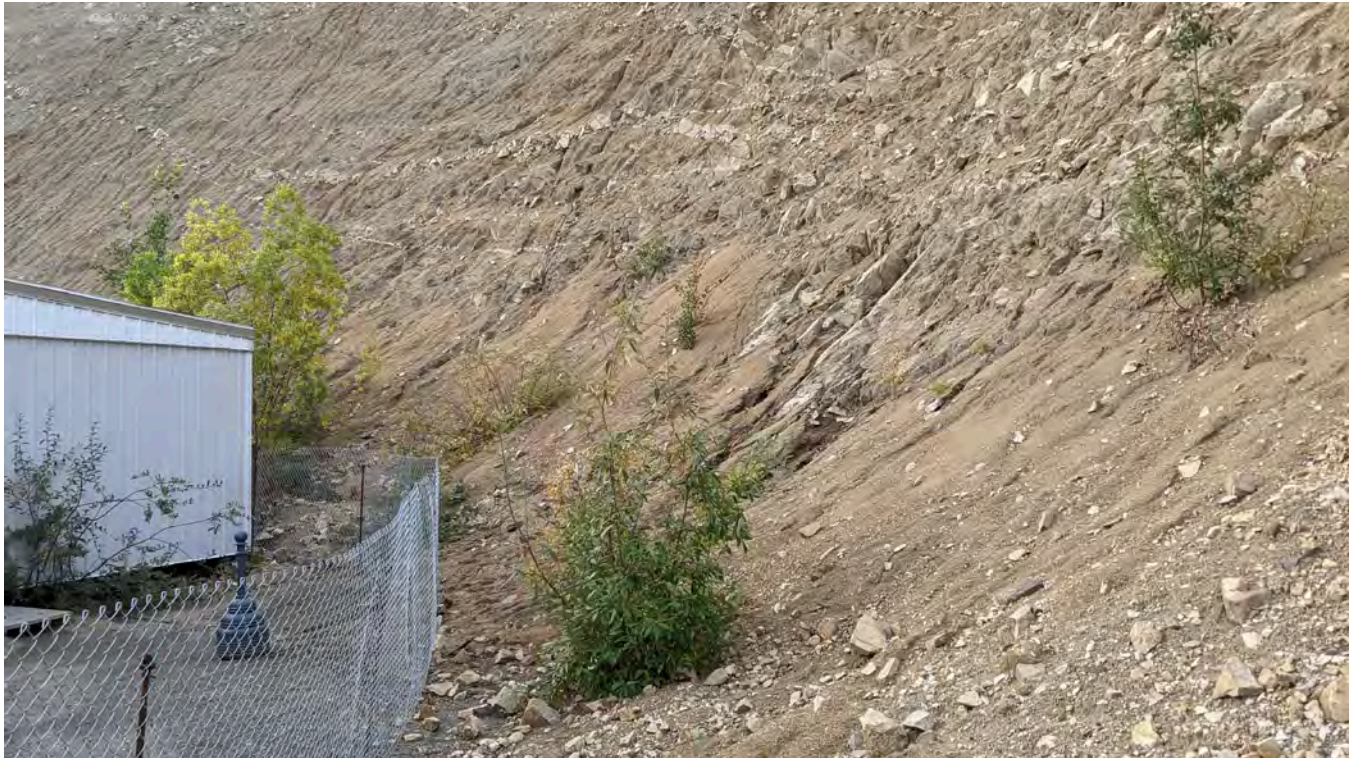
Photo 9-3: Historical seepage location located at the northeast corner of the mill area. No seepage was observed at the time of the inspection.
