# 2021 Geotechnical Annual Review

Minto Mine, Yukon  
Minto Explorations Ltd.

SRK Consulting (Canada) Inc. ■ 1CM002.073 ■ October 2021

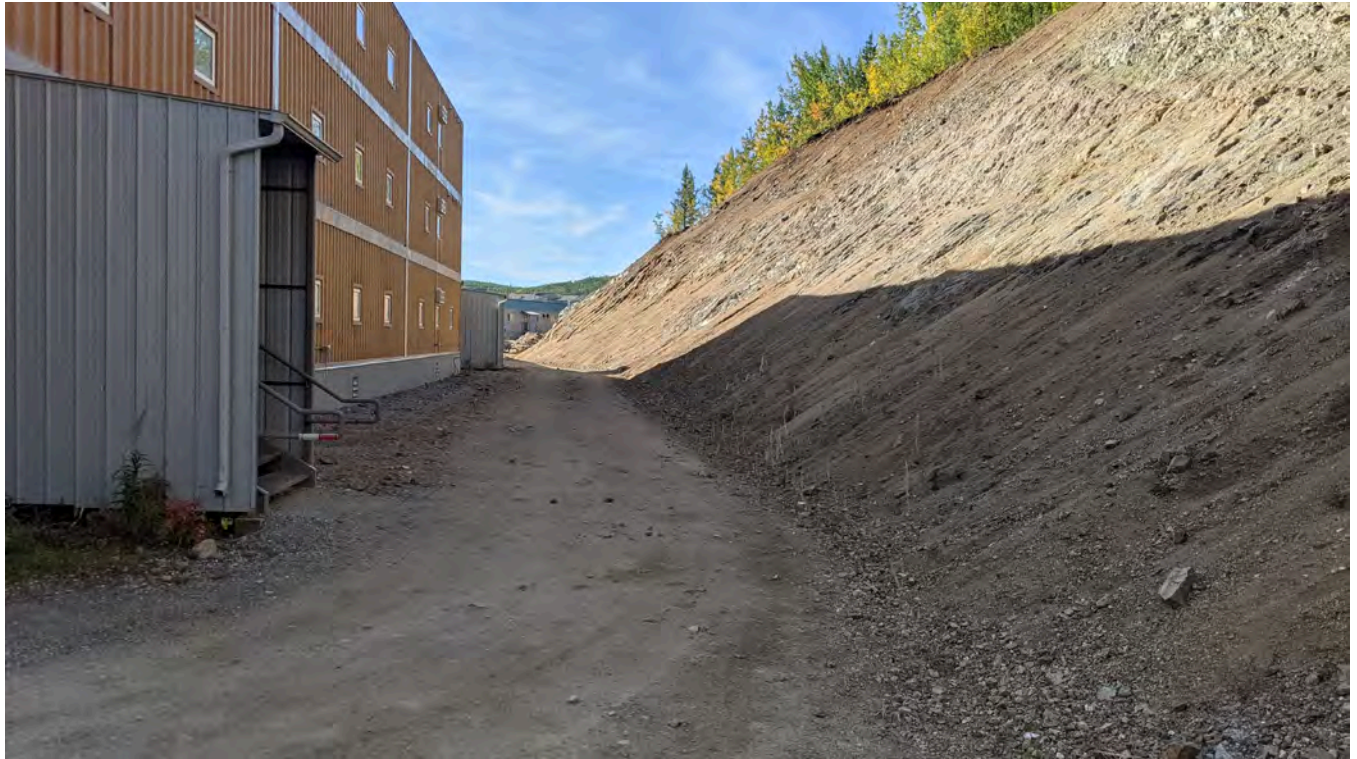
Photo 10-1: Highwall behind Selkirk Manor looking south from the north end of camp.

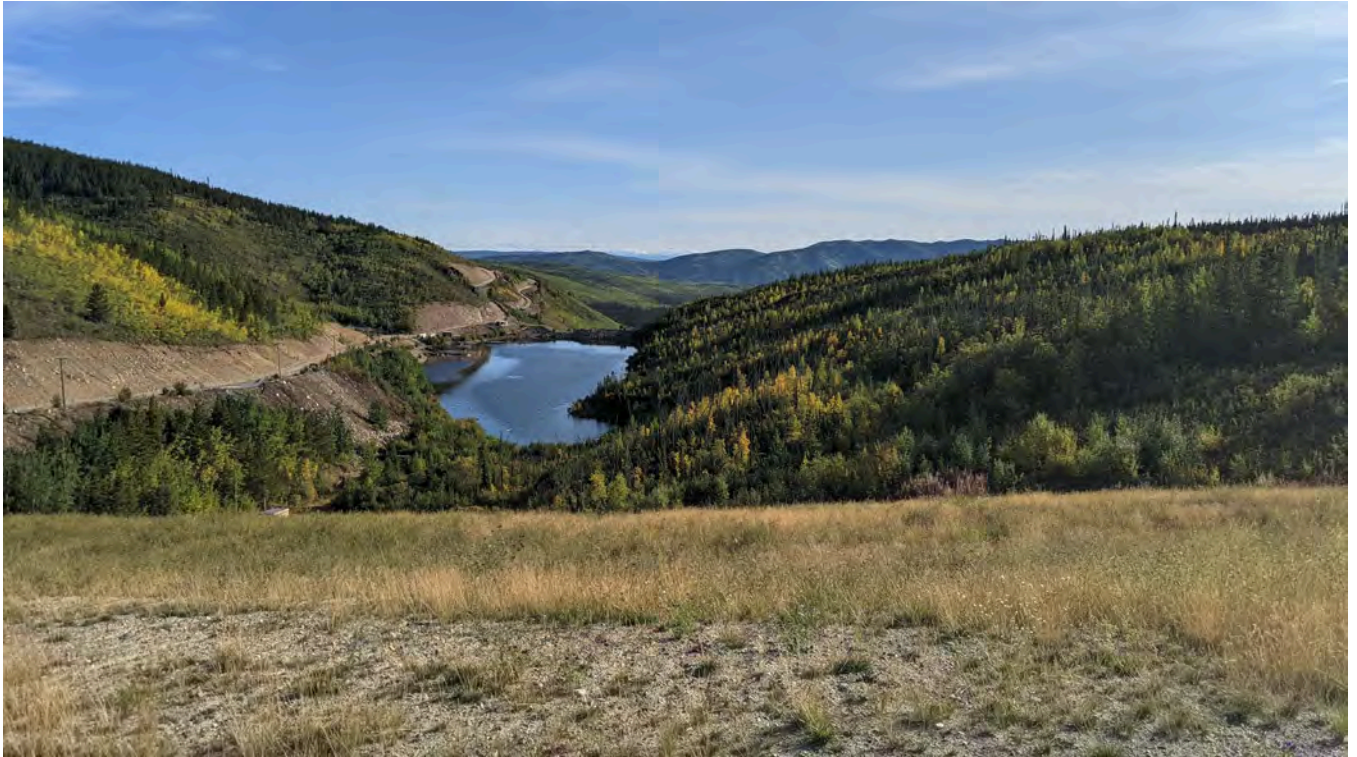
Photo 12-1: Overview of the WSP from the MVFE looking northeast.

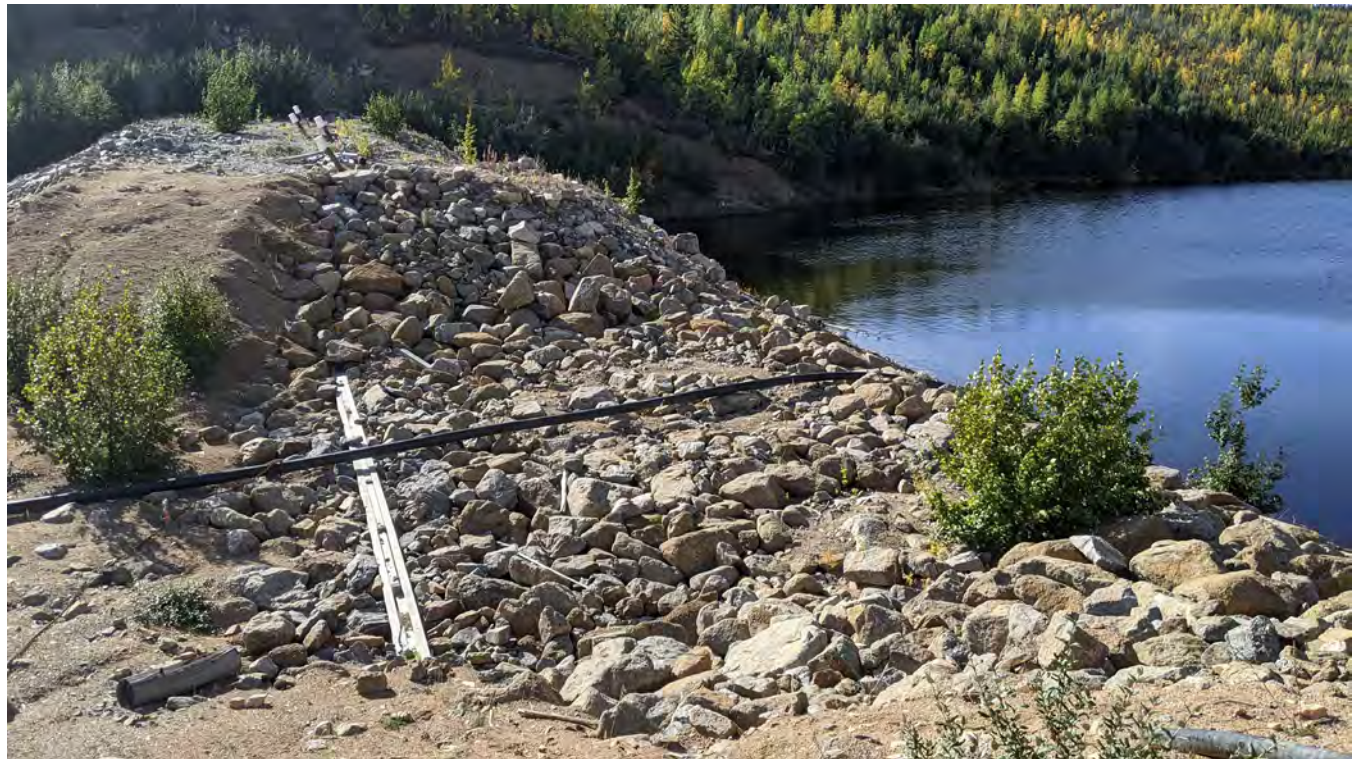
Photo 12-4: WSP spillway looking south from the dam crest.

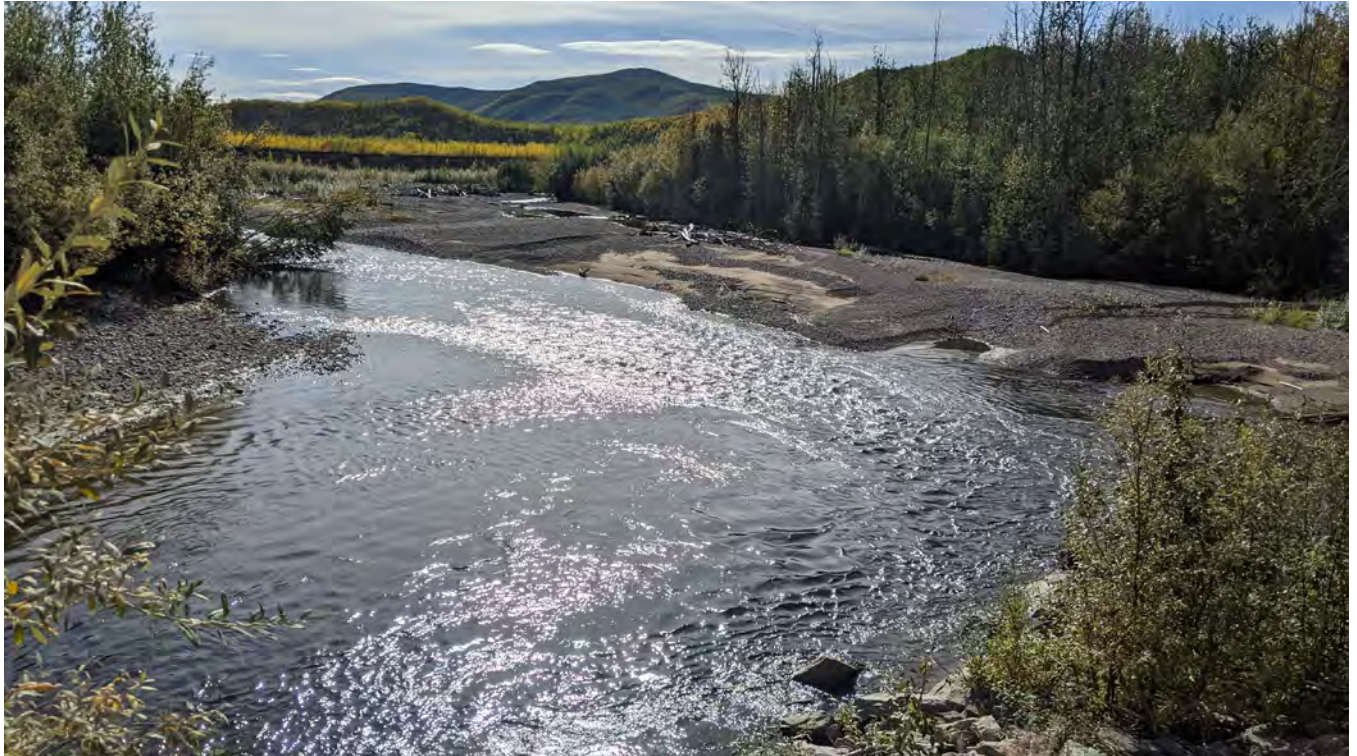
Photo 13-3: Big Creek looking upstream from the western abutment. An eddy is present upstream of the west abutment. The condition of the eddy and creek is the same as the 2020 inspection.

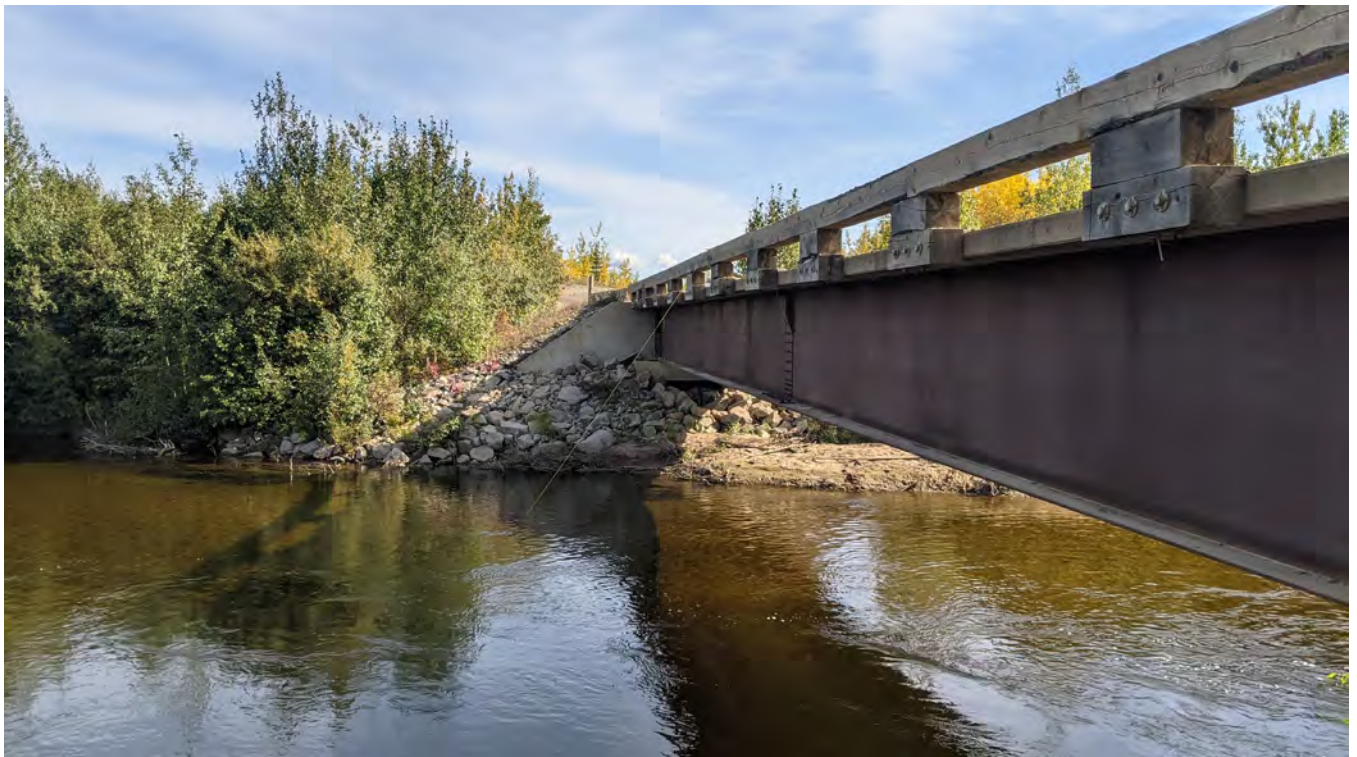
Photo 13-4: Downstream end of the eastern abutment. A rope is suspended from the bridge by the Minto Environmental department for environmental monitoring of the creek.

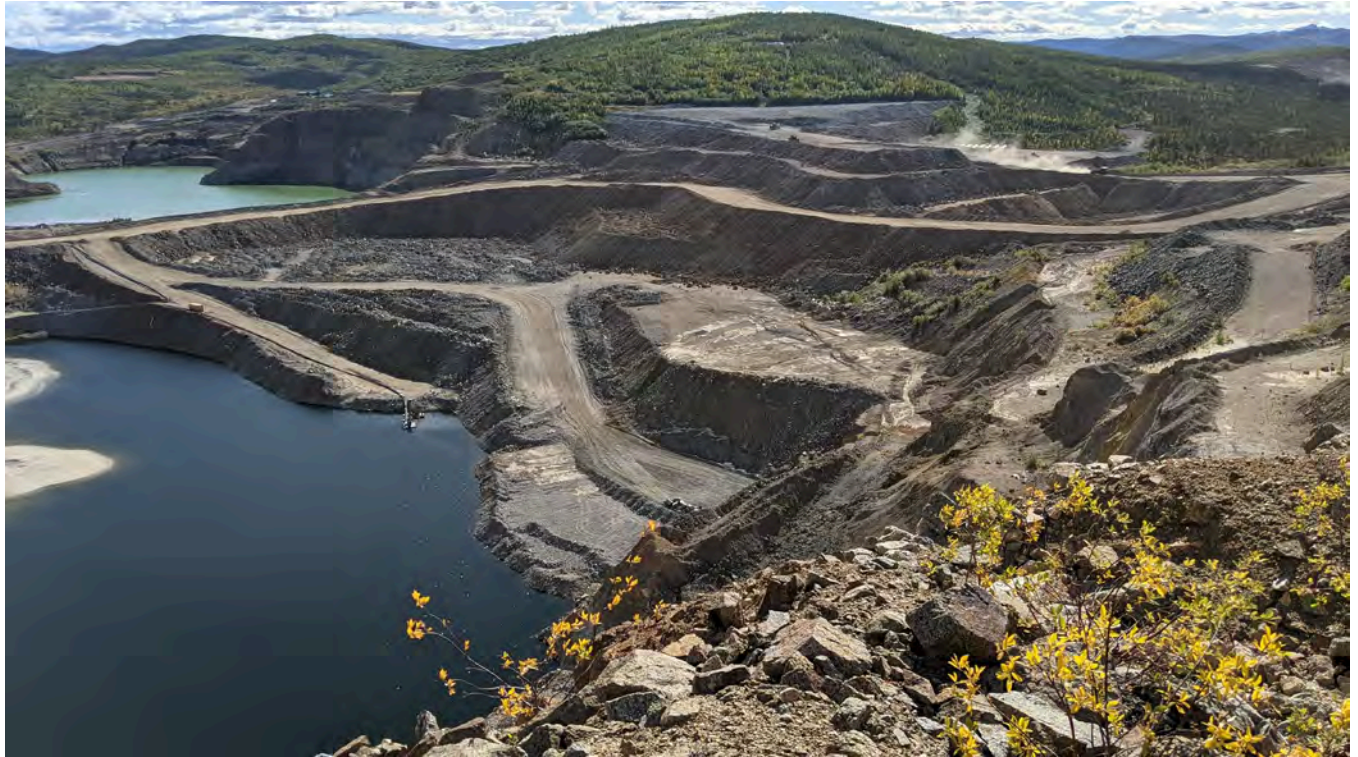
Photo 14-1: Main Pit and Main Pit Dump looking south.

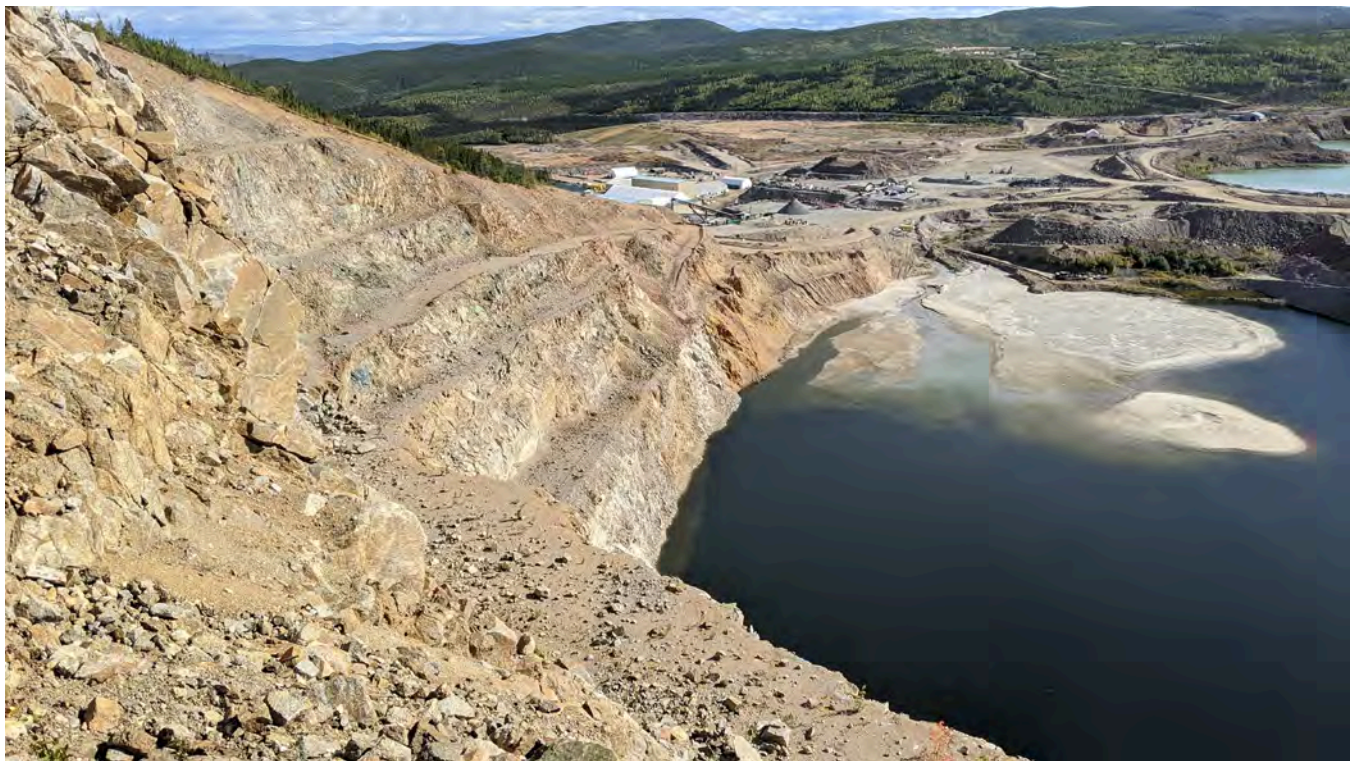
Photo 14-2: Main Pit looking east.

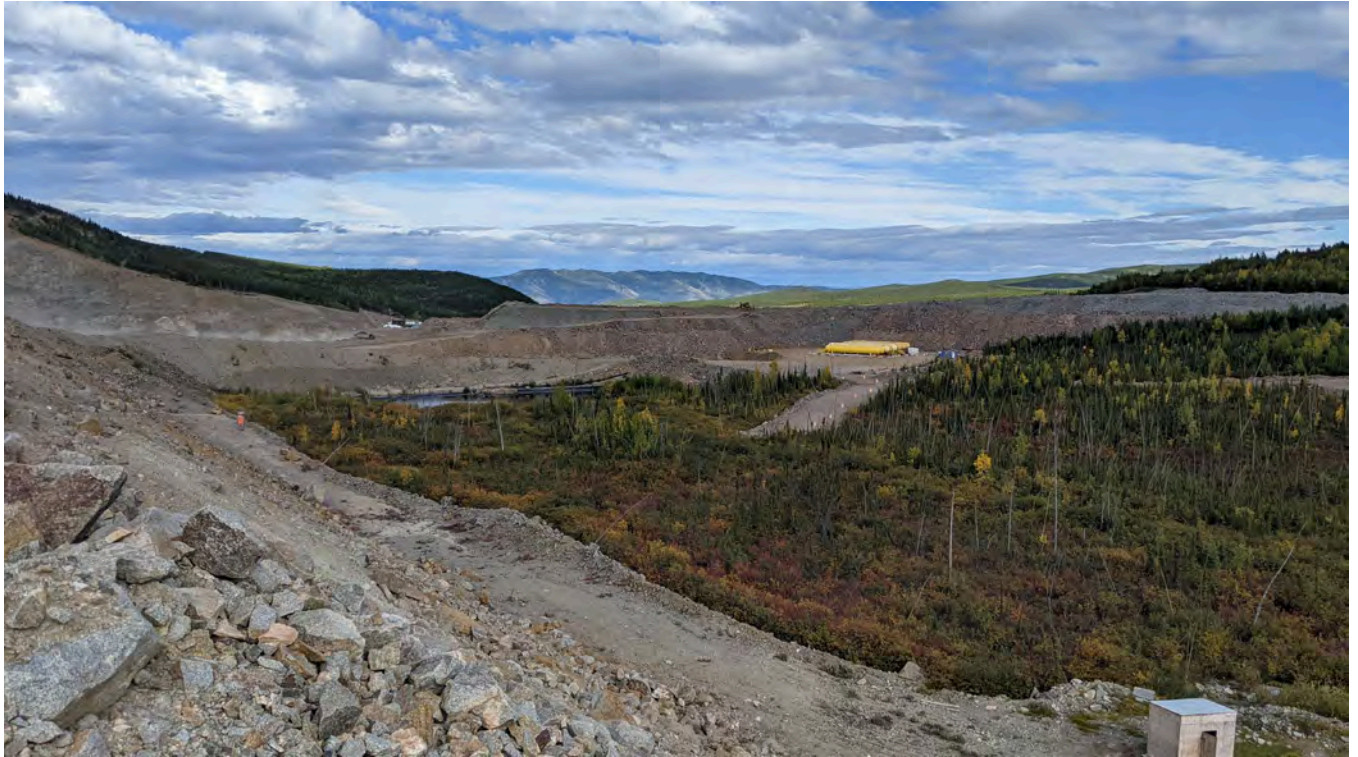
Photo 14-3: Veiw of the Main Pit Dump from the Southwest Dump.

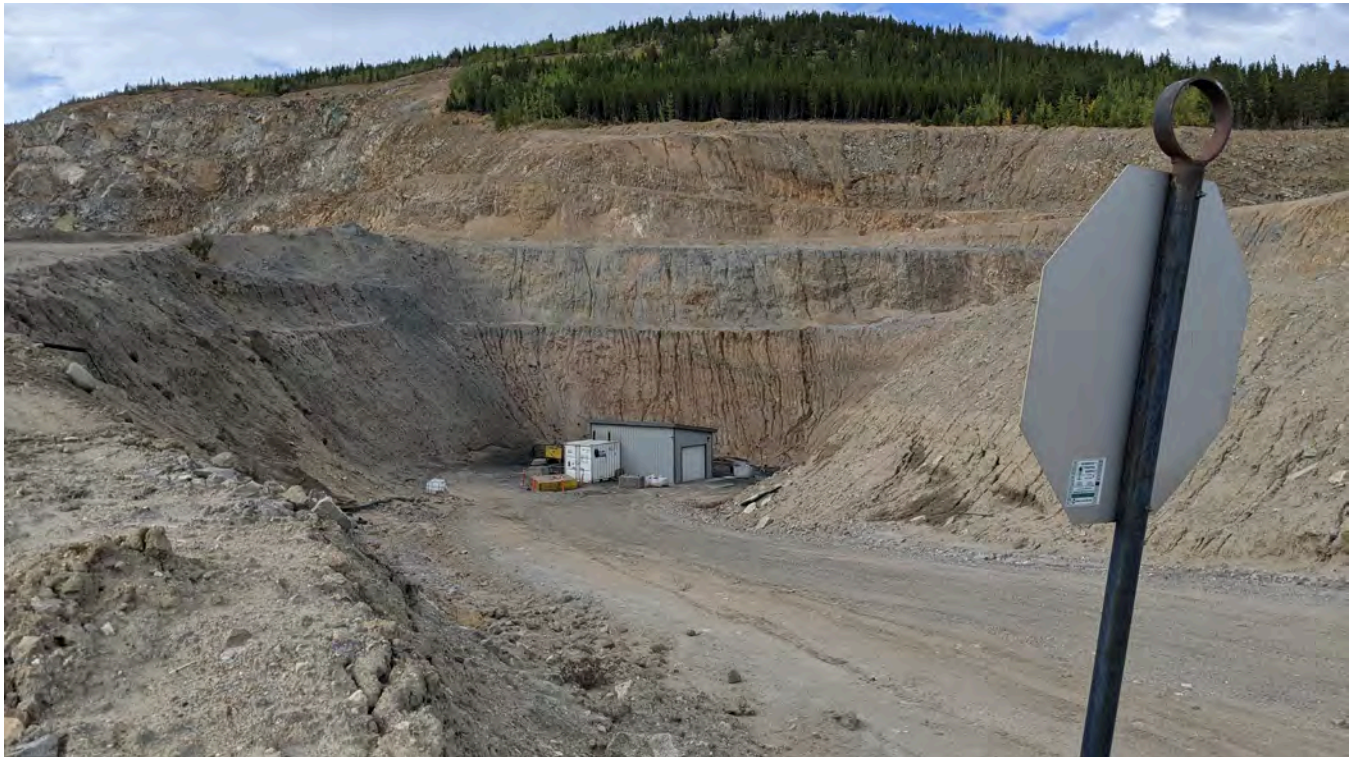
Photo 14-5: Vent raise located west of the Main Pit.

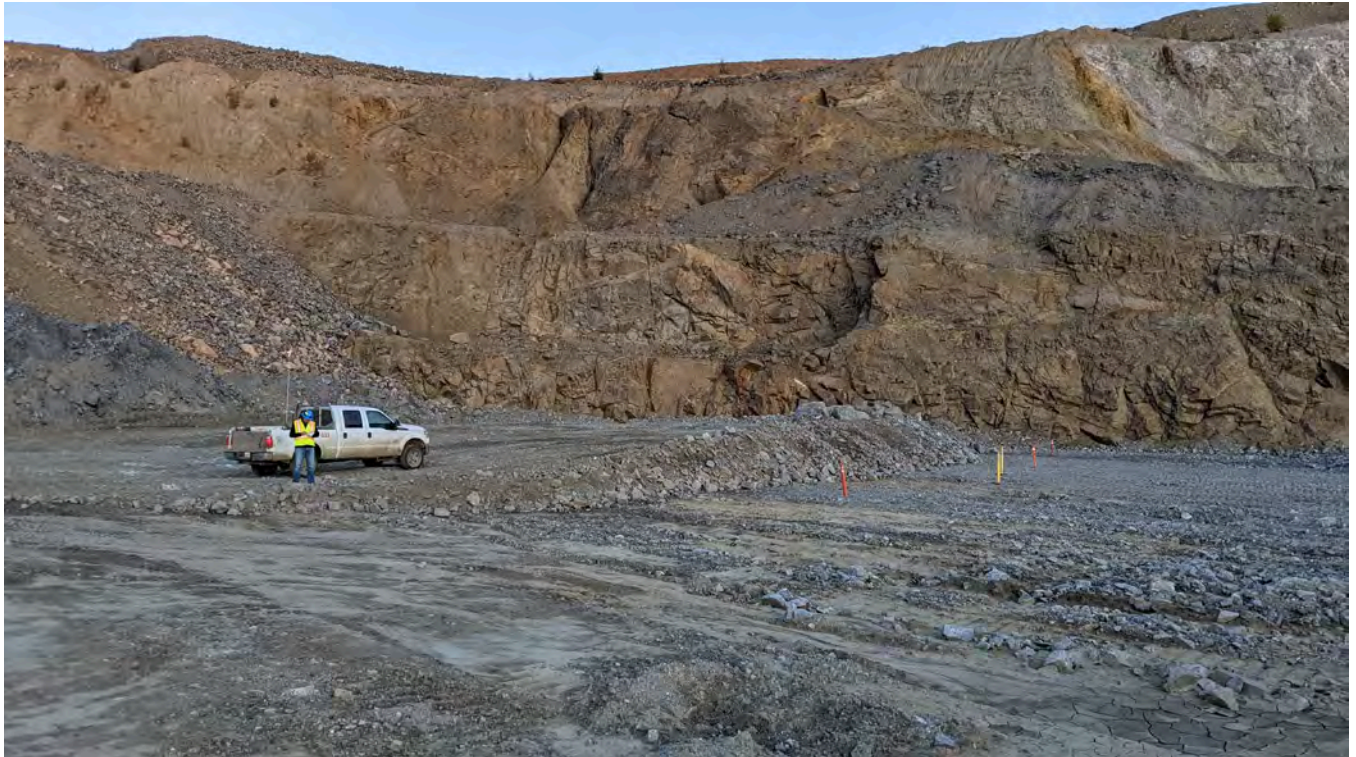
Photo 14-7: SAT Dump. An additional lift of SAT material has been placed on the SAT Dump in the past year. If the Main Dam does not proceed, this additional material will need to be relocated below the long-term water level.

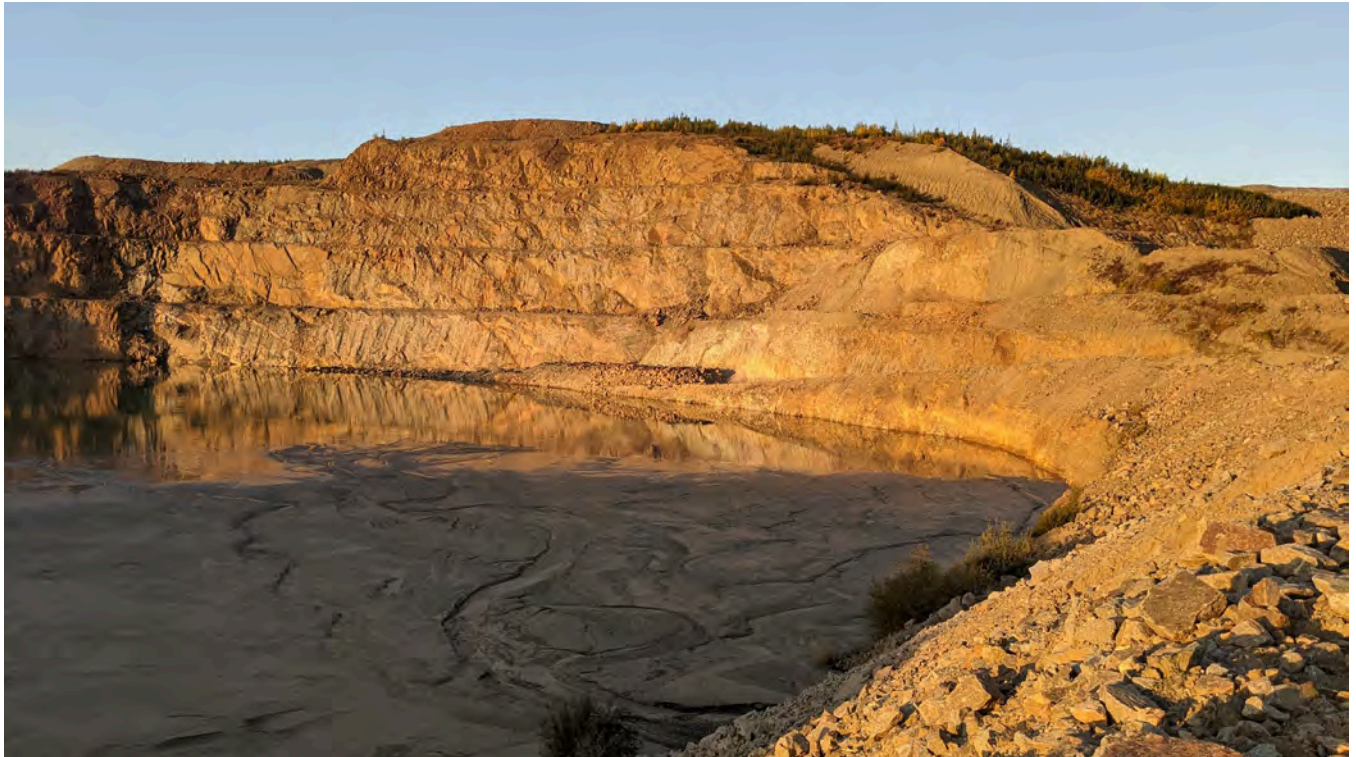
Photo 15-1: Area 2 Stage 2 Pit backfilled with tailings looking southwest

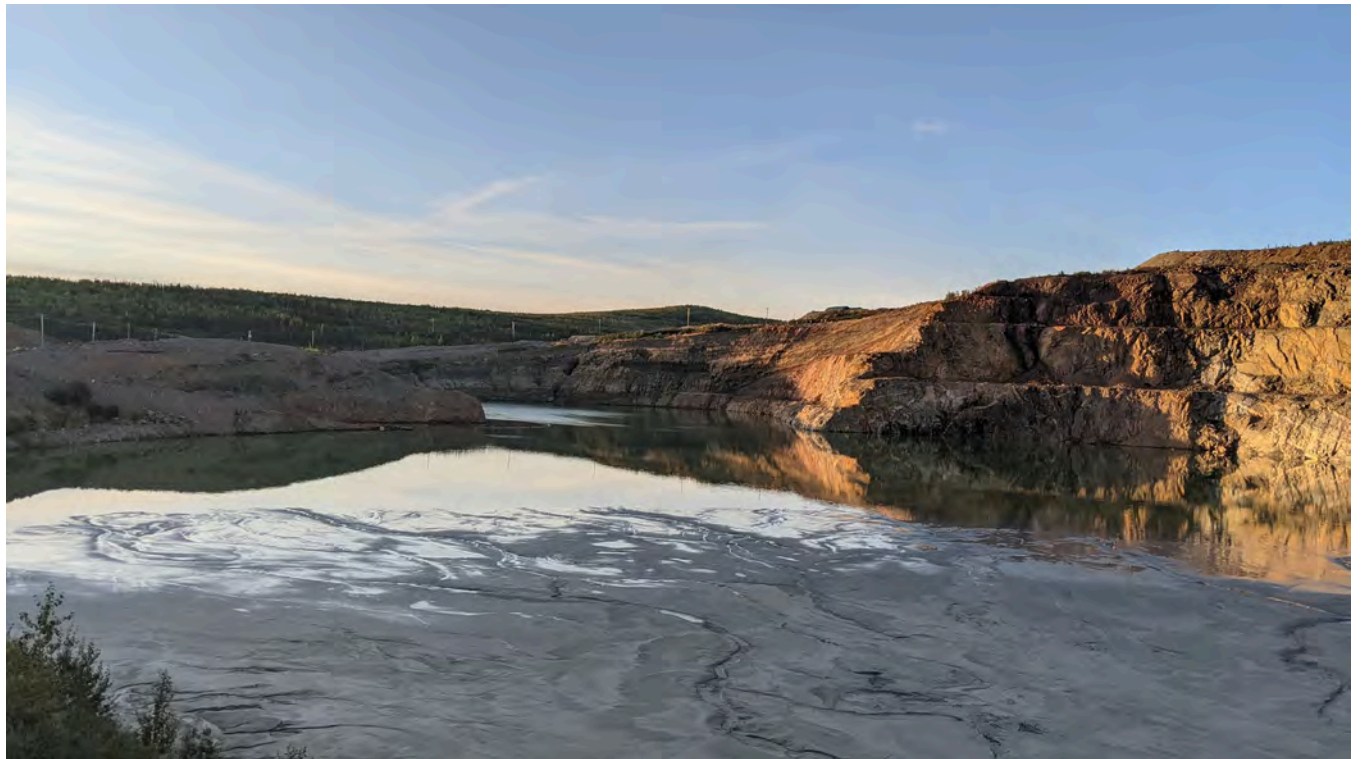
Photo 15-2: Area 2 Stage 2 Pit looking south.

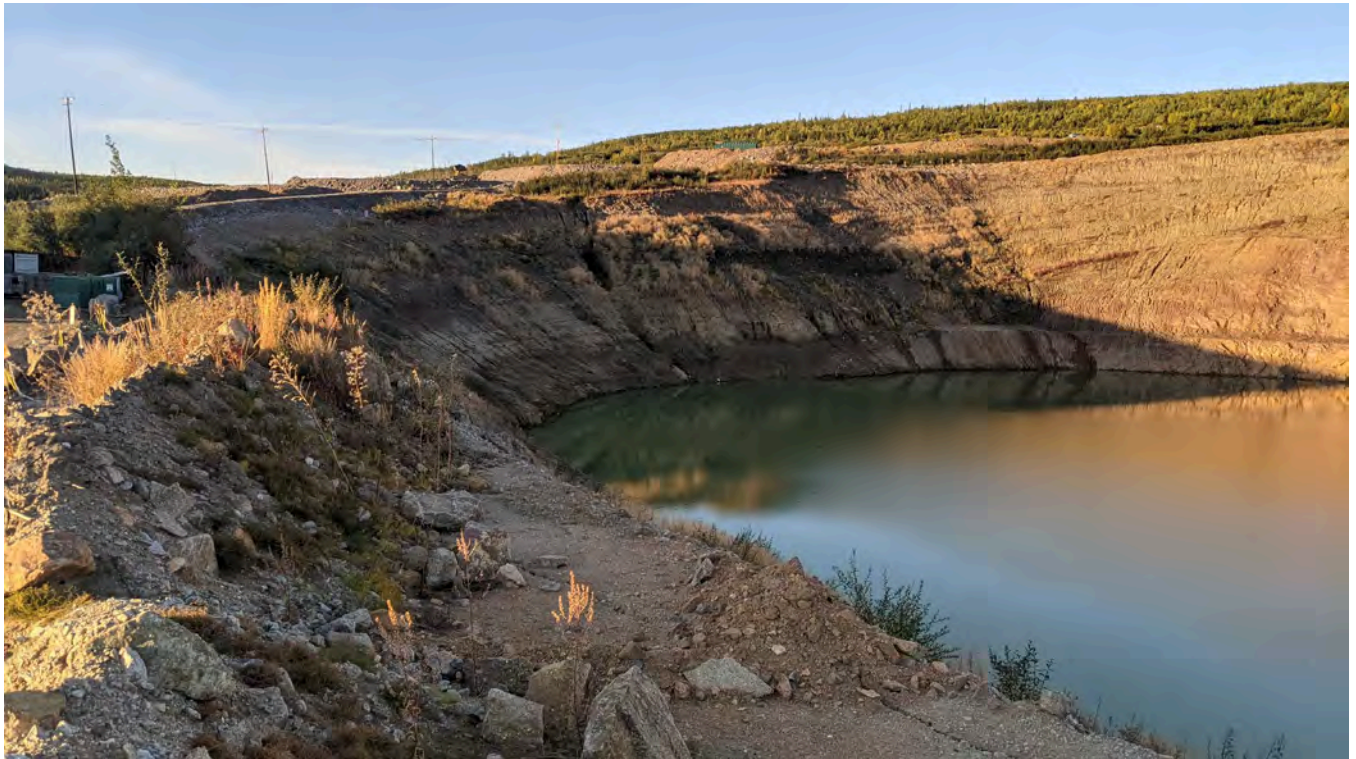
Photo 15-6: Area 2 Stage 3 Pit looking south.

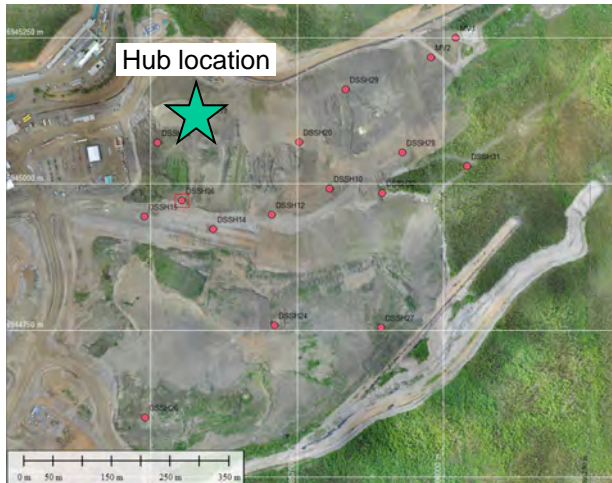
DSTSF Instrumentation Data		
		<b>Survey Hub – DSSH19</b>		
Job No: 1CM002.073	Minto Mine	Date: October 2021	Prepared by PHM	Figure: <b>8</b>
Filename: ApD_2021DSTFLandscape.pptx

- The survey hub was removed in December 2015 prior to MVFES2 construction. The hub was reinstalled in August 2016 following completion of construction.

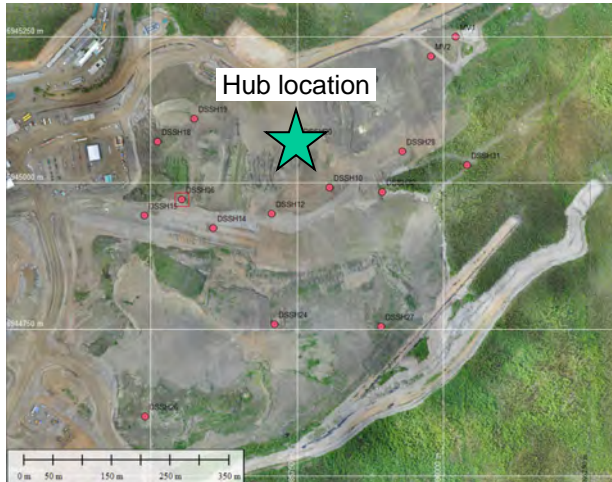
DSTSF Instrumentation Data		
		<b>Survey Hub – DSSH20</b>		
Job No: 1CM002.073 Filename: ApD_2021DSTFSLandscape.pptx	Minto Mine	Date: October 2021	Prepared by PHM	Figure: <b>9</b>

- The survey hub was removed in December 2015 prior to MVFES2 construction. The hub was reinstalle August 2016 following completion of construction.

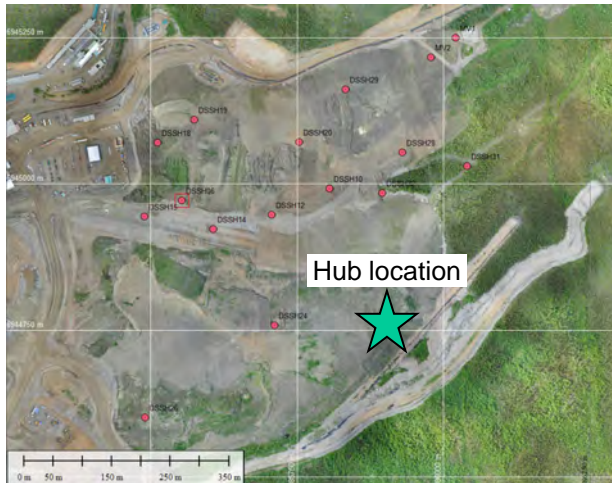
### DSSH27 - Northing Vs. Easting Movement Plot

- Note:  
1. The survey hub was repositioned in June 2017.
