**YUKON ZINC CORP.  
WOLVERINE MINE**

**TAILINGS STORAGE FACILITY AND ON-SITE  
EARTH STRUCTURES 2016 INSPECTION**

VA101-677/1-1  
Rev 0  
December 2, 2016

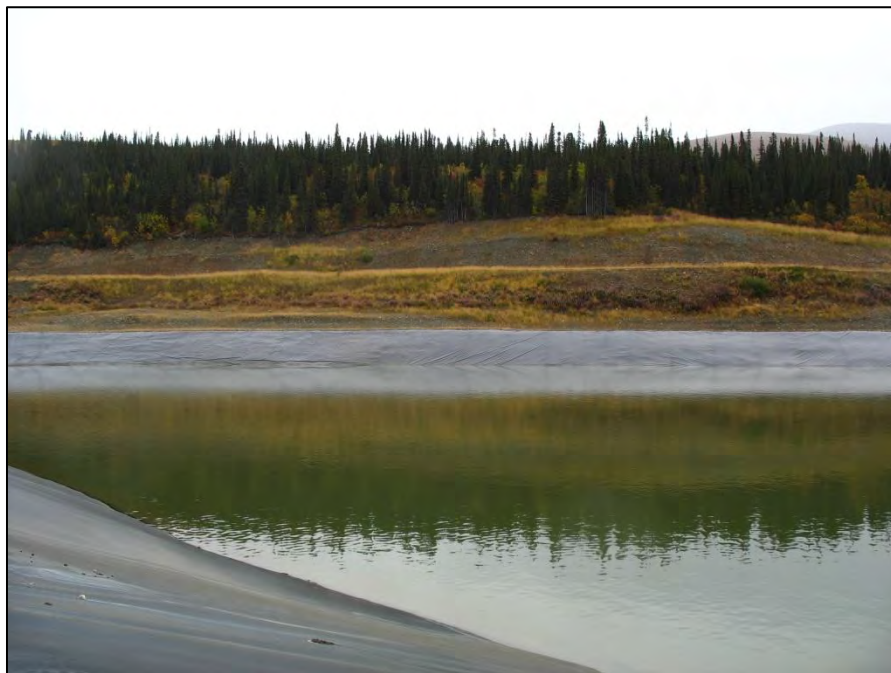
**PHOTO 19** – West Side of TSF – Looking east

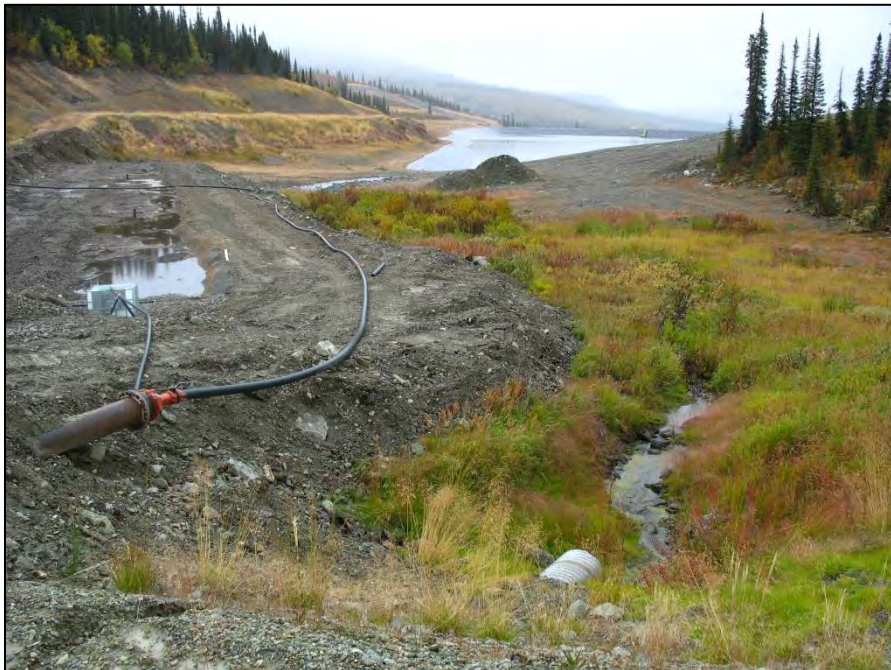
**PHOTO 32** – Passive treatment area north of TSF.

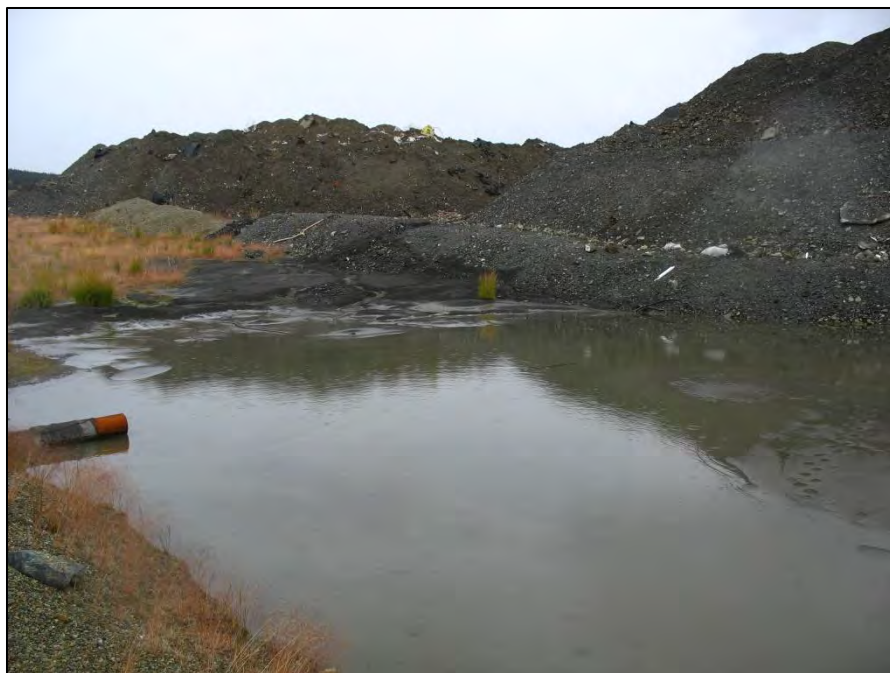
**PHOTO 33** – Small collection area downstream of the Waste Rock Storage Area.

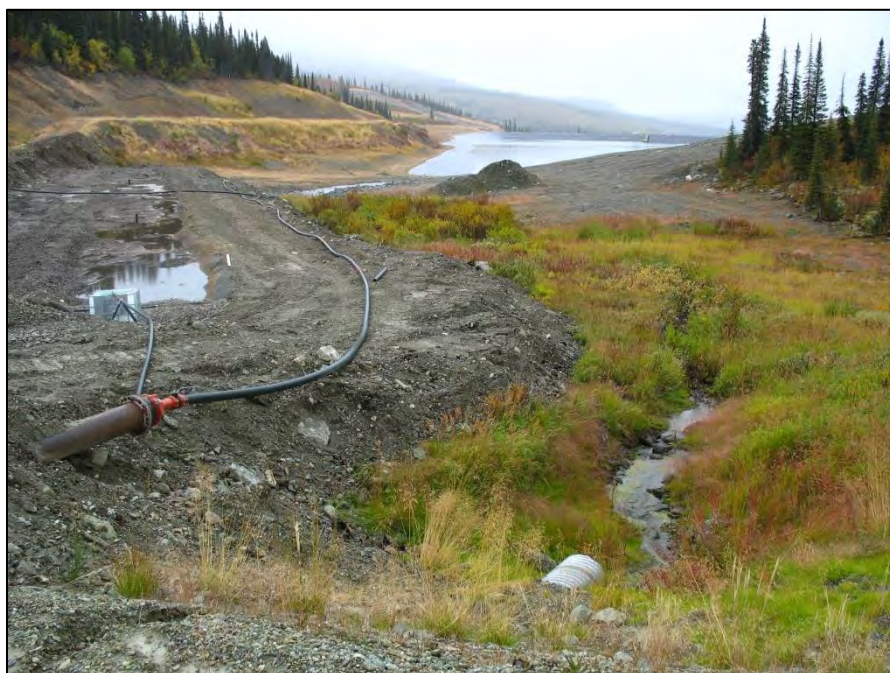
**PHOTO 34** – Passive treatment area north of TSF.

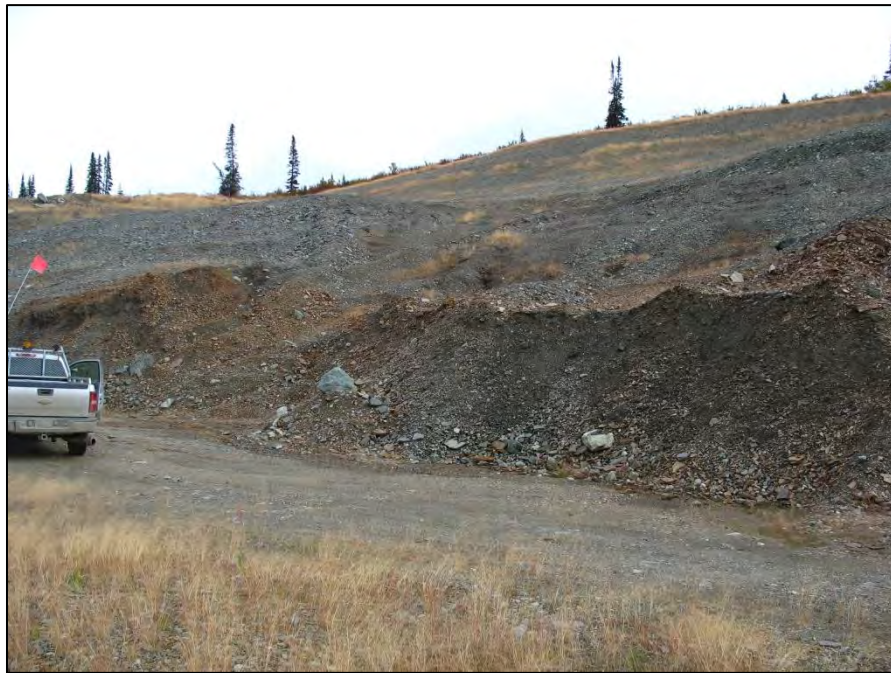
**PHOTO 35** – SE borrow

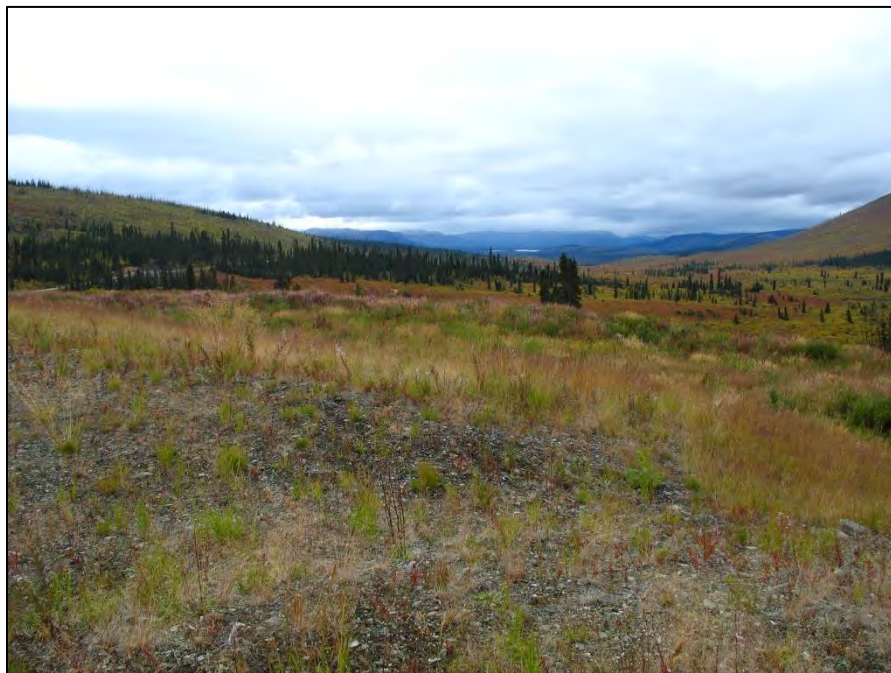
**PHOTO 36** – SE waste pile

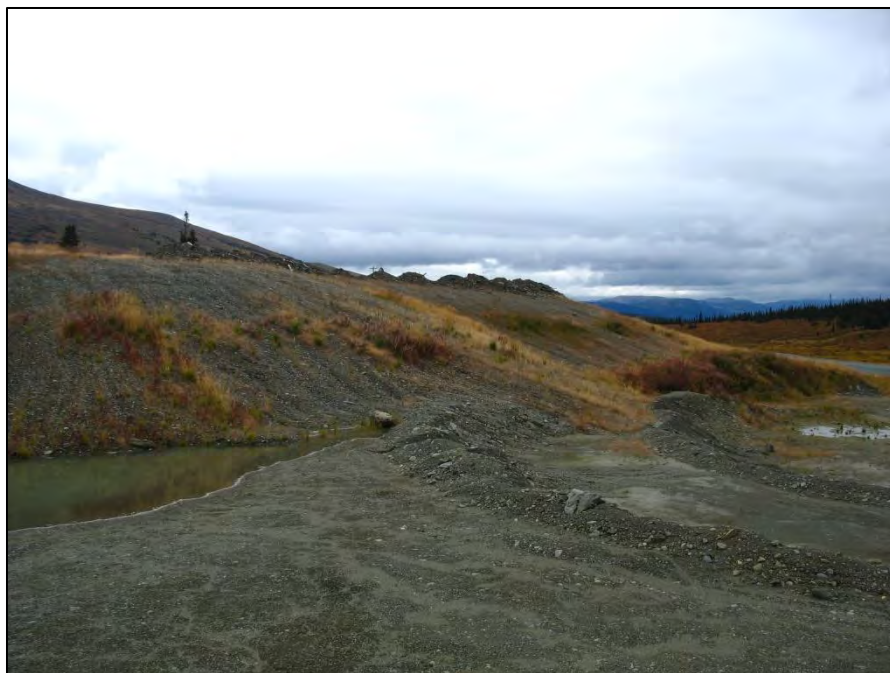
**PHOTO 37** – NW waste pile

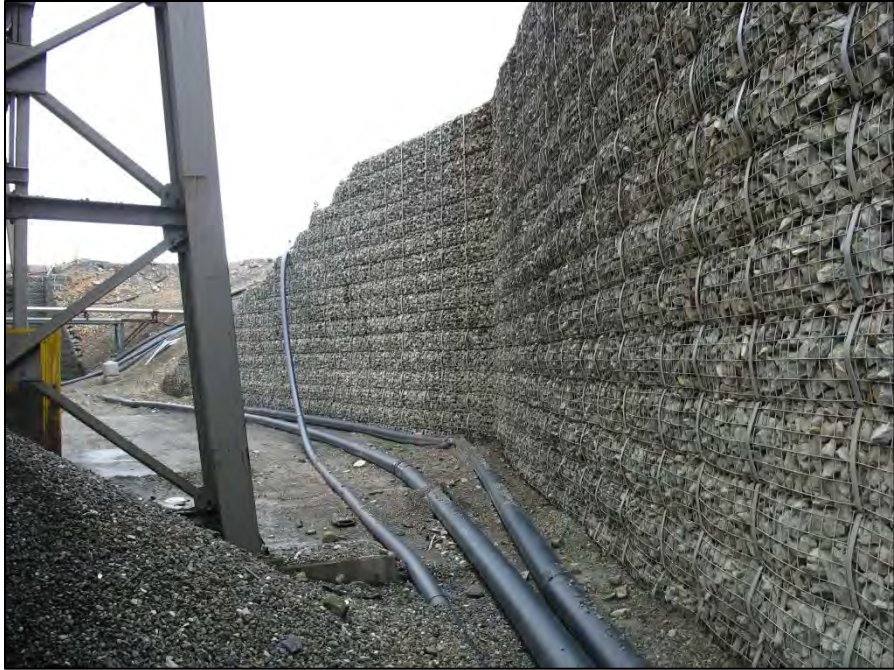
**PHOTO 39 – MSE Wall**
