WOLVERINE MINE

QUARTZ MINING LICENSE QML-0006

2014 ANNUAL REPORT

Prepared by:
Yukon Zinc Corporation
Vancouver, British Columbia

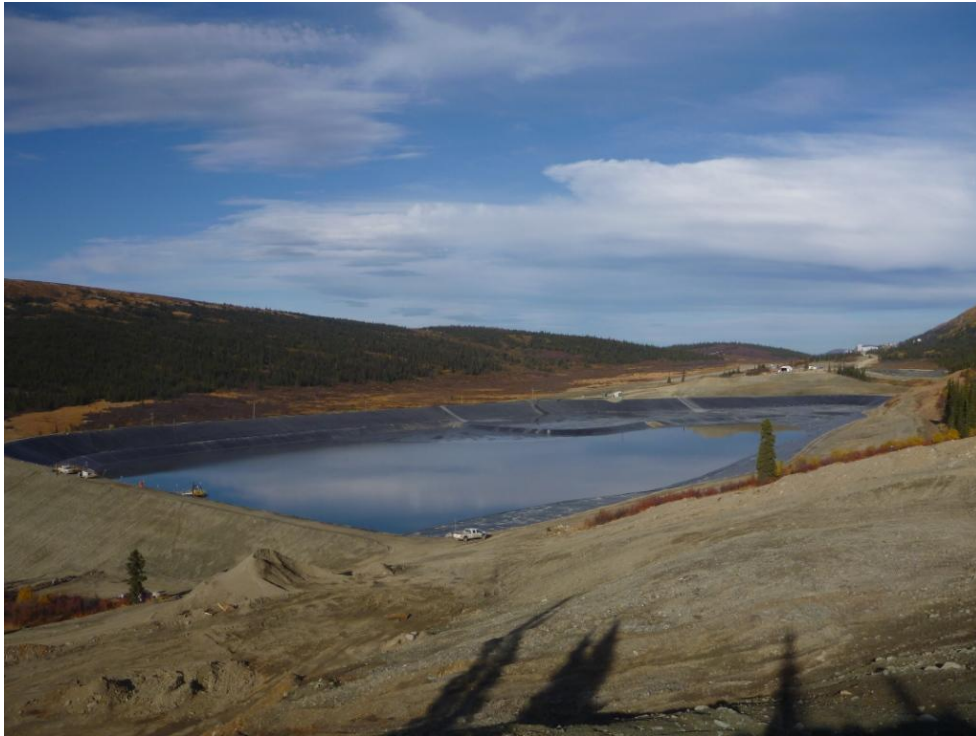
Picture 2-1: Tailings storage facility after dam lift construction project, looking east (top) and west (bottom).

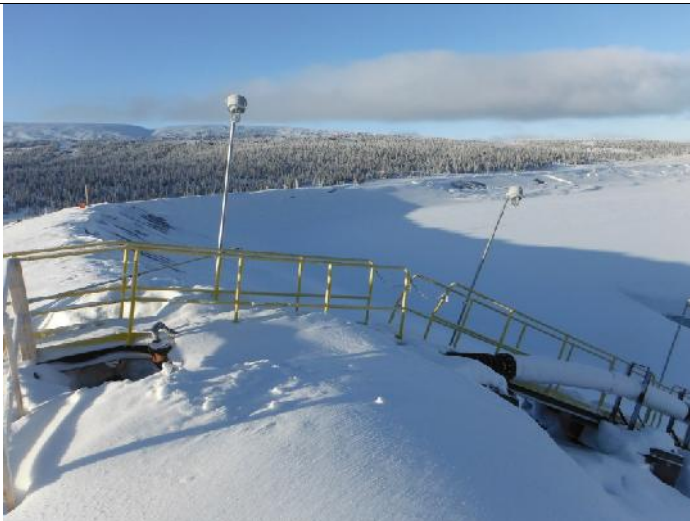
Photo 3: South wall view with walk way to the barge.

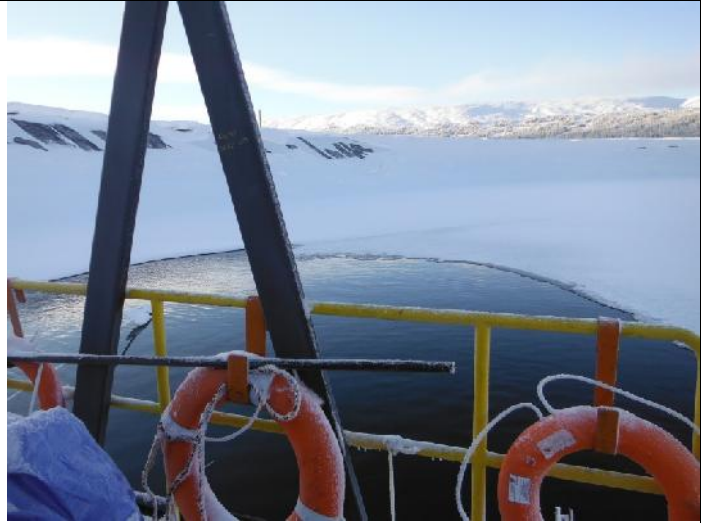
Photo 6: looking west from barge capturing south west corner of TSF

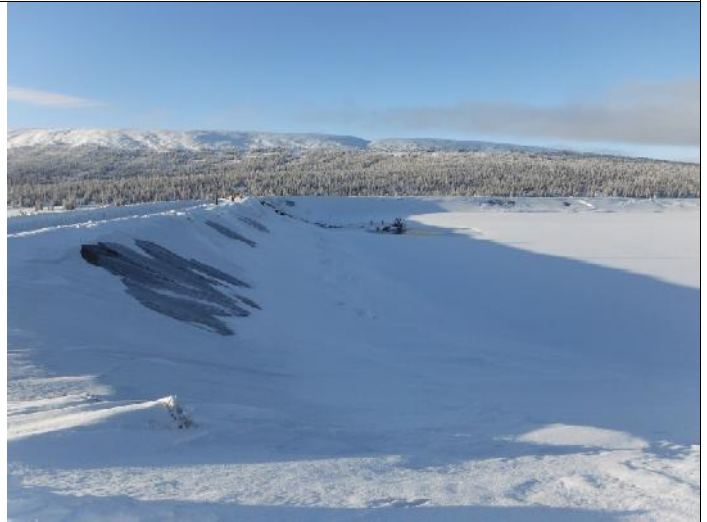
Photo 8: looking west from south east corner of TSF

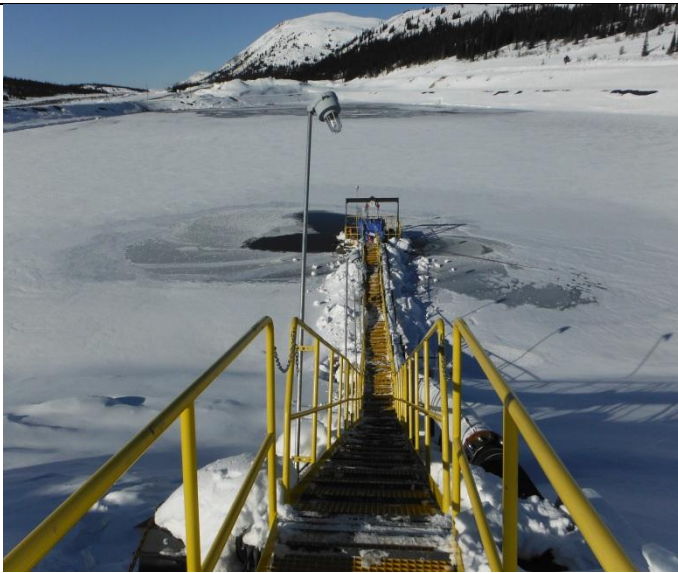
Photo 3: South wall view with walk way to the barge.

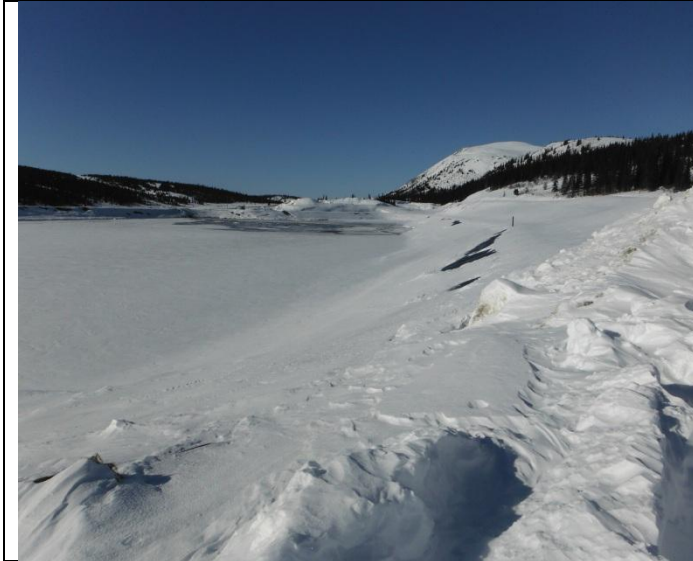
Photo 5: looking at East wall from South East corner of TSF

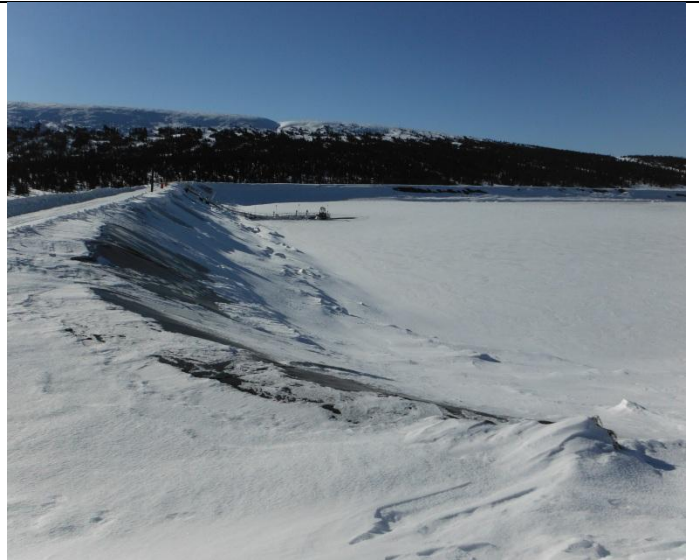
Photo 8: looking west from south east corner of TSF

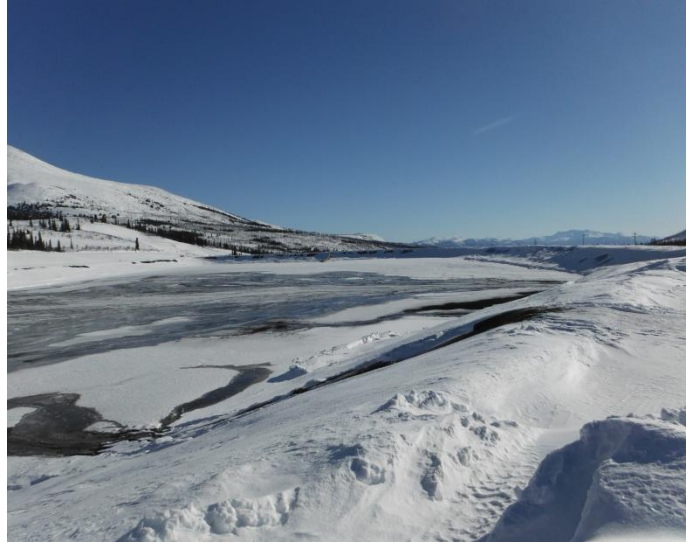
Photo 2: Looking towards barge from North West corner of TSF

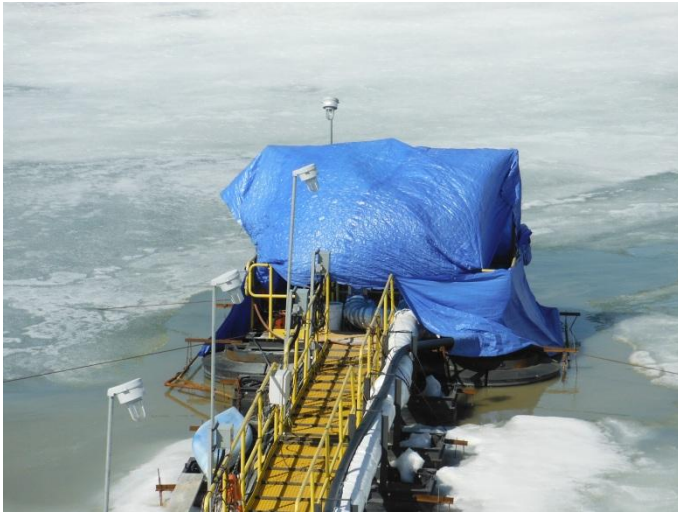
Photo 5: looking at barge from south wall.

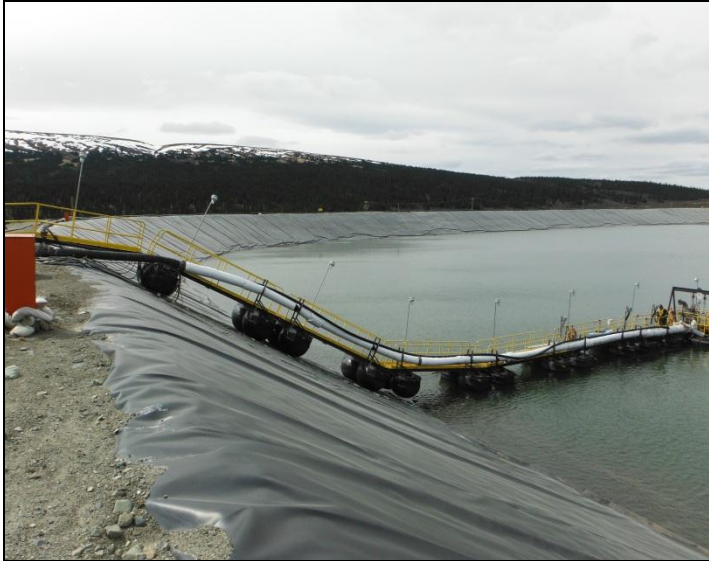
Photo 5: looking at barge from south wall.

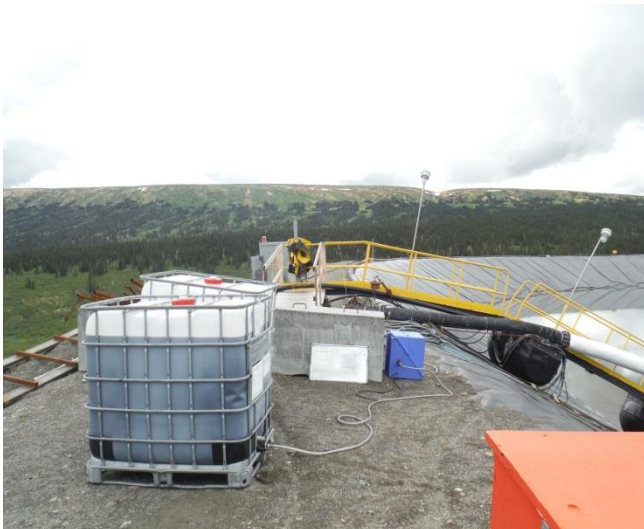
Photo 7: looking at Winterhib anti-scalent at east dam of TFS.

2. Brief on any maintenance: No major reported service\repair maintenance on barge or booster pump during the month. Winterhib Anti-scalant application into suction inlet the barge pump #1 continues at dose rate of 30 cc/min. The stainless steel coupon that was installed in reclaim water system in the mill will to be removed on Aug 6th to analyze for scale formation after 60-days of anti-scalent application & will send to Power Chemicals in Vancouver. Maintenance is preparing to work on the barge\pumps de-icing blower & moving the 20' sea-can for de-scalant system & lines winterization.

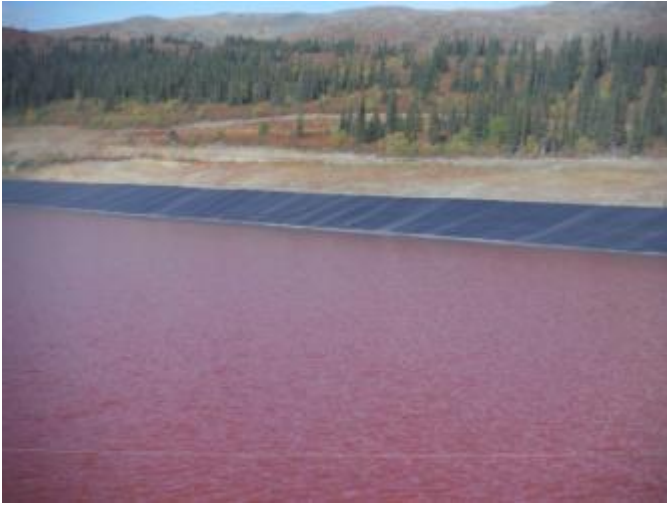
Photo 5: View of North-east slope from the South of TSF.

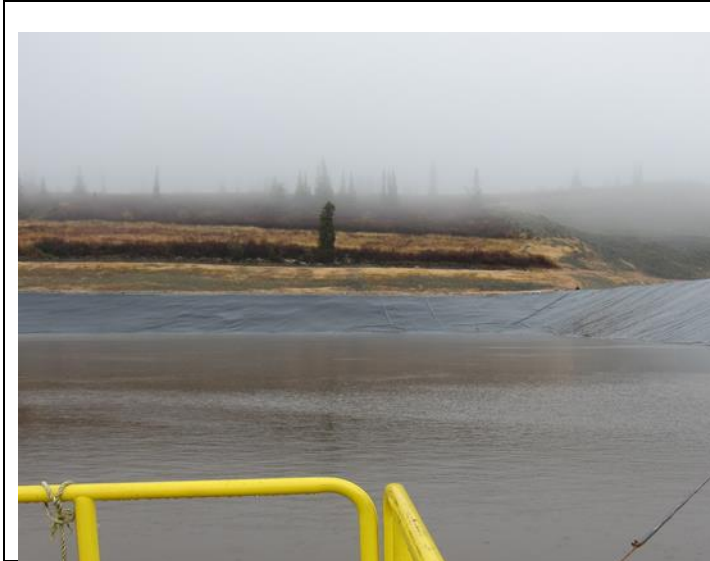
Photo 5: View of North-east slope from the South of TSF.

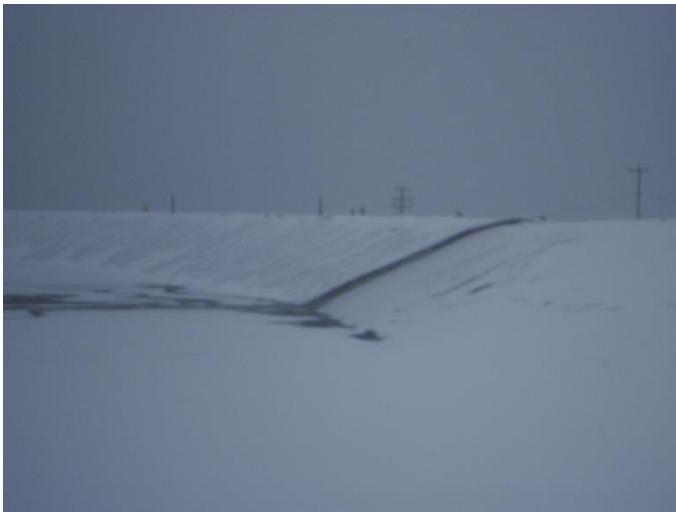
Photo 3: Closer view of discharge pipe location North-west corner of TSF.

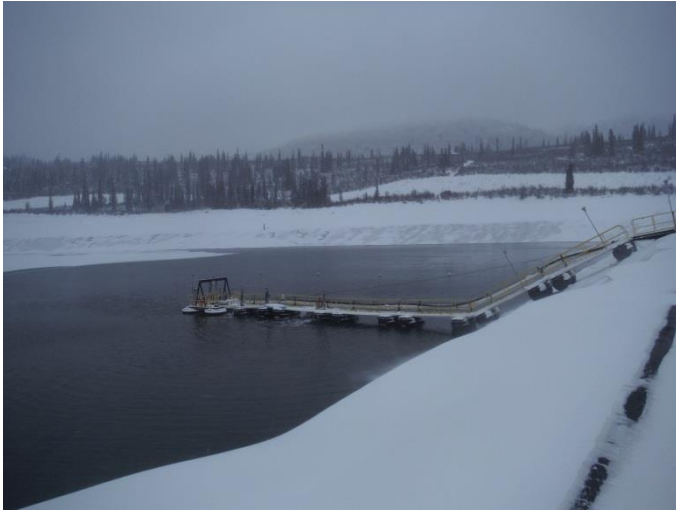
Photo 5: View of North-east slope from the South of TSF.

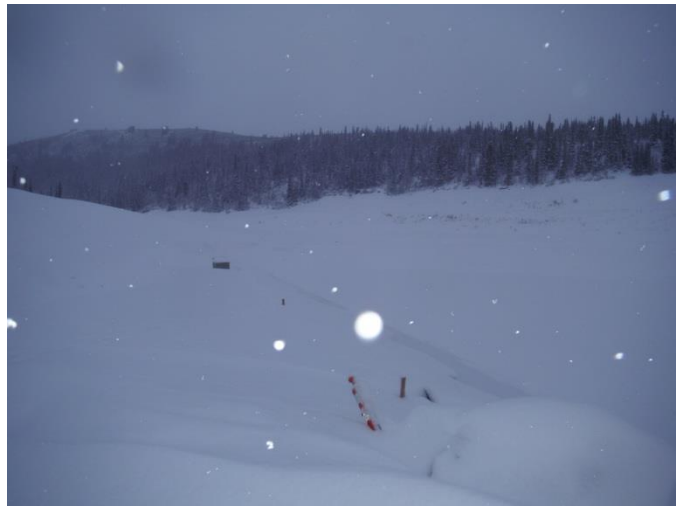
Photo 8: View of north corner of TSF.

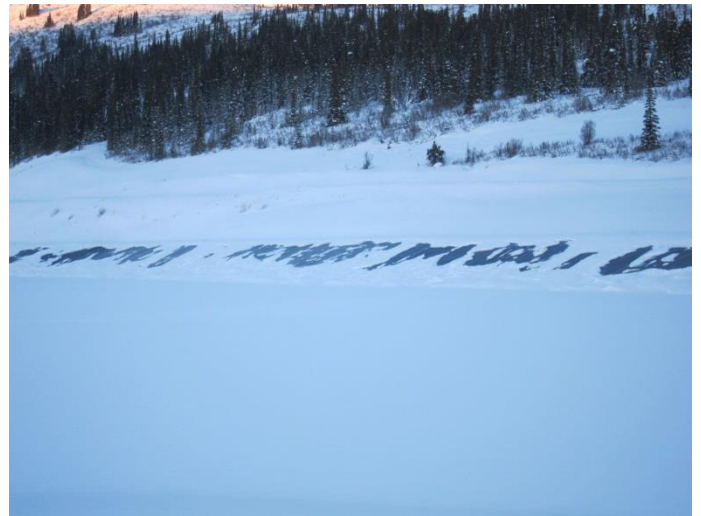
Photo 4: View of north side walls of TSF.

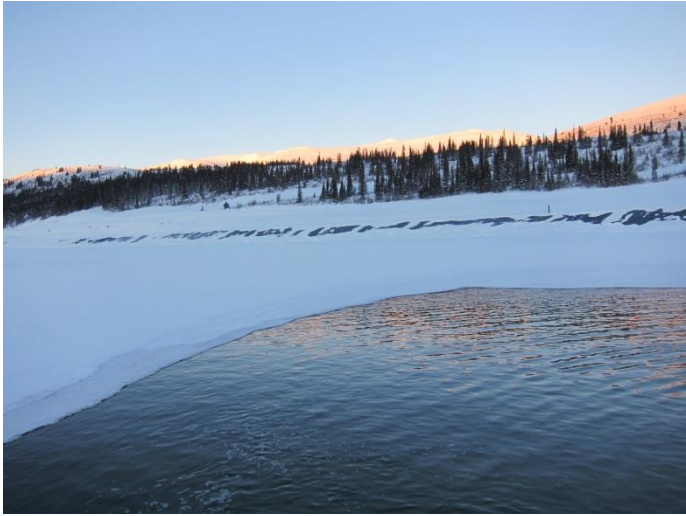
Photo 5: View of east slope from the north side of the TSF.

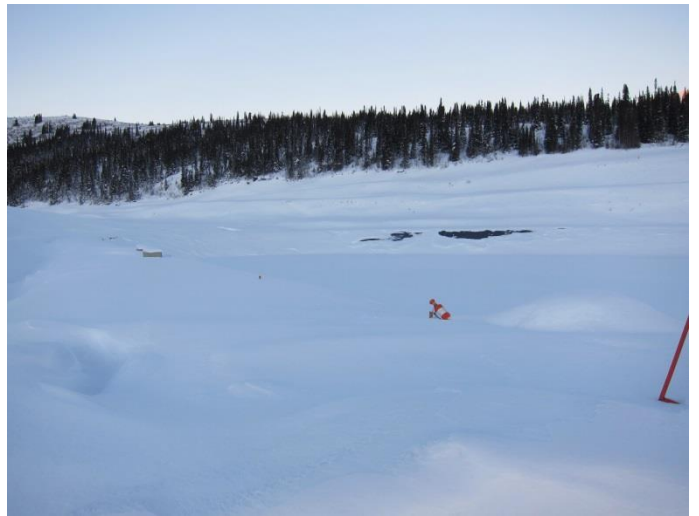
Photo 8: View of north west corner of TSF.
