MPERG Report 2009-4

**Brewery Creek:
From Assessment and Permitting
Through Production to Post Closure:
A Post Closure Analysis of a
Northern Heap Leach Mine**

Access Consulting Group

2010

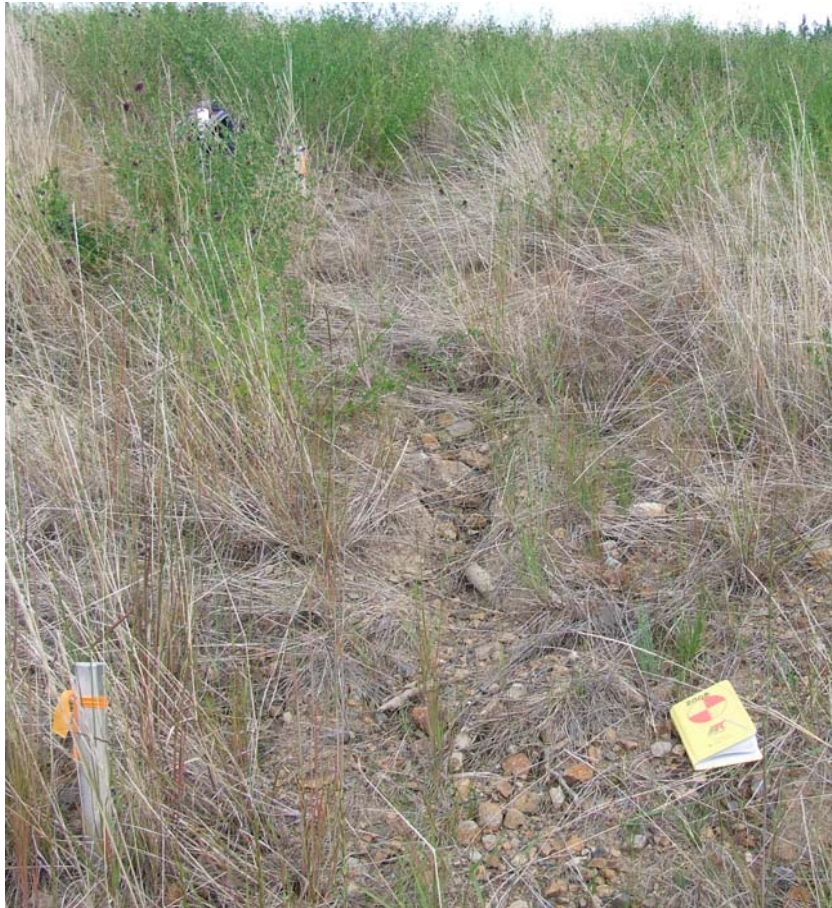
Photo #1: Small erosion gully in Plot 2 of the Blue Zone WRSA gradually filling in with leaf litter and soil.

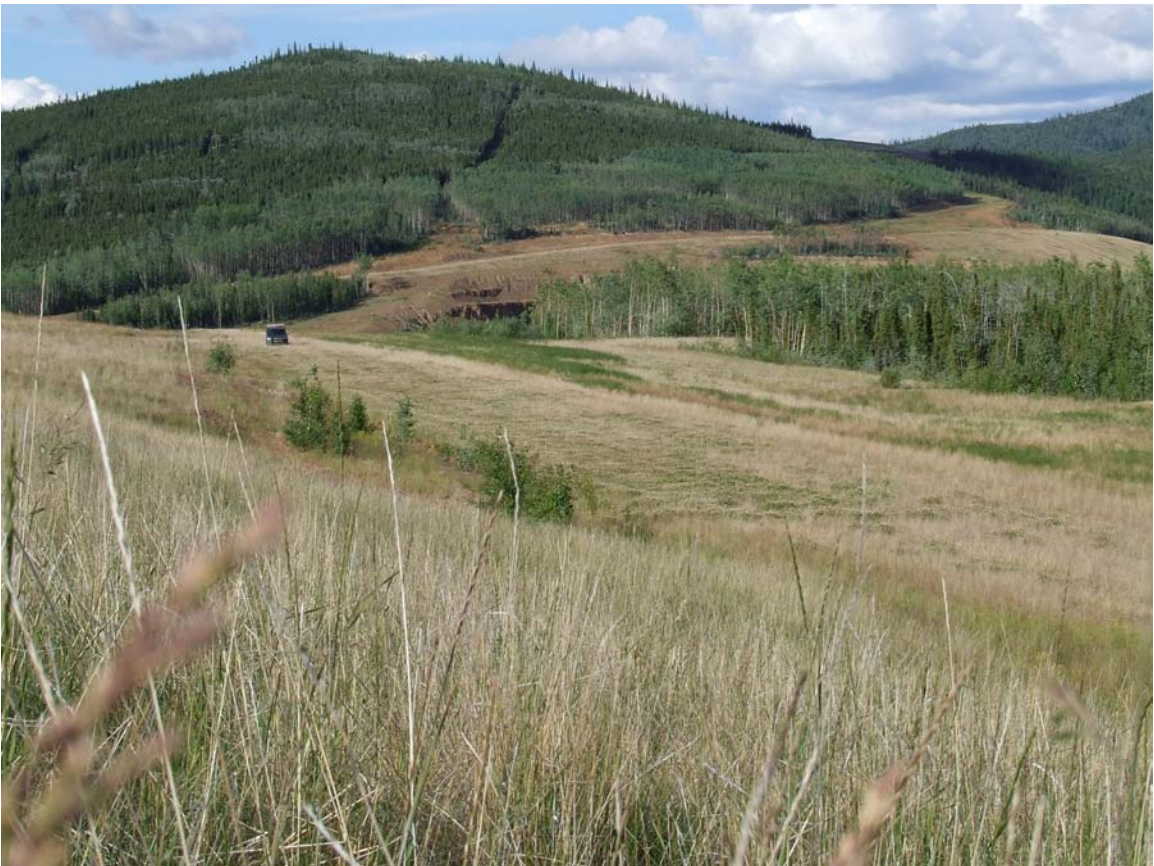
Photo #4: Plot #3 on the southeast slope of the Leach Pad.

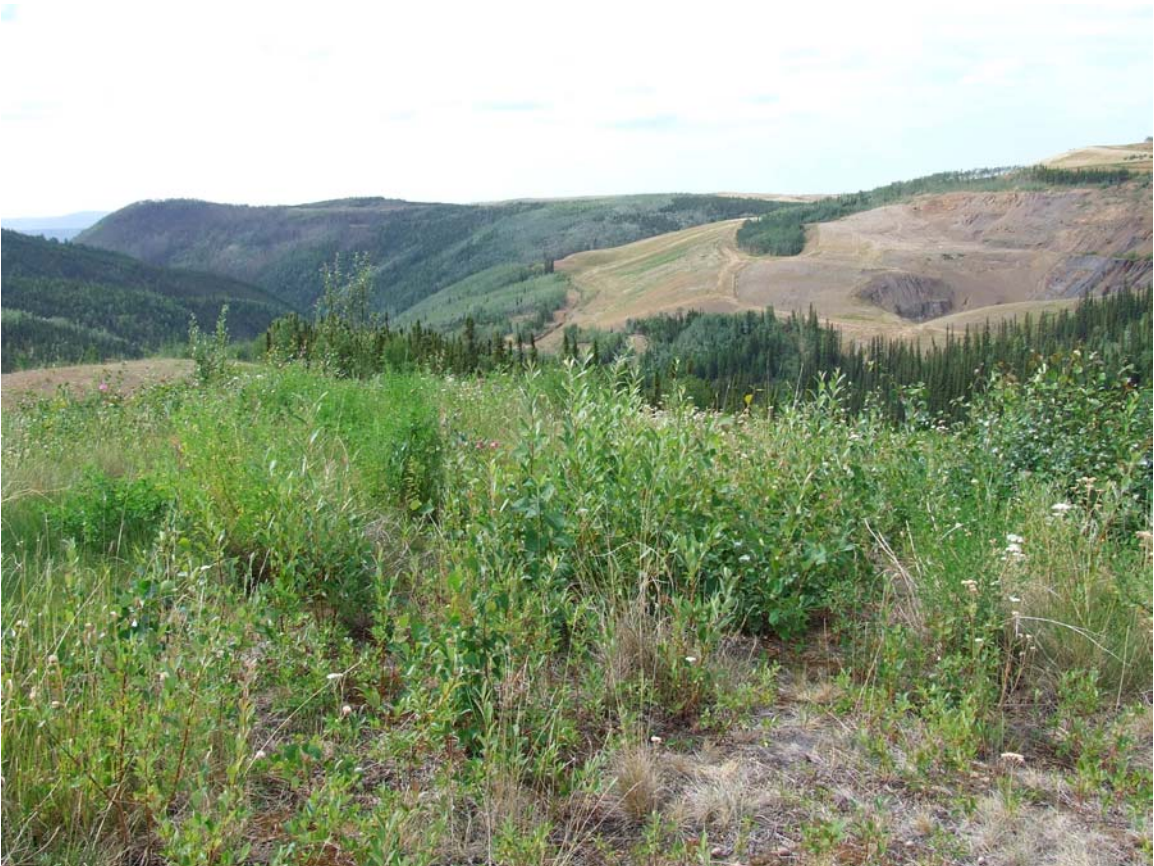
Photo #6: Willows, aspen and birch are colonizing the top of Canadian WRSA, looking toward Blue Zone.

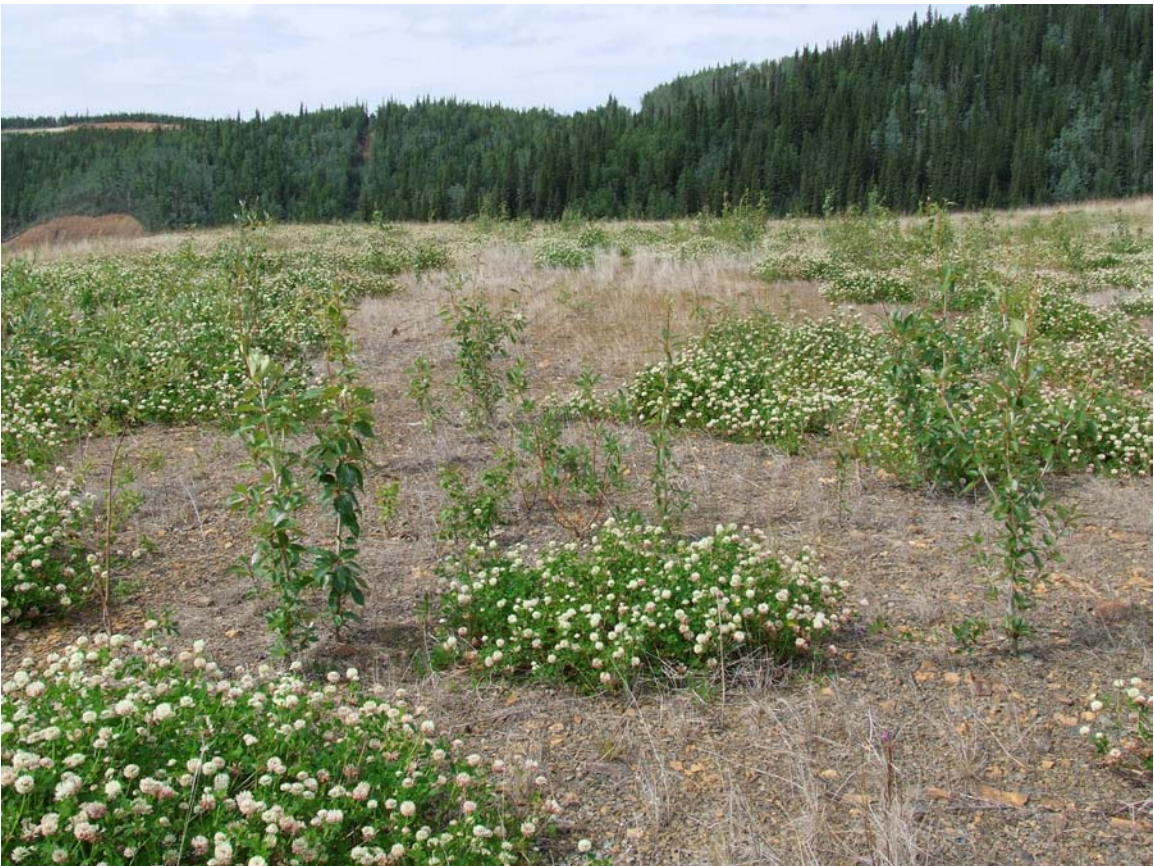
Photo #8: Several species of willow are colonizing the flat section of Upper Fosters.

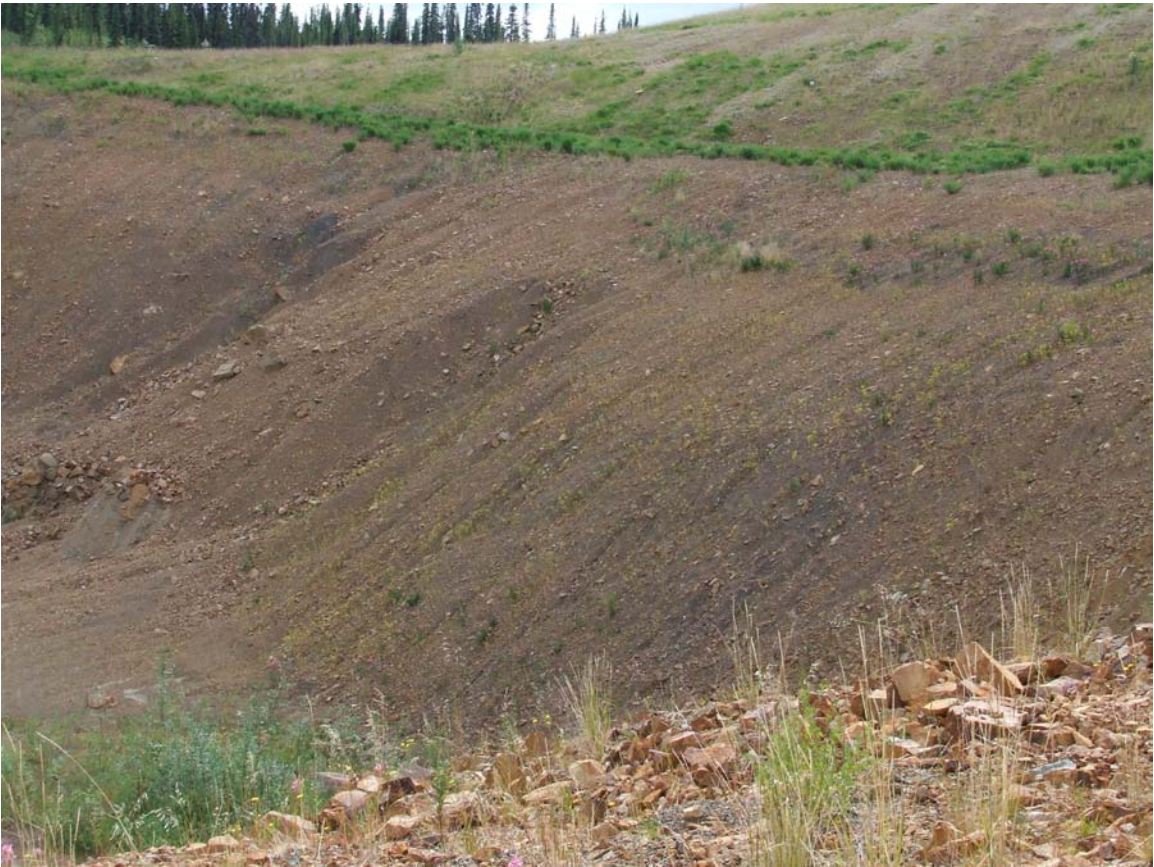
Photo #11: The side walls of South Golden are gradually revegetating naturally.

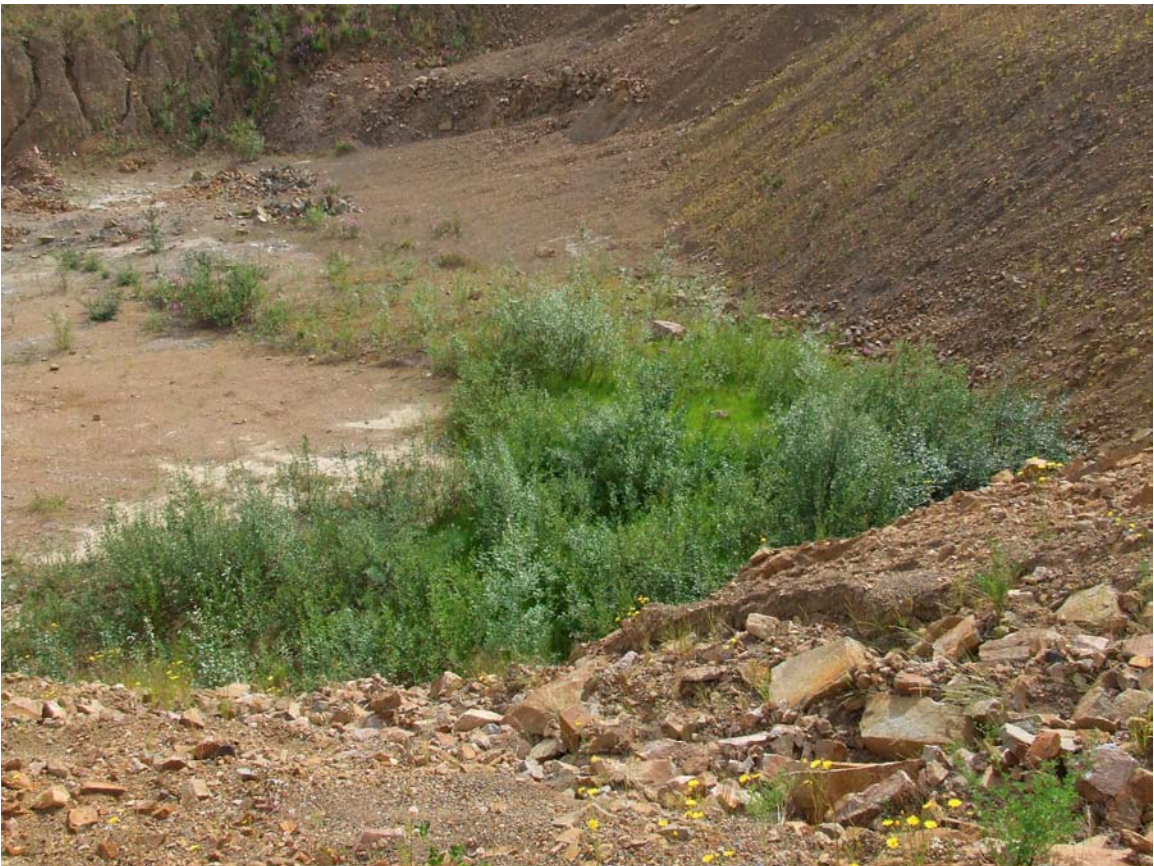
Photo #12: A dense growth of aspen and willows have become established at the base of the wall of South Golden.

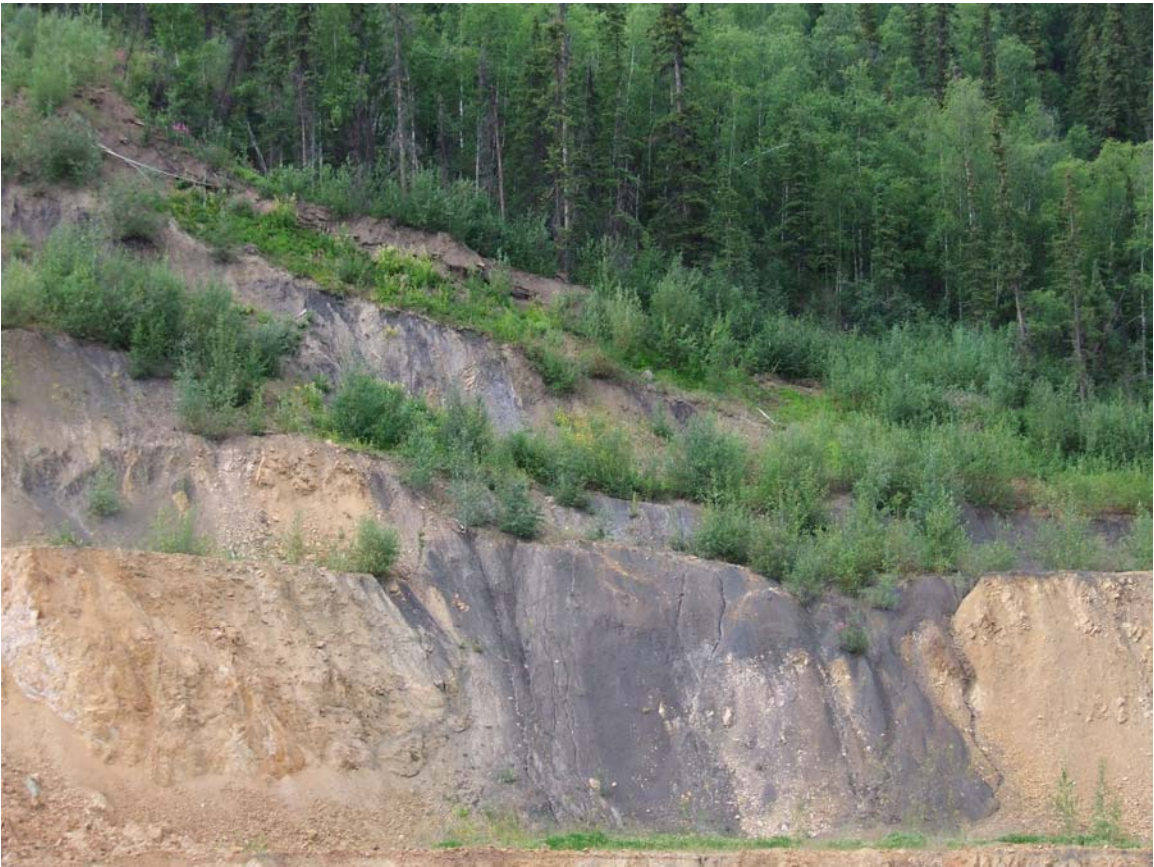
Photo #13: Willows are growing on the wall of Lucky Pit.

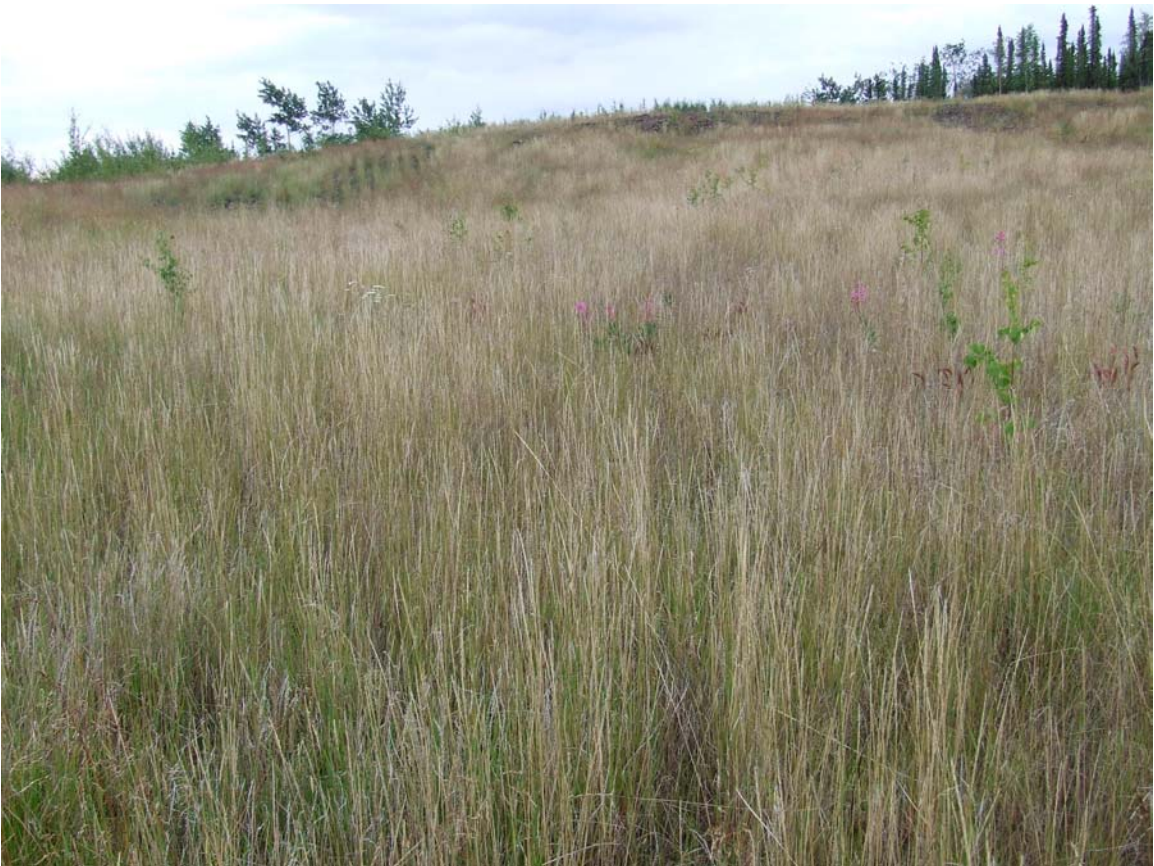
Photo #16: Fireweed and shrubs are starting to colonize Shale Hill.
