2023 Annual Geotechnical Inspection

Sa Dena Hes Mine, Watson Lake, Yukon
Teck Resources Ltd.

SRK Consulting (Canada) Inc. ■ CAPR002559 ■ August 2023

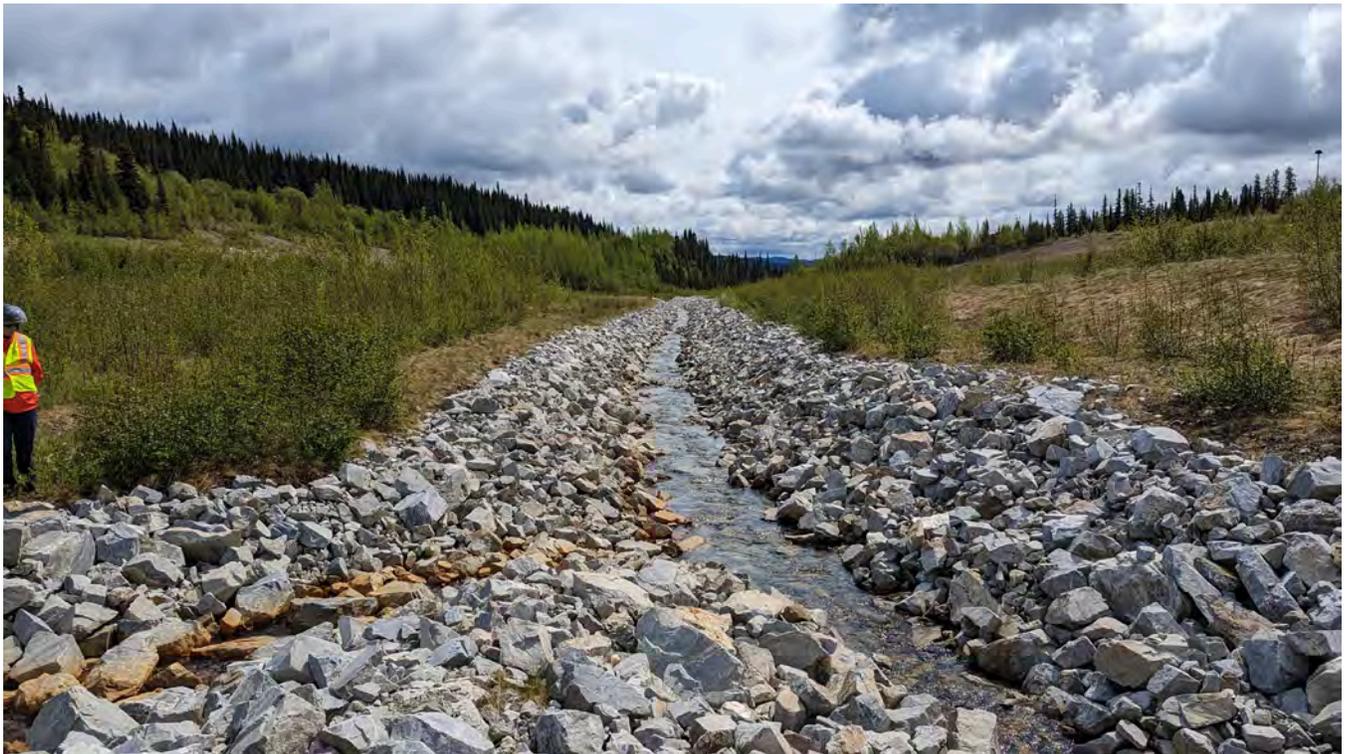
<ul style="list-style-type: none"> Iron-staining on the riprap is present over the last 30 m of the channel. 	B-7	DC-03, DC-04	n/a
Camp Creek Channel	<ul style="list-style-type: none"> The Camp Creek Channel is in good condition with no signs of major subsidence or movement of the riprap erosion protection. 	B-7, B-8	DC-04, DC-05, DC-06	n/a

Photo DC-04: Camp Creek looking downstream from the confluence with the South Drainage Channel.

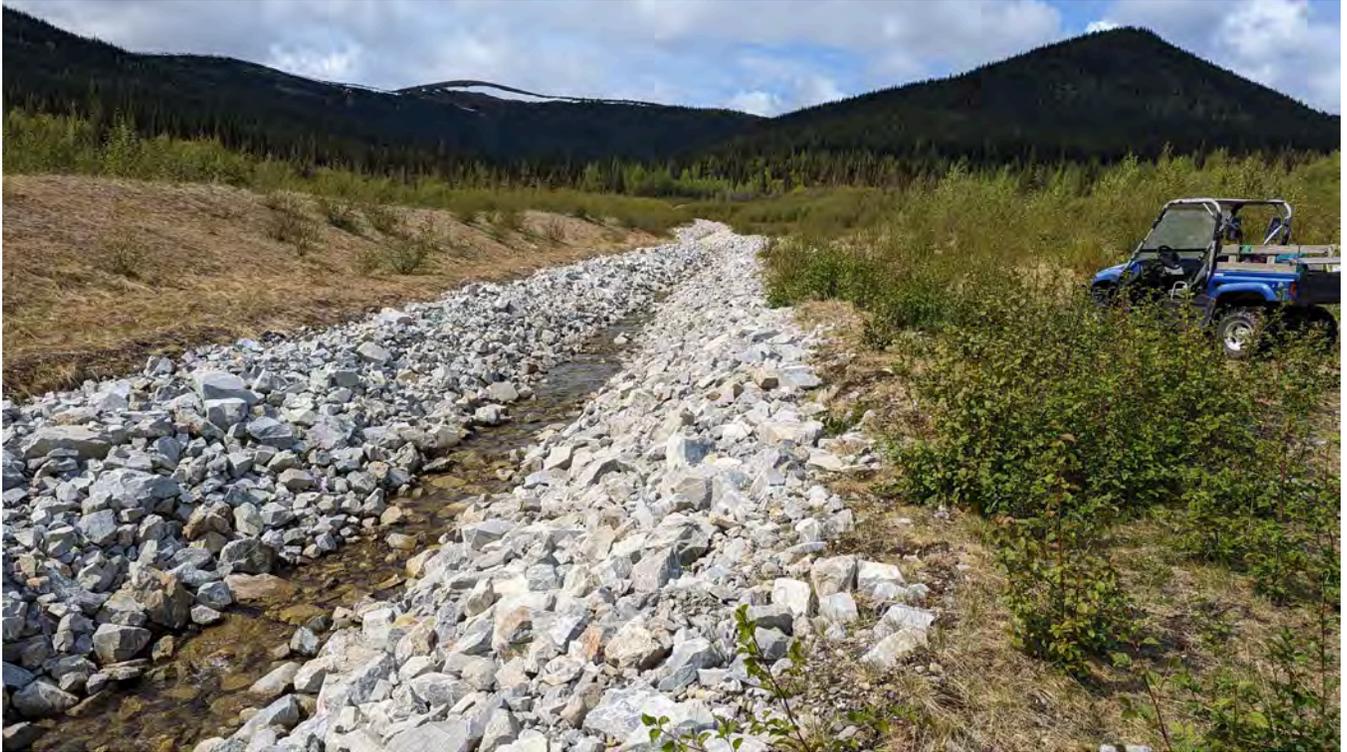
Photo DC-05: Camp Creek looking upstream from the confluence with the South Drainage Channel.

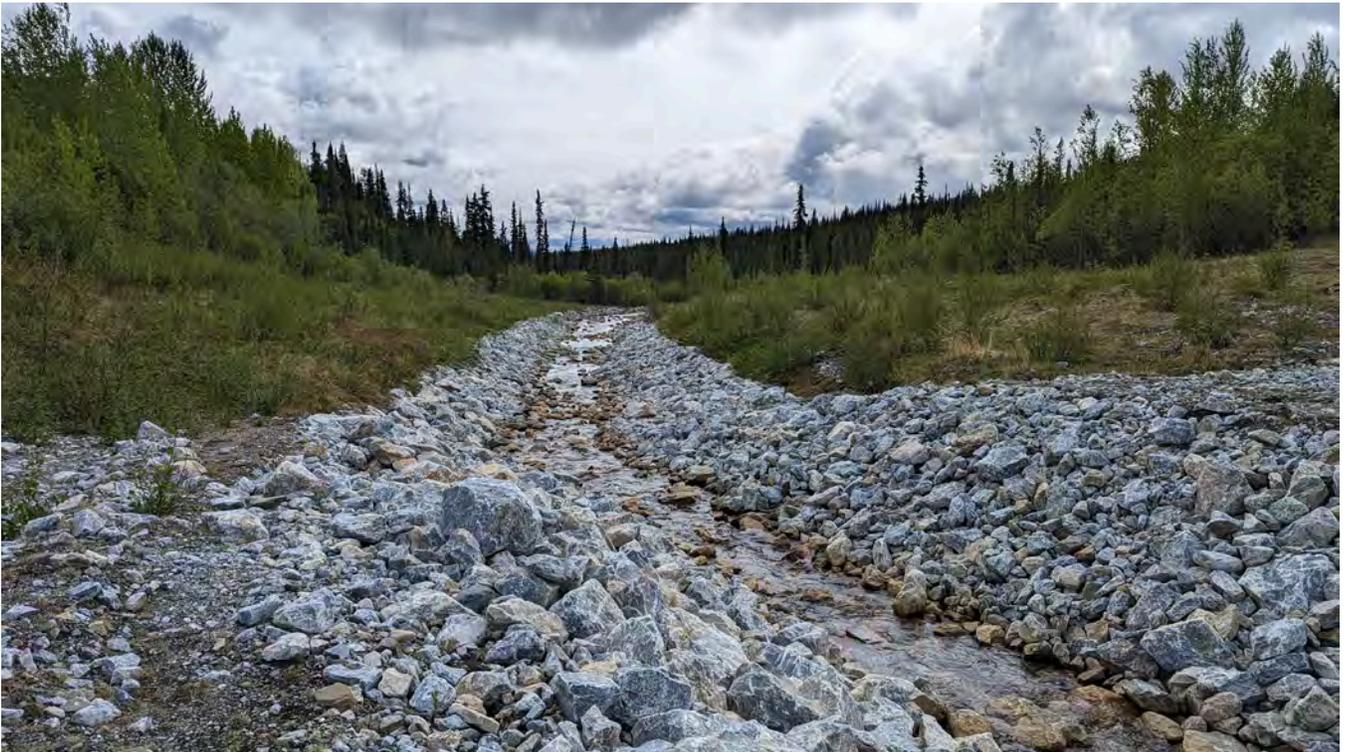
Photo DC-06: Camp Creek near the former Reclaim Dam area looking downstream.

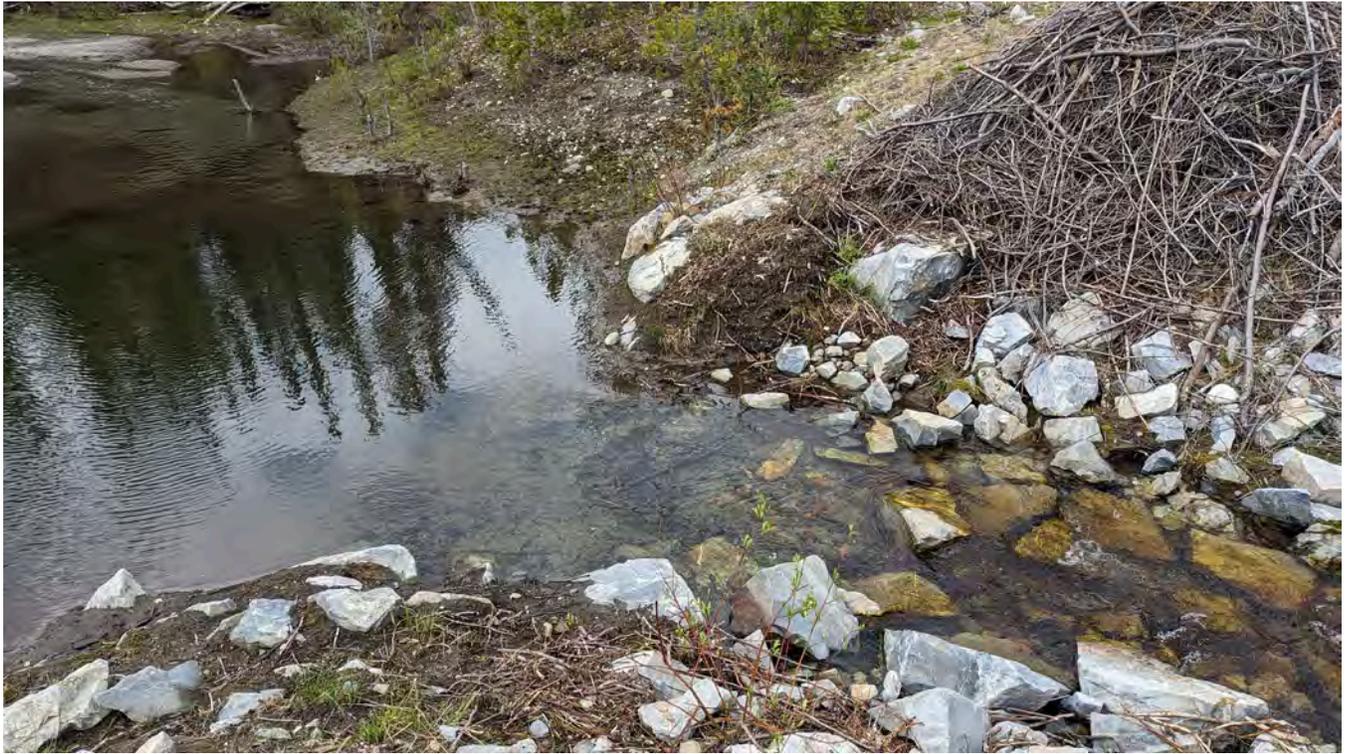
Photo NC-03: Former North Creek Dyke area. Inlet to the decommissioned dyke.

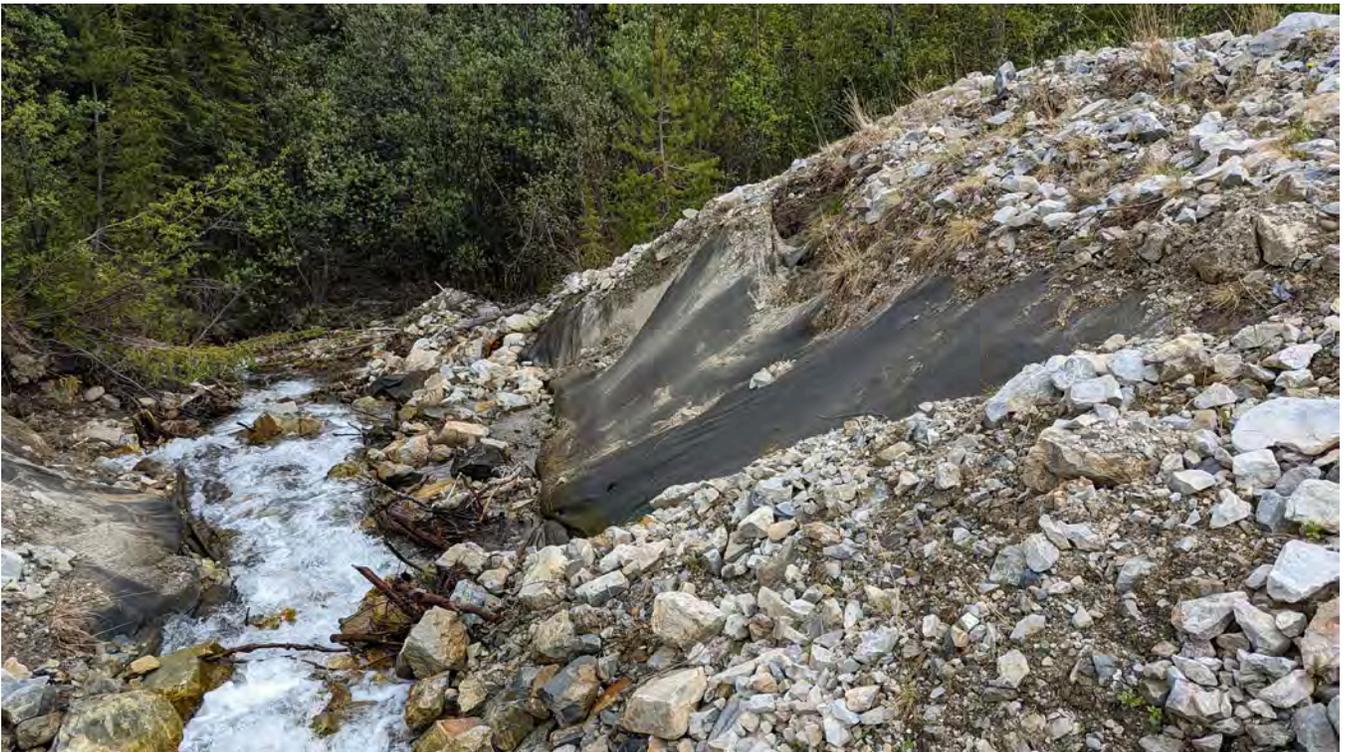
Photo NC-04: Downstream end of the decommissioned North Creek Dyke.

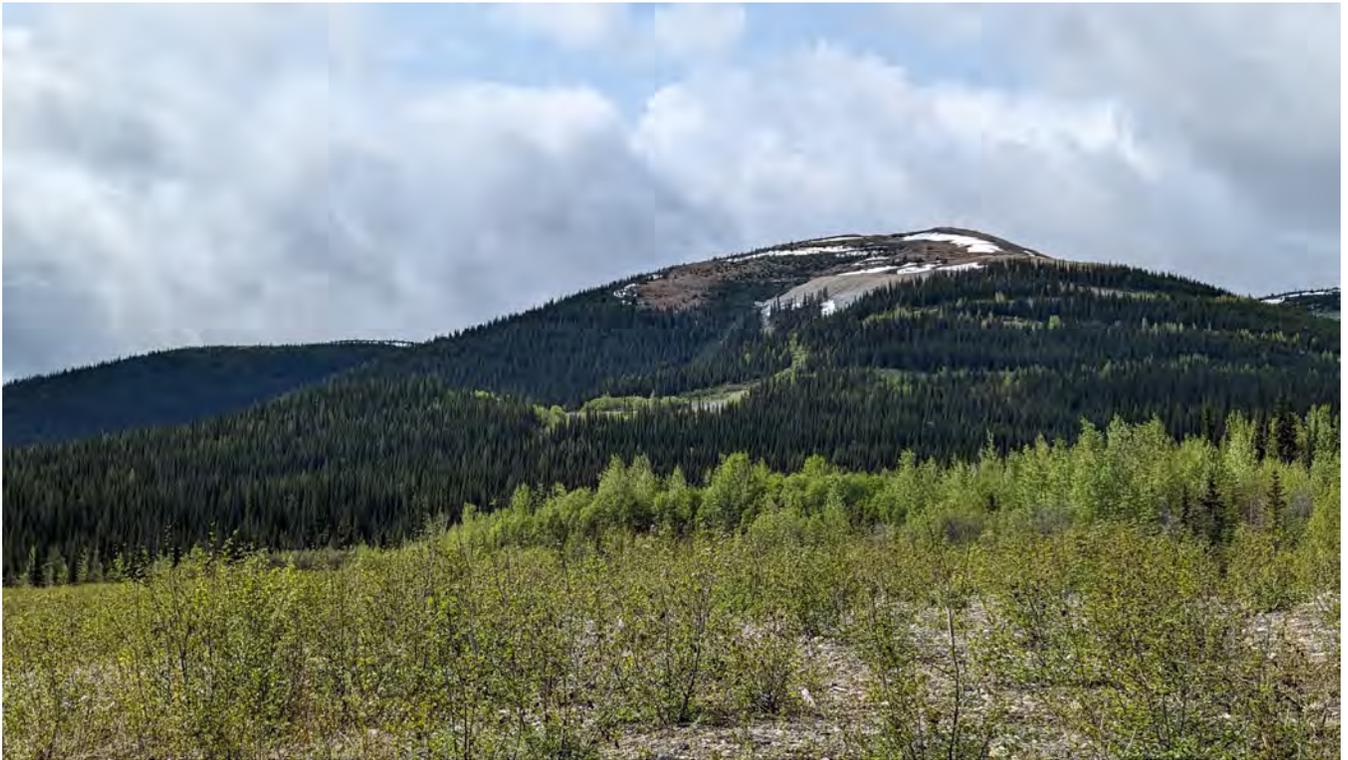
Photo WR-01: View of the Jewelbox and Main Zone Area from the Tailings Area.

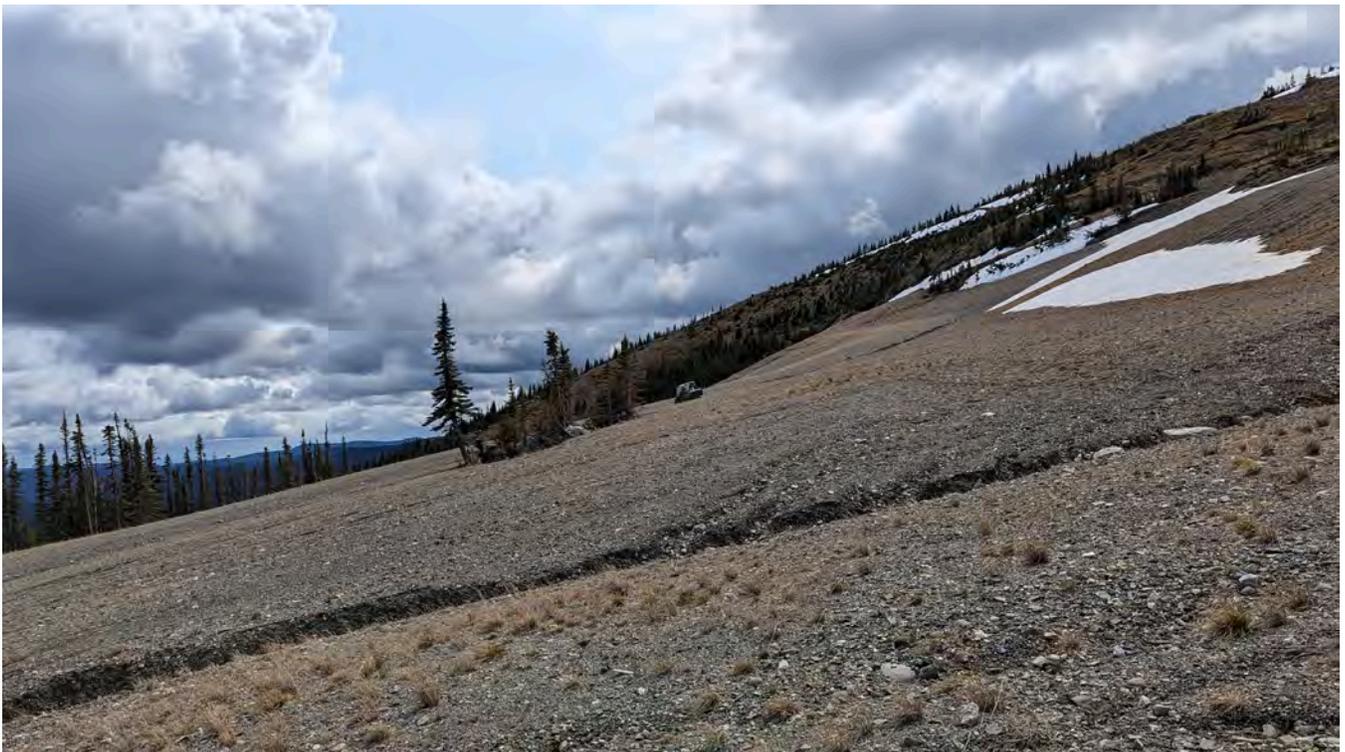
Photo WR-02: 1408 Portal Waste Rock Dump looking south.

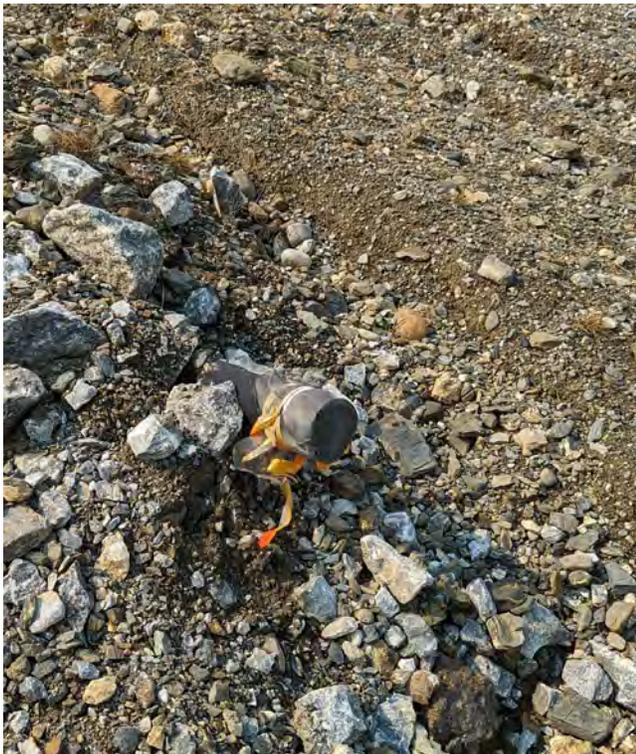
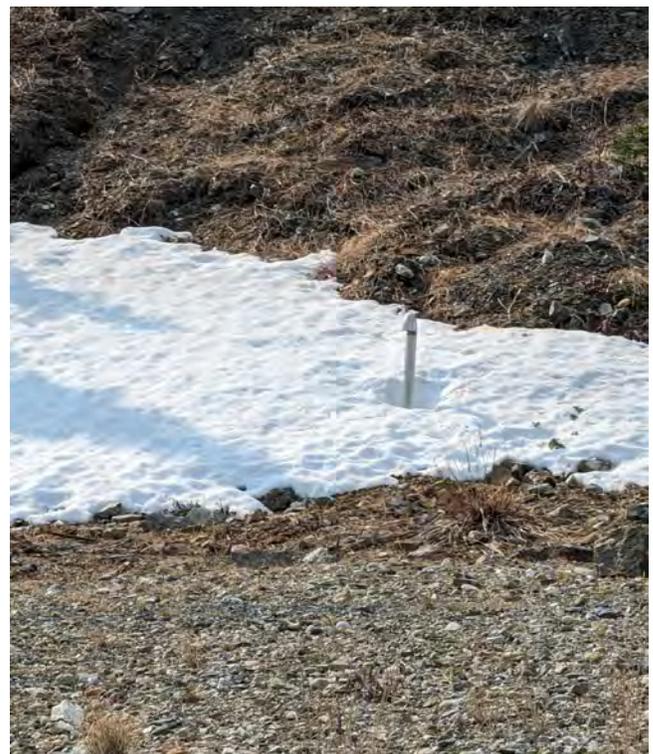
<ul style="list-style-type: none"> ■ The 1408 Portal drainpipes and the vent pipe in the 1408 Portal area are in good condition. 	B-14	WR-06a, WR-06b	n/a
<ul style="list-style-type: none"> ■ Rill erosion in the soil cover is present at the south end of the 1408 Portal WRD where the slope is approximately 2H:1V. The condition of the rill erosion appears unchanged compared to the 2021 inspection and no action is required. 	B-14	WR-05	n/a

Photo WR-06a and b: (a) one of the two 1408 Portal drainage pipes; (b) Vent pipe from the 1408 Portal.

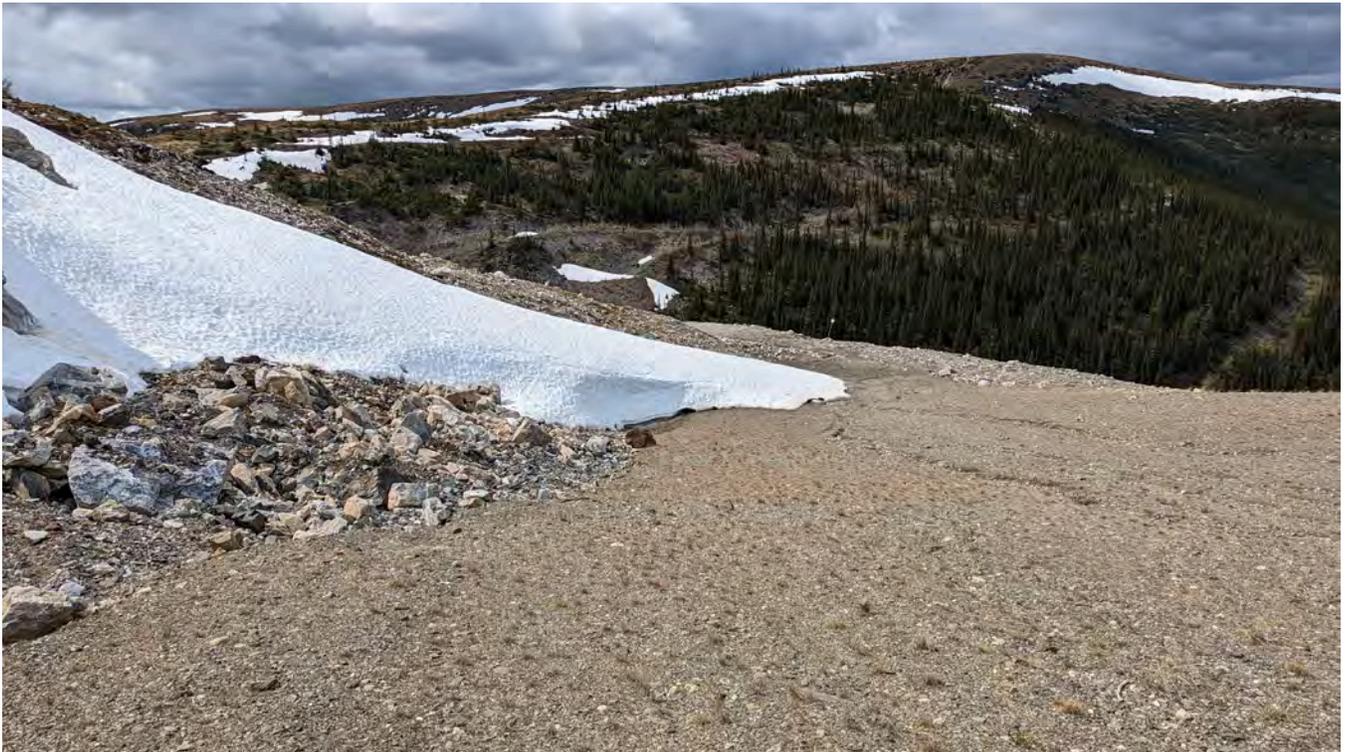
Photo WR-08: Partially backfilled Jewelbox Pit looking west.

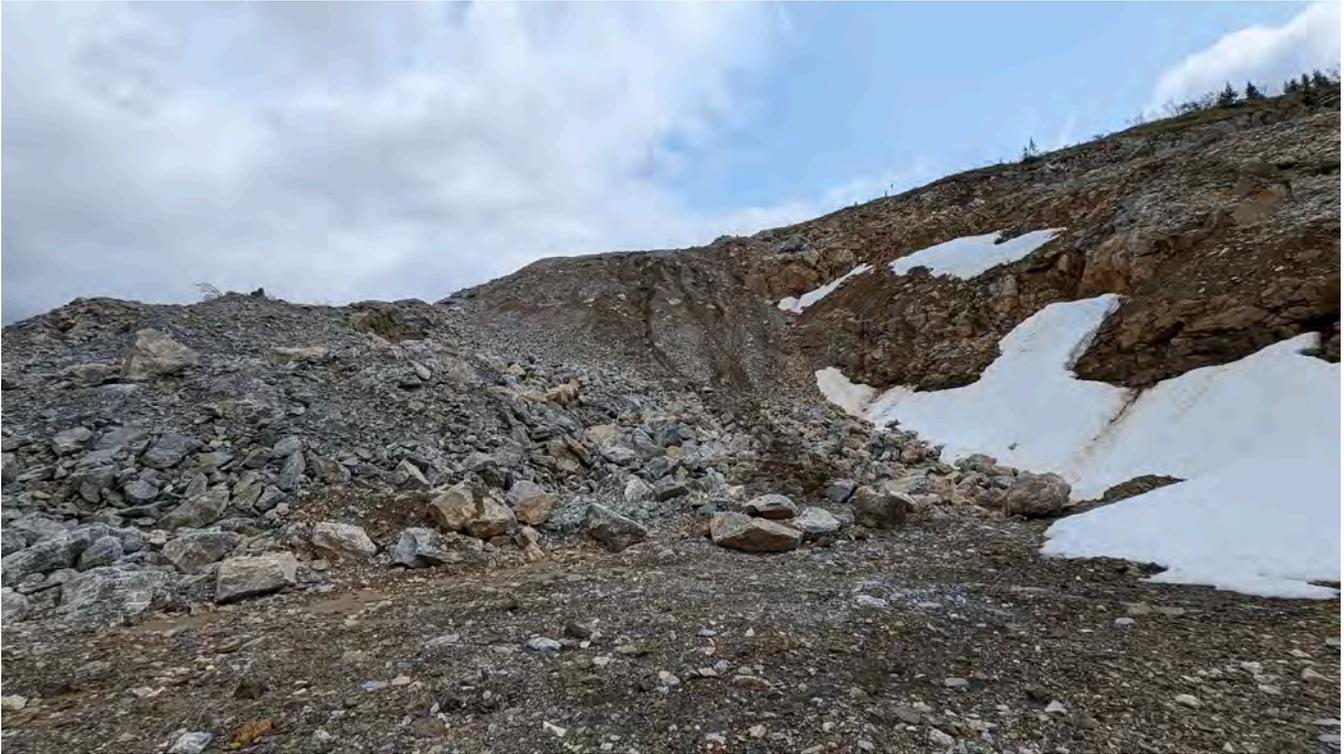
Photo WR-09: Backfill at the 1380 Portal below the Main Zone Waste Rock Dump.

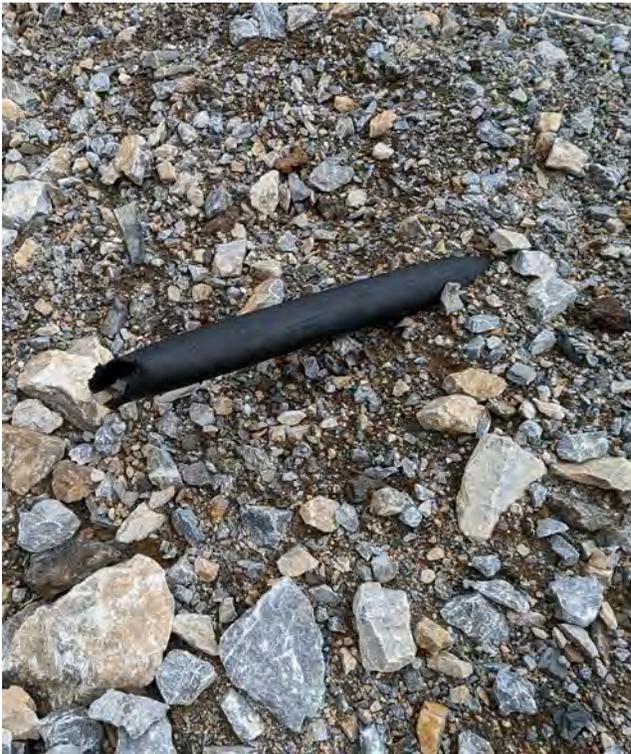
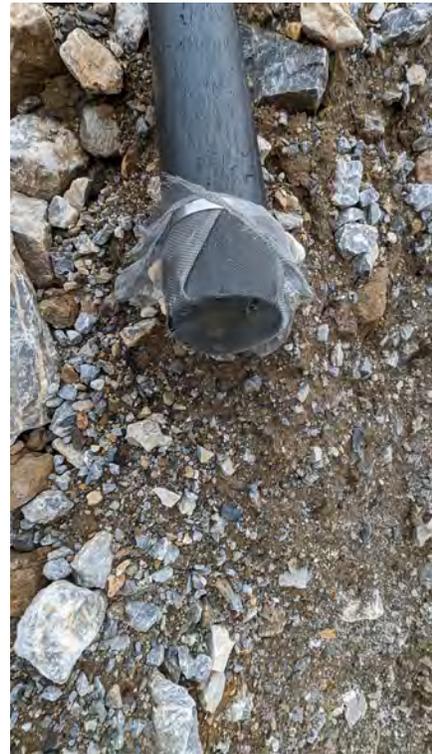
Observation	Figure (App. B)	Photo	Associated Recommendation
<ul style="list-style-type: none"> Previous inspections have noted two small openings in the Jewelbox Pit highwall. These openings may have been caused by internal subsidence but currently do not pose a safety concern. During the 2023 inspection, the openings were covered with snow, with an apparent animal burrow opening present. No action is required. 	B-15	WR-08	n/a
<ul style="list-style-type: none"> The erosion gully first observed in 2022 on the Main Zone Pit backfill above the 1380 Portal appears unchanged from the 2022 inspection. The gully is situated in waste rock and appears to be self-armouring with no significant catchment that reports to the gully at the upstream end. No remedial action is required. 	B-16	WR-09	n/a
<ul style="list-style-type: none"> The two 1380 Portal drainpipes are functional. 	B-17	WR-10a, WR-10b	n/a

Photo WR-10a and b: Two drainage pipes at the 1380 Portal.

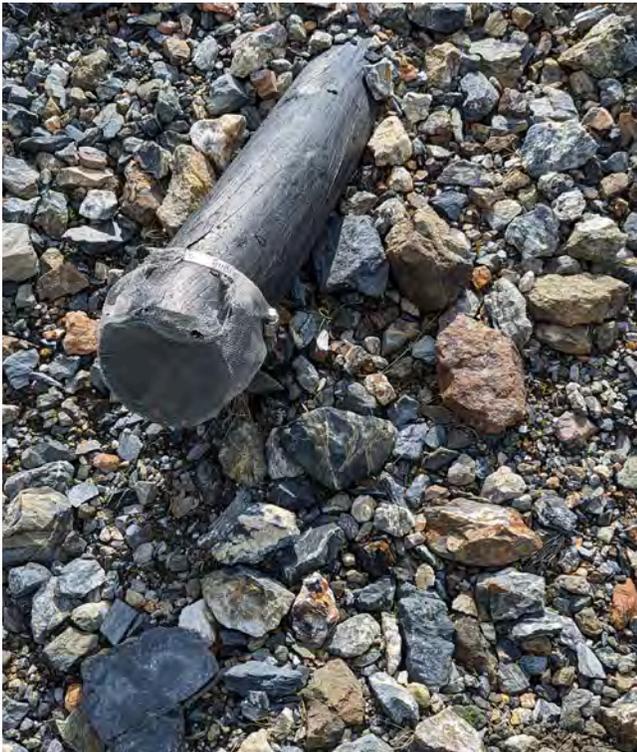
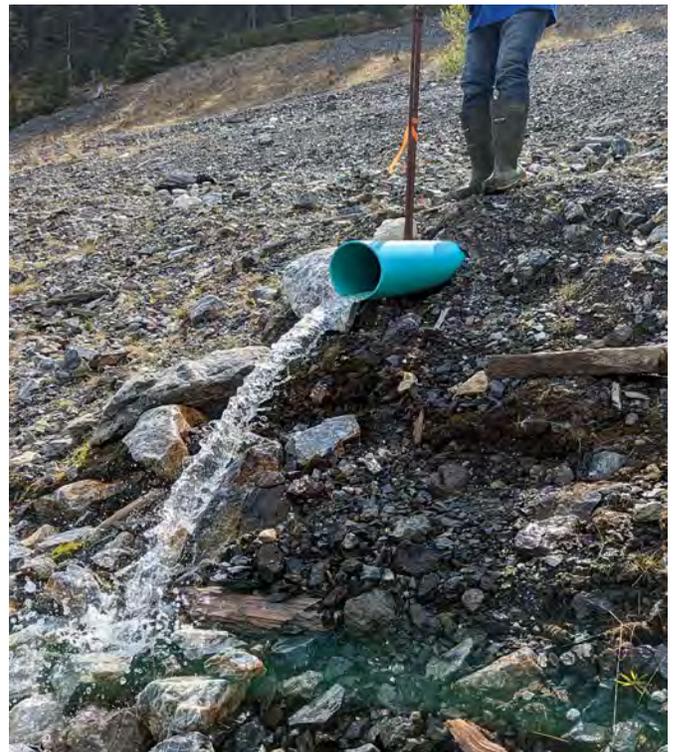
Observation	Figure (App. B)	Photo	Associated Recommendation
<ul style="list-style-type: none"> The regraded fill over the 1200 Portal is in good conditions and the portal drainpipe is functional. Minor settlement of the fill that was placed over the 1200 portal has resulted in a settlement crack in the fill. This crack was noted in previous inspections and is approximately 10 m long, up to 15 cm wide, and up to 10 cm deep. No action is required. 	B-17	WR-11, WR-12	n/a
<ul style="list-style-type: none"> The regraded waste rock in the 1300 Portal area is also in good condition with no signs of deformation. The 1300 Portal drainpipe appears functional with no flow observed. A drip-like sound could be heard through the pipe indicating no blockage. 	B-18	WR-13, WR-14	n/a

Photo WR-12a and b: Two drainage pipes at the Burnick 1200 Portal.

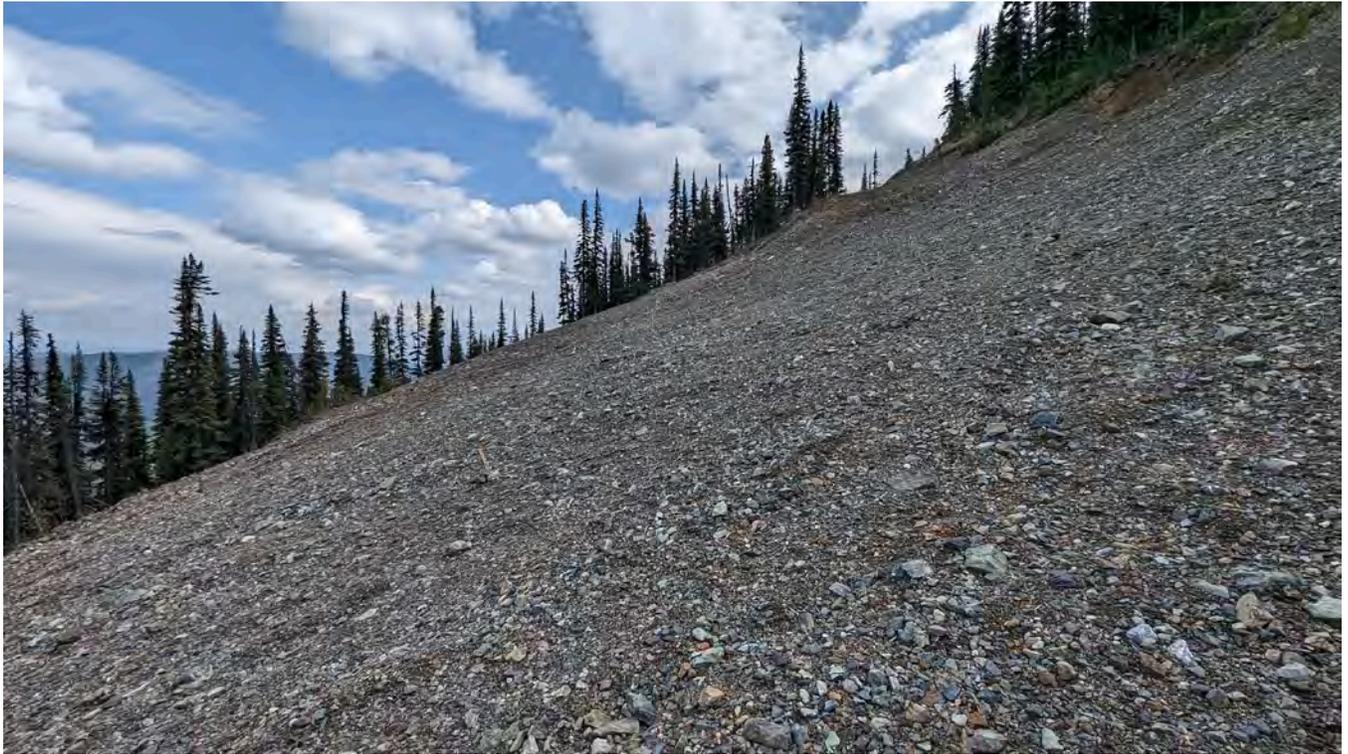
Photo WR-13: Regraded 1300 Portal Waste Rock Dump and 1300 Portal area.

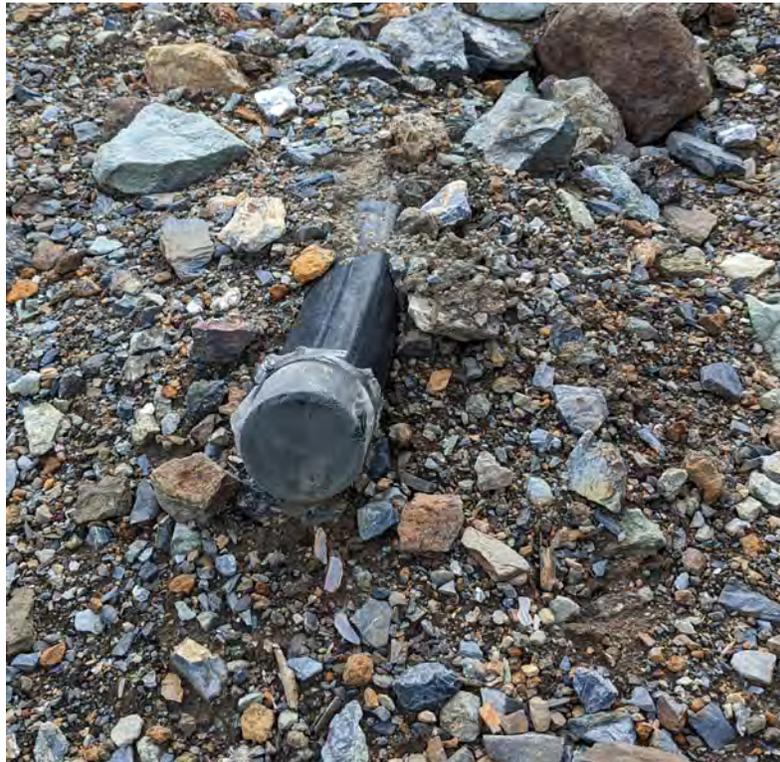
Photo WR-14: 1300 Portal drainpipe.

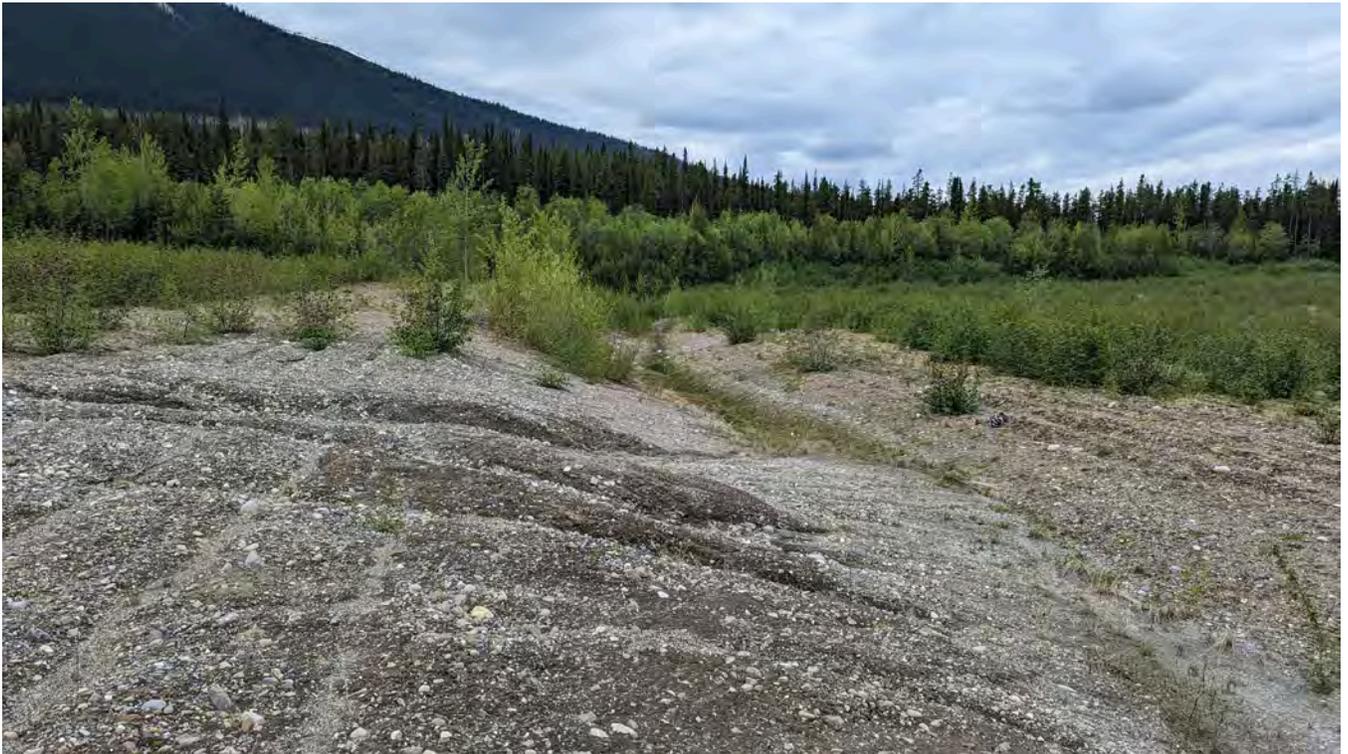
Photo L-1: Landfill drainage channel looking upstream.

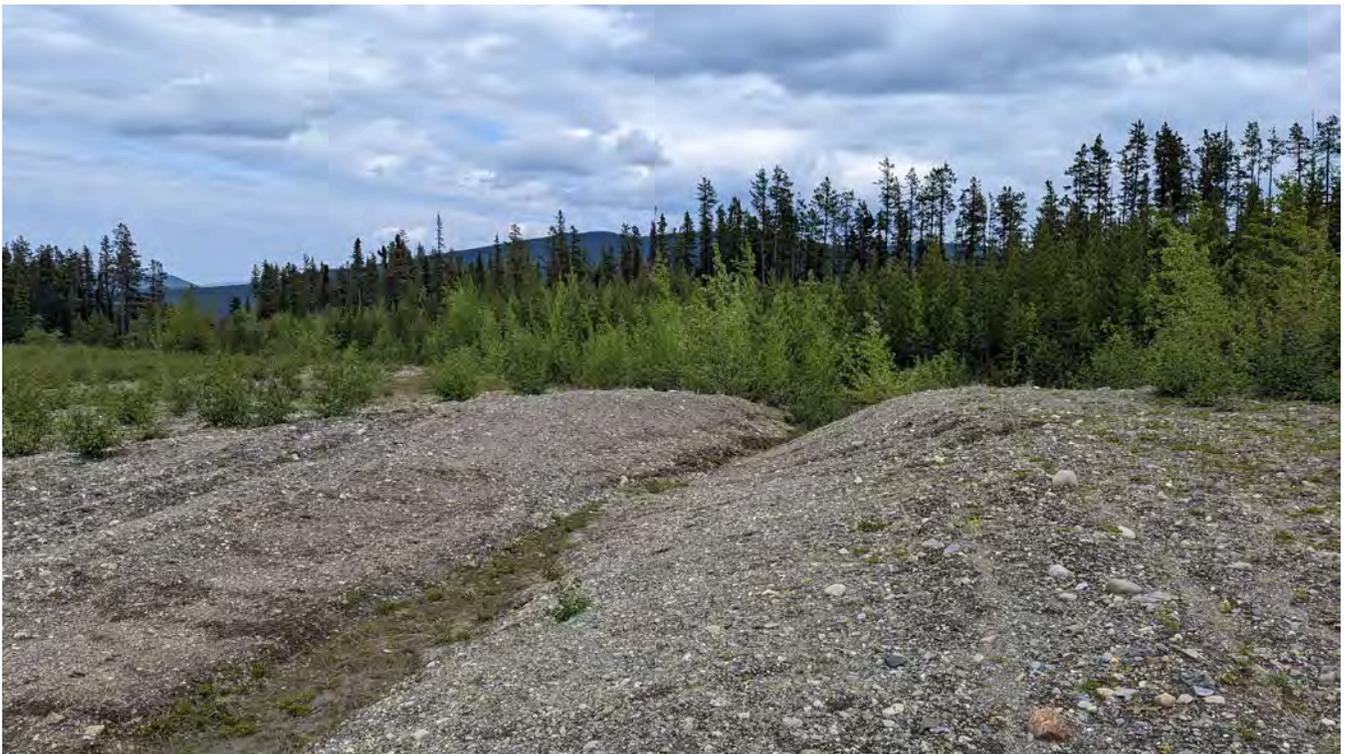
Photo L-2: Landfill drainage channel looking downstream.

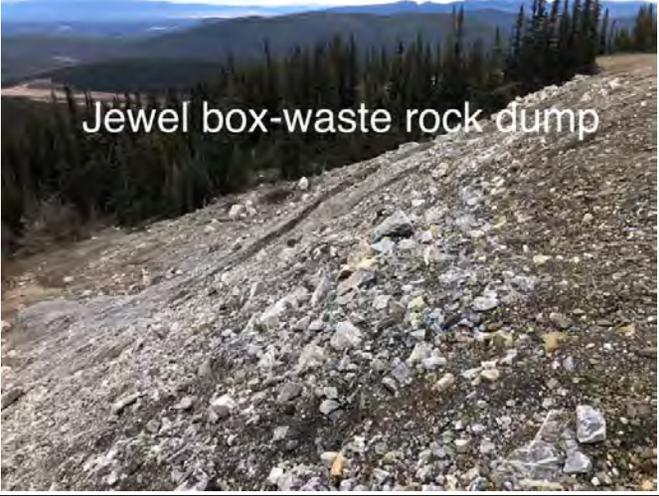
Photo Discription	Photo	Photo Location
Jewelbox waste rock dumps

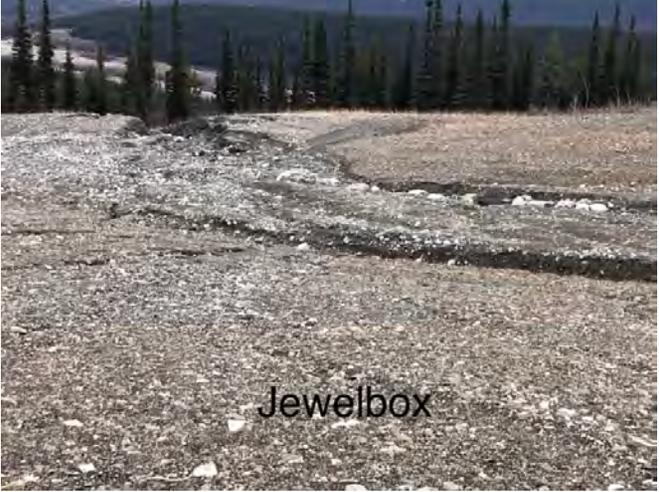
<p>Jewel box-waste rock dump</p>	
Deepening erosion at access entrance to Jewelbox

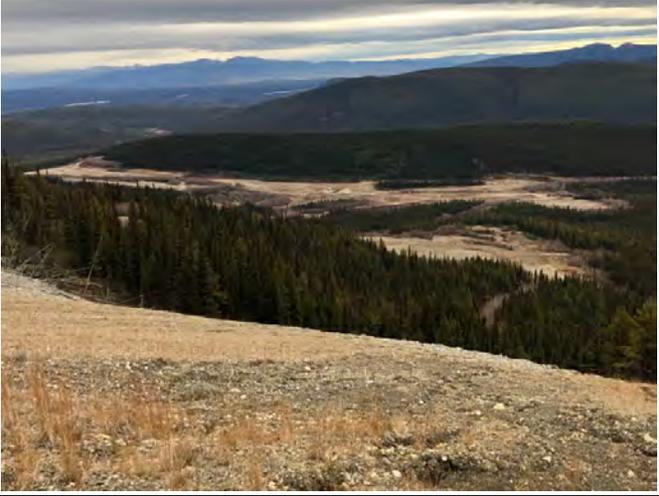
Photo Discription	Photo	Photo Location
Jewelbox- slumps below 40+ meters below old portal area

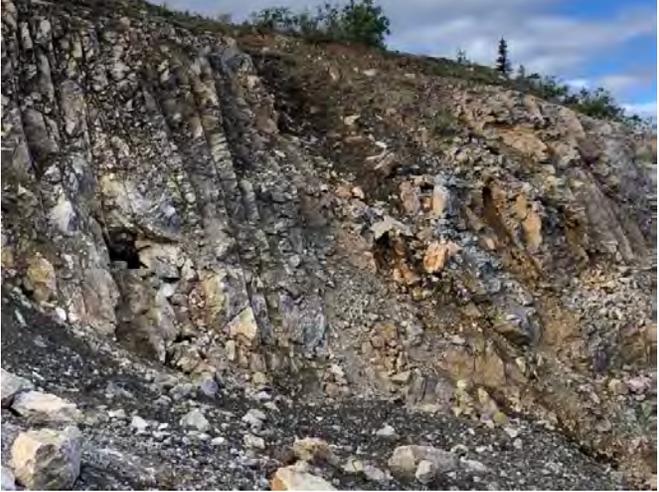
Jewelbox-hole in the wall getting slightly larger

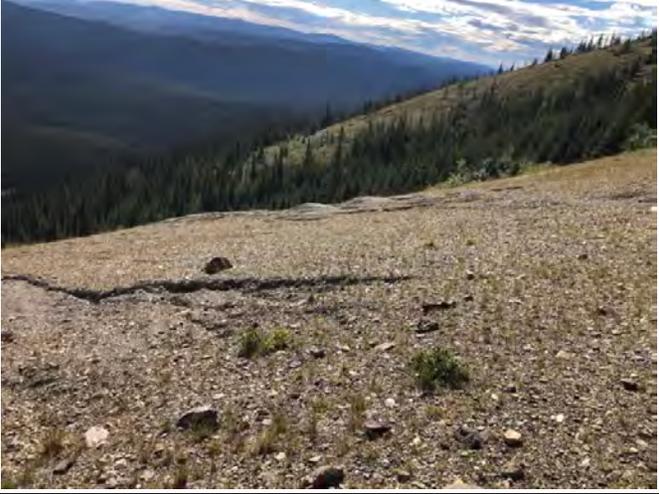
Photo Discription	Photo	Photo Location
Slumping along slope below old portal area

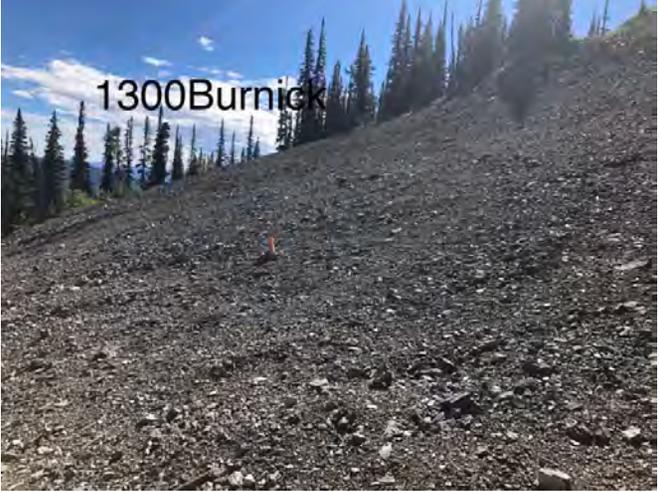
<p>Burnick 1200-W rock dump</p>	
Burnick 1300 portal-waste rock dump, no issues.

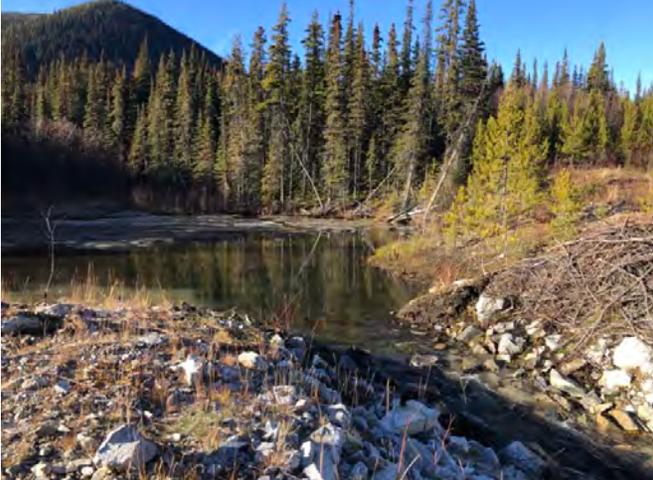
Photo Discription	Photo	Photo Location
Cleaned out

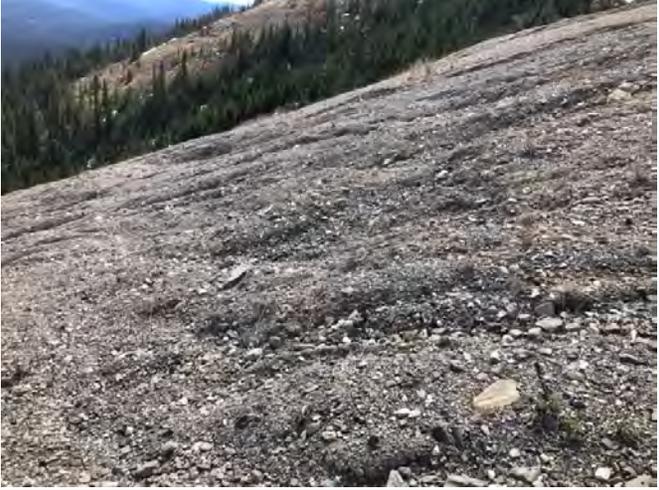
Photo Discription	Photo	Photo Location
Slumping below portal area and along contour of hillside

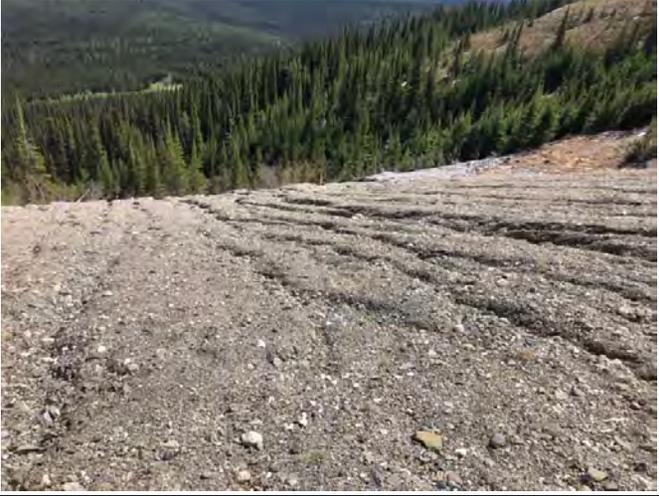
Photo Discription	Photo	Photo Location
Rills & erosion

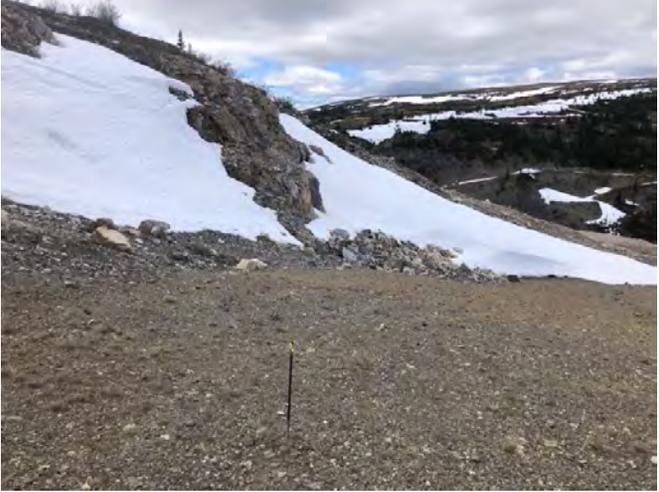
Hole in the wall still snow covered

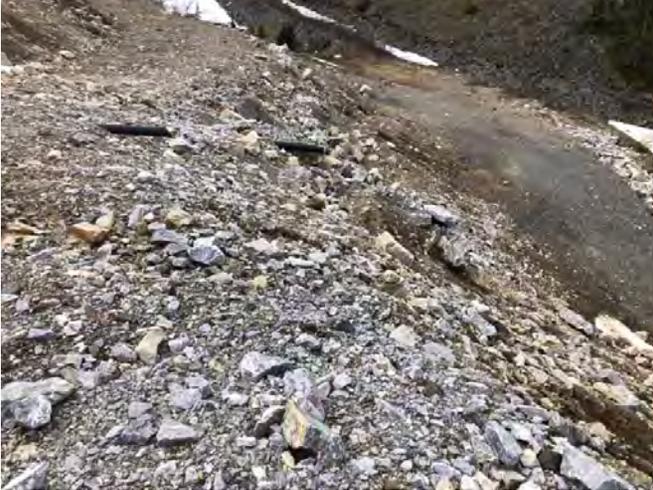
1390 portal drains, no apparent flow.

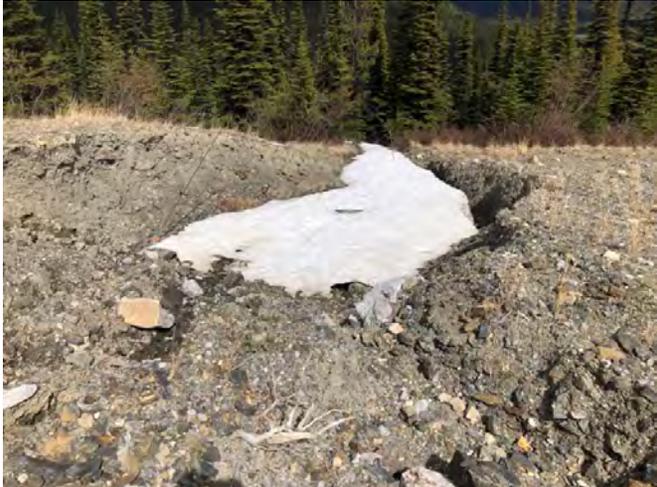
Photo Discription	Photo	Photo Location
Erosion monitoring posts - Erosion channel at entrance to Jewelbox.

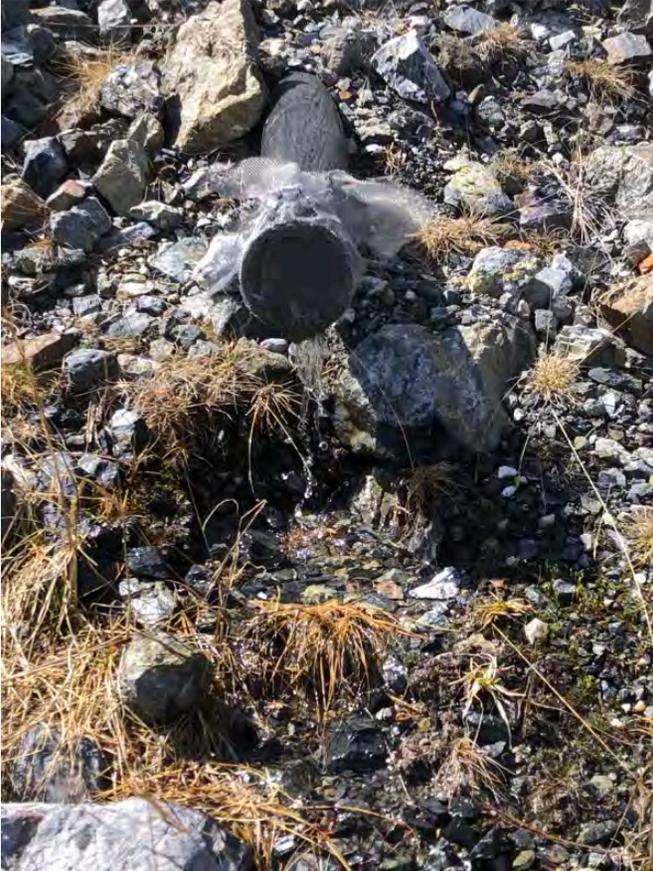
Photo Discription	Photo	Photo Location
Flow from middle portal drain(1B) flow rate 4.5L/per min.

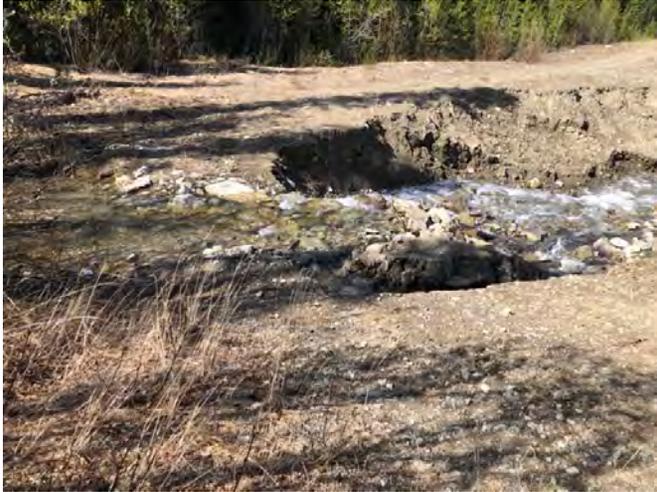
Date: 27/05/2023	Settlement/Depressions No Issues Found	Vegetation No Issues Found
Sideslopes Severely eroded	Debris at Inlet No Issues Found	
Riprap Getting washed downstream, will need to move it back to repair trail crossing.	Discharge No Issues Found

Photo Discription	Photo	Photo Location
Erosion of crossing

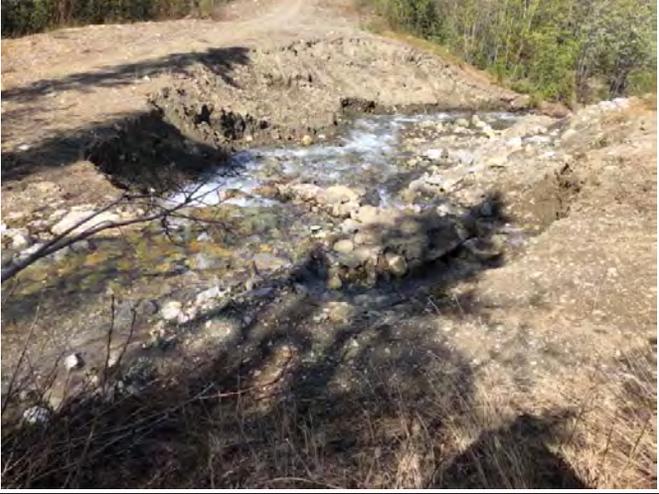
Photo Discription	Photo	Photo Location
Trail eroded

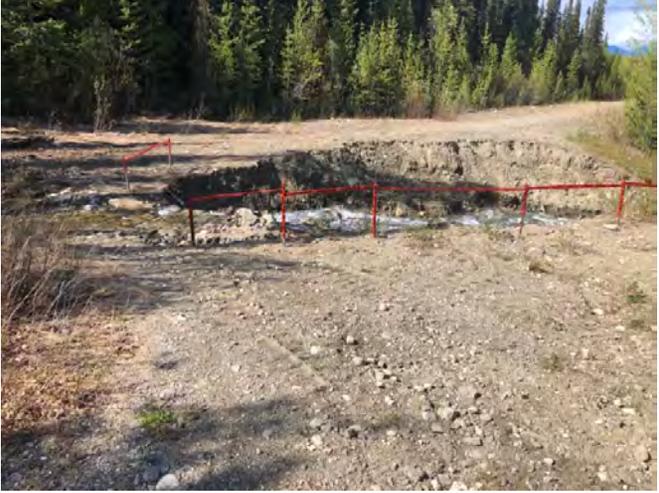
Soft barricading of erosion in crossing

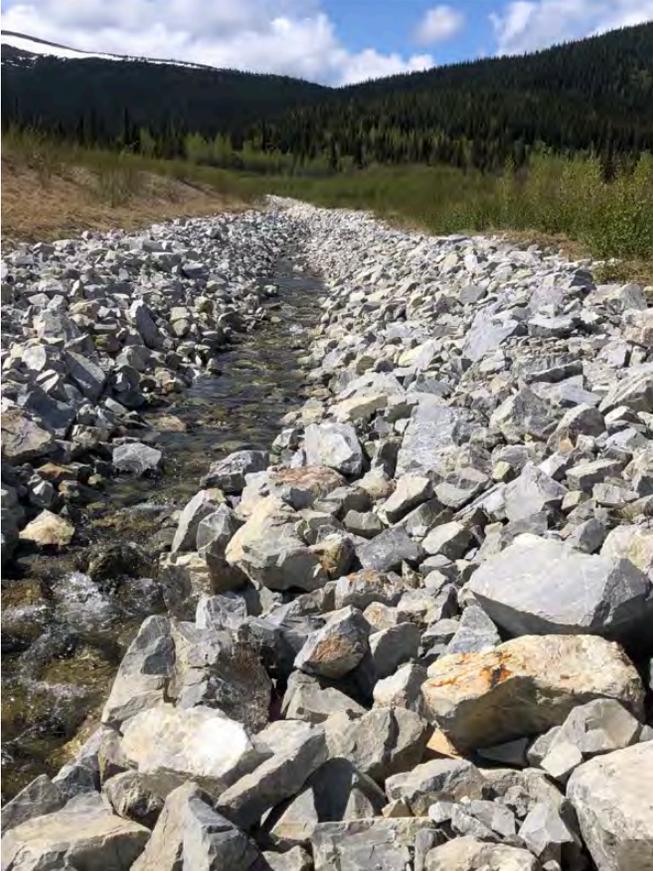
Latitude: 60.526676 Longitude: -128.849915

Photo Discription	Photo	Photo Location
Camp creek upstream from Reclaim/South channel.
