2023 Annual Geotechnical Inspection

Sa Dena Hes Mine, Watson Lake, Yukon
Teck Resources Ltd.

SRK Consulting (Canada) Inc. ■ CAPR002559 ■ August 2023

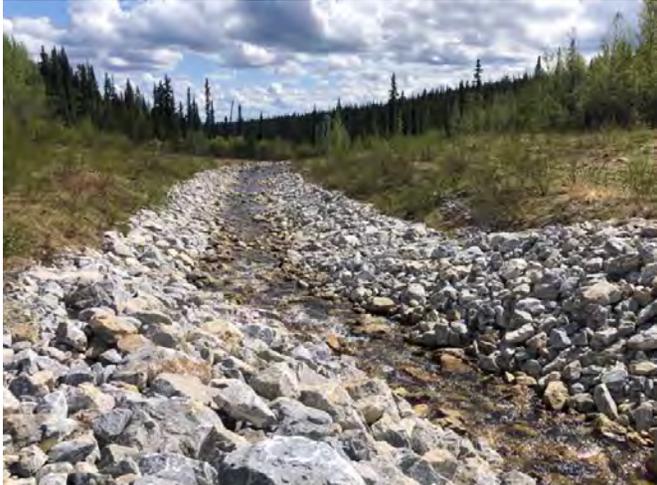
Photo Discription	Photo	Photo Location
South end, into wetland.

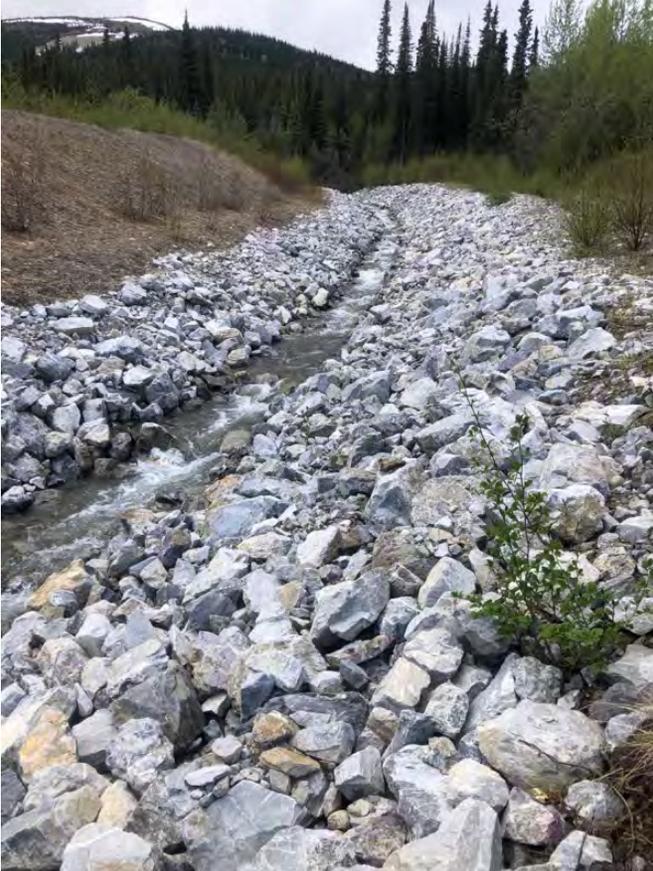
Latitude: 60.527695 Longitude: -128.856110

Photo Discription	Photo	Photo Location
Upstream end

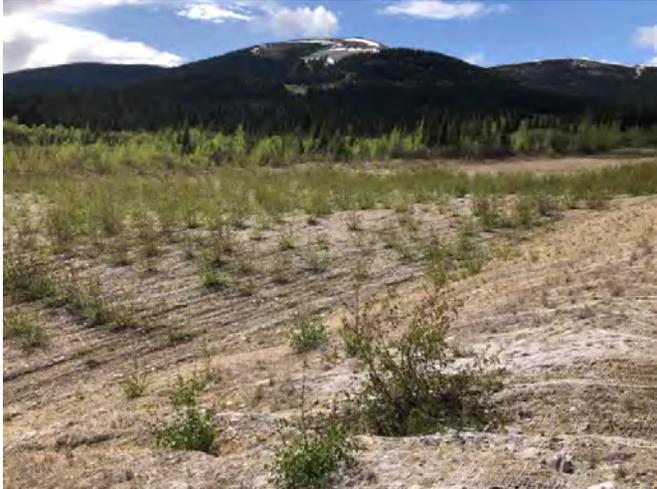
Photo Discription	Photo	Photo Location
Soil cap looking west

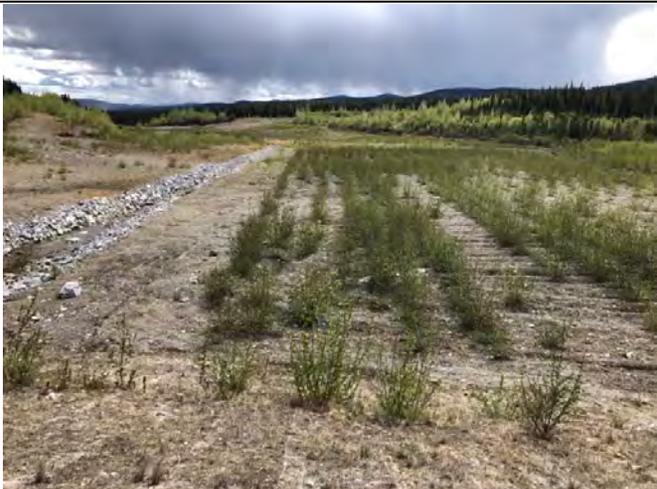
Latitude: 60.528740 Longitude: -128.850983
Soil cap facing South

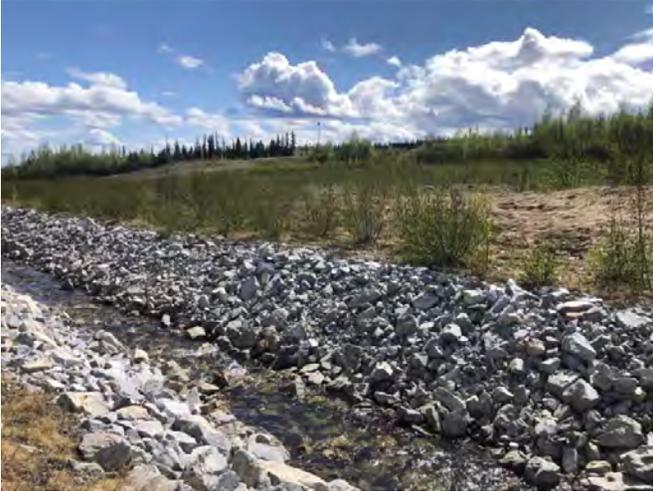
Photo Discription	Photo	Photo Location
S/E end of Reclaim pond , Osprey nest.

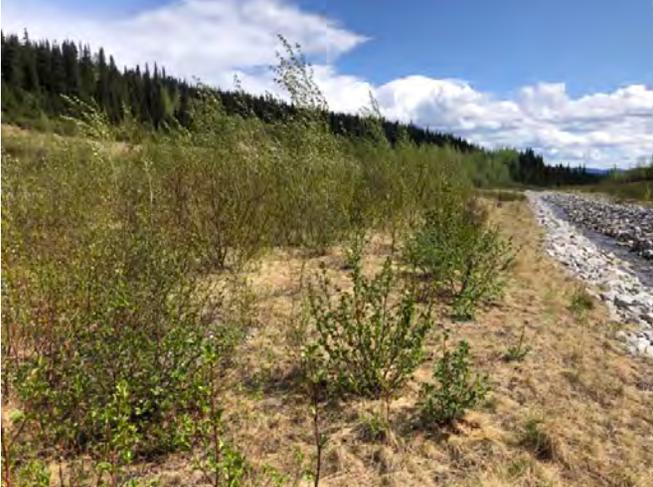
Latitude: 60.526638 Longitude: -128.849579
Sizeable Poplar growth
