August 11, 2015

Yukon Zinc Corp.
#701 – 475 Howe Street
Vancouver, British Columbia
V6C 2B3

Wolverine Mine
2015 Annual Physical Inspection of TSF and On-site Earth Structures

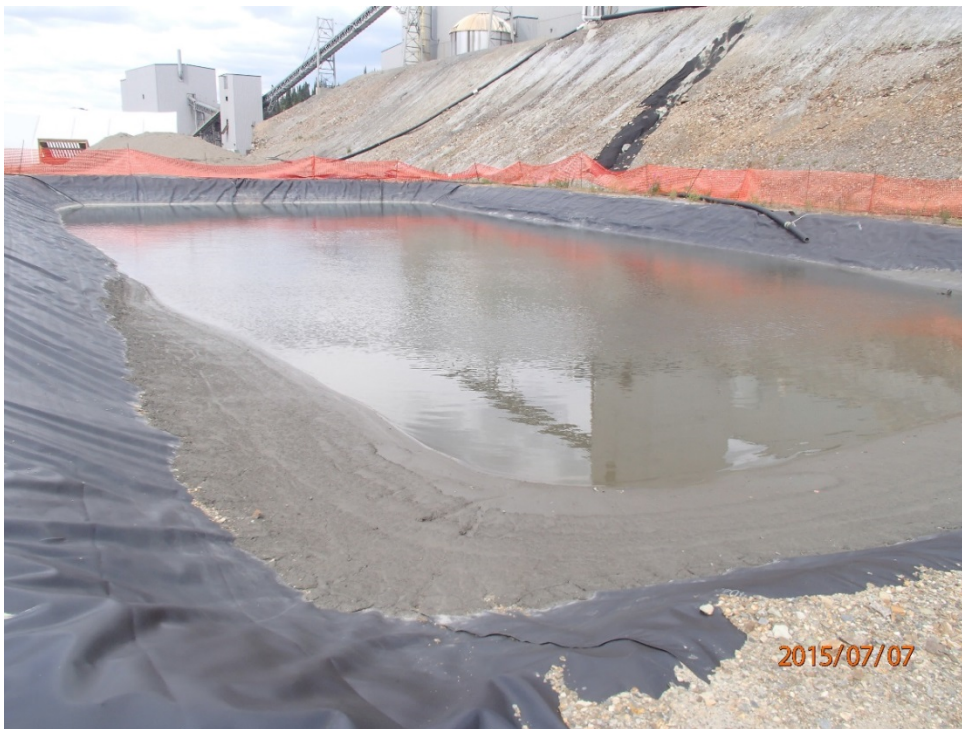
Photo 12 Sump 2 – bulge in the liner in the cross dyke, caused by groundwater
