## **Wolverine Project**

**QUARTZ MINING LICENSE QML-0006**

**2008 ANNUAL REPORT**

**Prepared by:  
Yukon Zinc Corporation  
Vancouver, British Columbia**

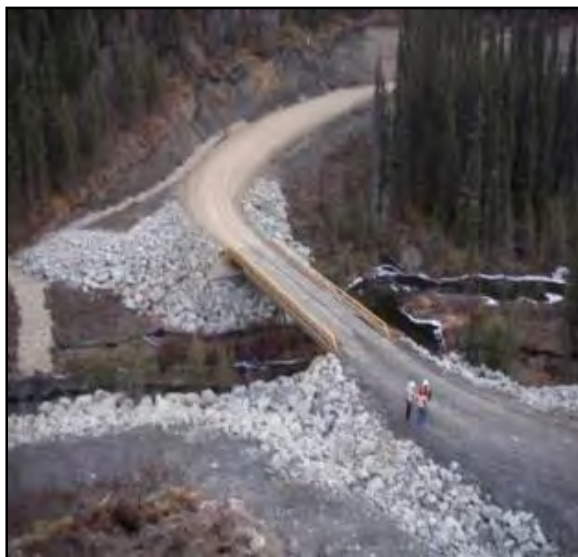
**Picture 9-1: Bunker Creek Permanent Bridge, capped road completed looking towards Robert Campbell Hwy, 10/15/08.**

The temporary bridge at over Bunker Creek at Km 10.5 was replaced with a permanent bridge during September and October 2008 (Picture 9-1).

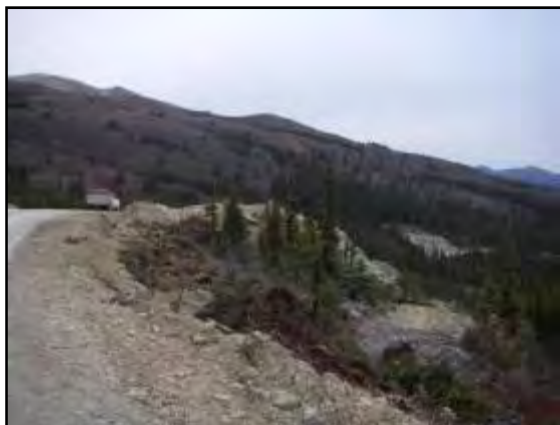
**Picture 9-2: Before blasting, stripping and clearing, looking north, 09/26/08**

In September 2008, road realignment commenced, starting with the drilling and blasting to the rock outcrop followed by stripping and clearing along the steep down slope side (Picture 9-2). Cutting and filling was done to bring the road to grade design from km 15 to km 15+300. Stripping and road widening was done up towards km14 from the new alignment around knob hill (Picture 9-3).

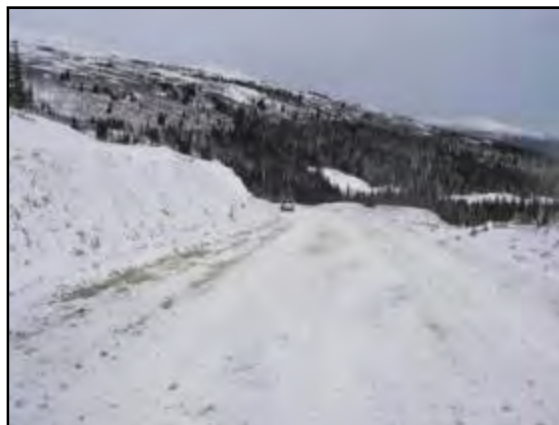
**Picture 9-3: Final grade complete, looking north, 10/27/08**

The original culvert at 15+100 was removed and replaced with a larger one as the road widened. The ditch line was increased by a 2 m depth to capture groundwater and prevent glaciation through the winter months.

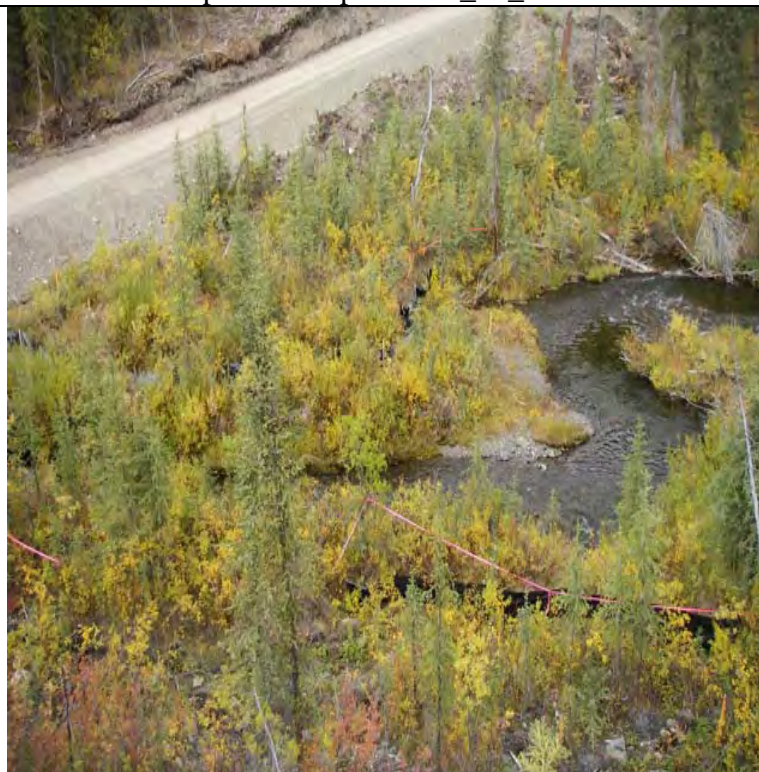
Bunker empty Silt Fence 09\_05\_08

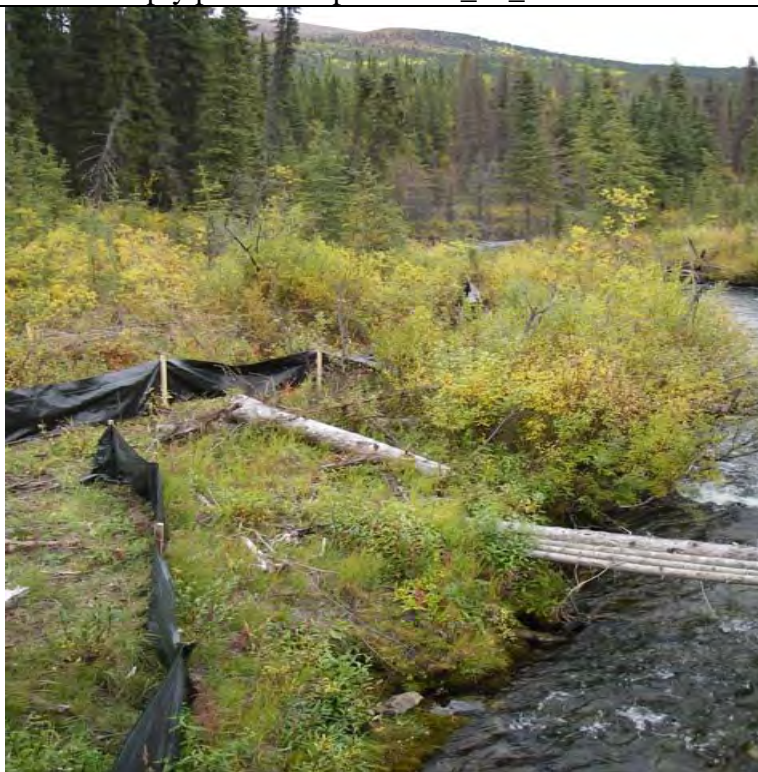
Bunker D/S dilt fence 09\_05\_08

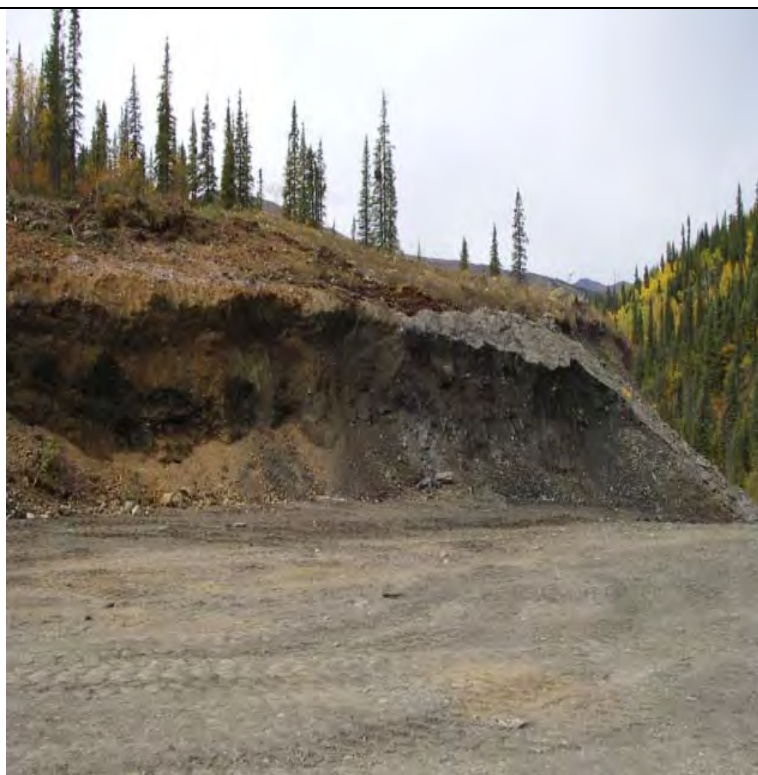
Bunker cut slope upchain of bridge 09\_07\_08

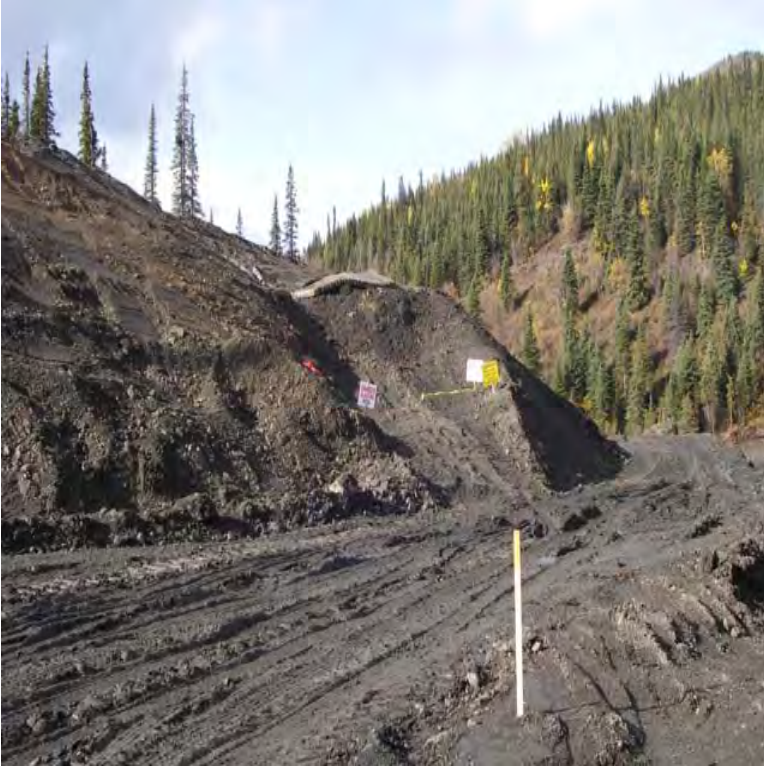
Bunker cut slope upchain of bridge 09\_17\_08

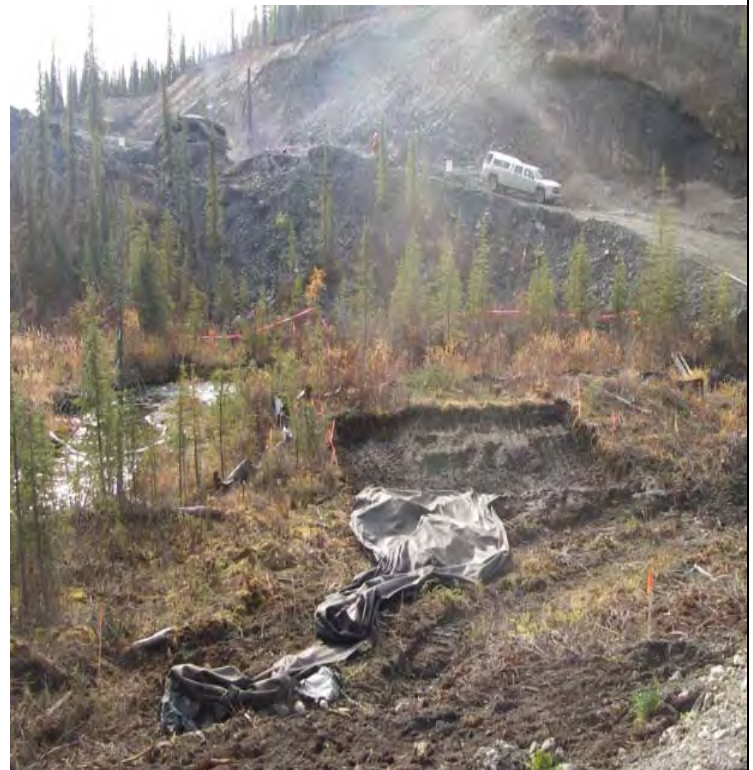
Bunker binwall excavation downchain side 09\_22\_08

Binwall area excavation has been completed and is being filled with drain rock, followed by compaction before binwall installation. The excavated area was close to creek, but is now filled and silt fenced, reestablishing stability and preventing bank rupture.

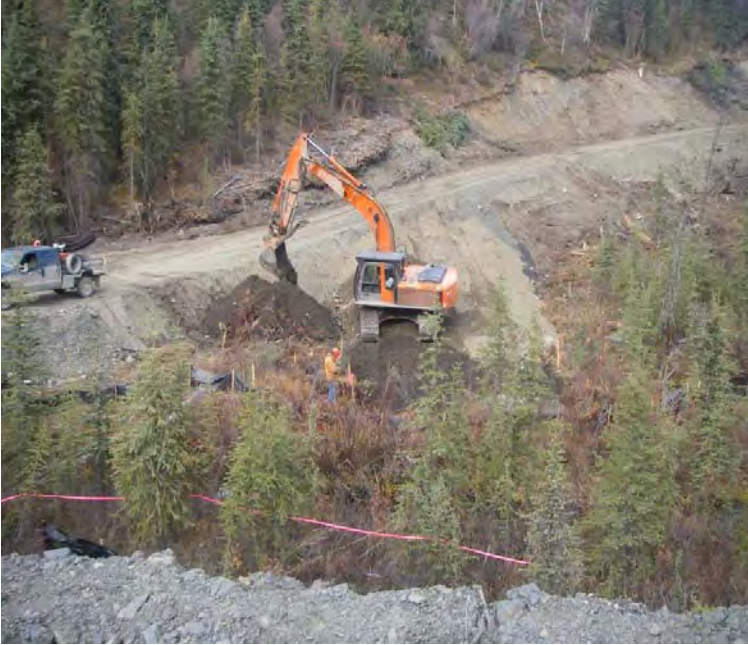
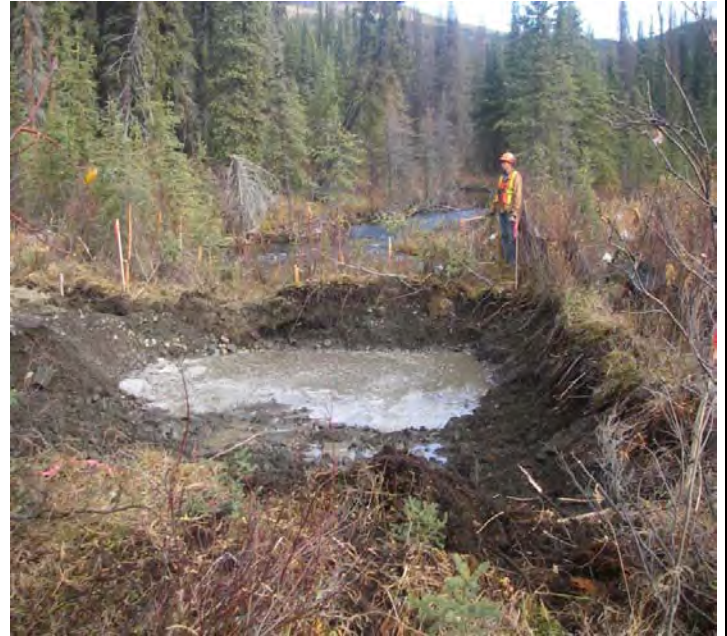
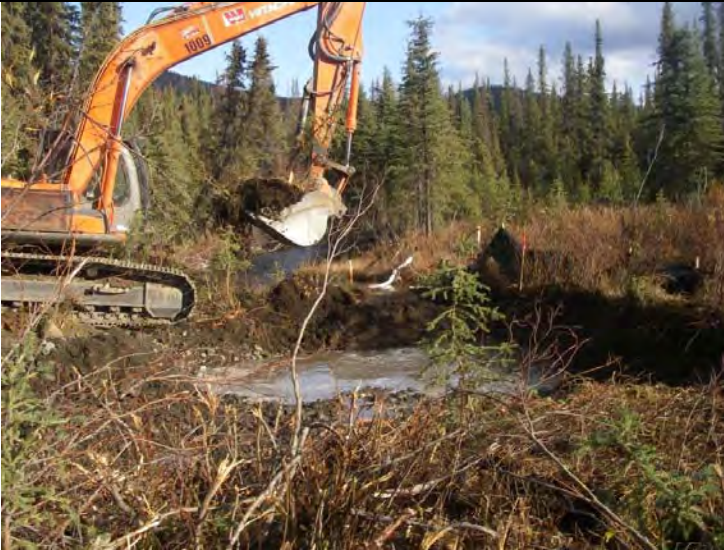
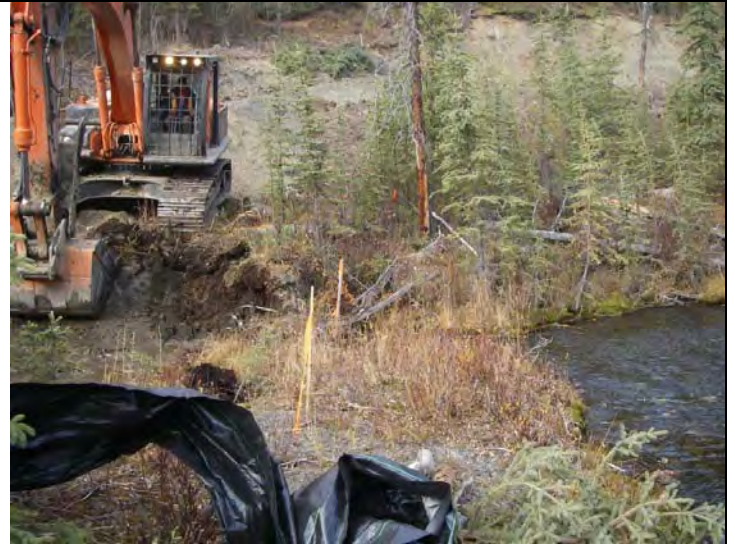
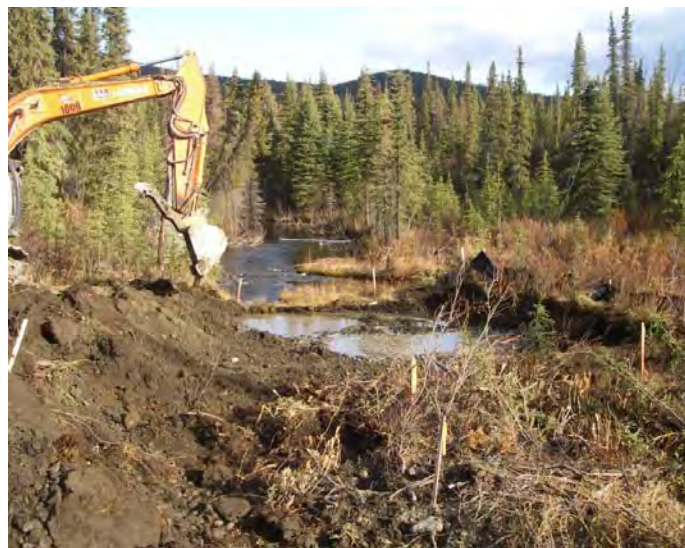
Bunker downchain binwall excavation 09\_23\_08

Bin wall area excavation has been completed and is being filled with drain rock, followed by compaction before bin wall installation. The excavated area was close to creek, but is now filled and silt fenced, reestablishing stability and preventing bank rupture.

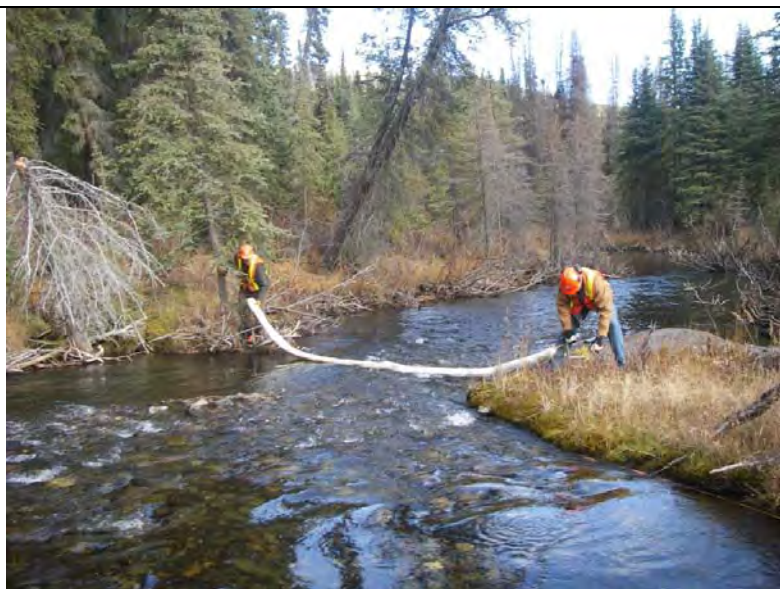
Bunker downstream spill sock 09\_23\_08

Continue to monitor condition of silt fencing and spill sock, as well as encroachment of construction areas to creek.

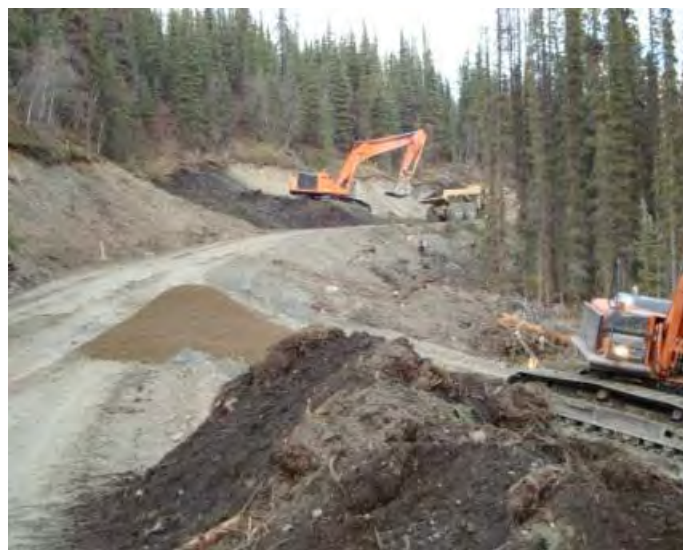
Bunker downchain cutslope work 09\_24\_08

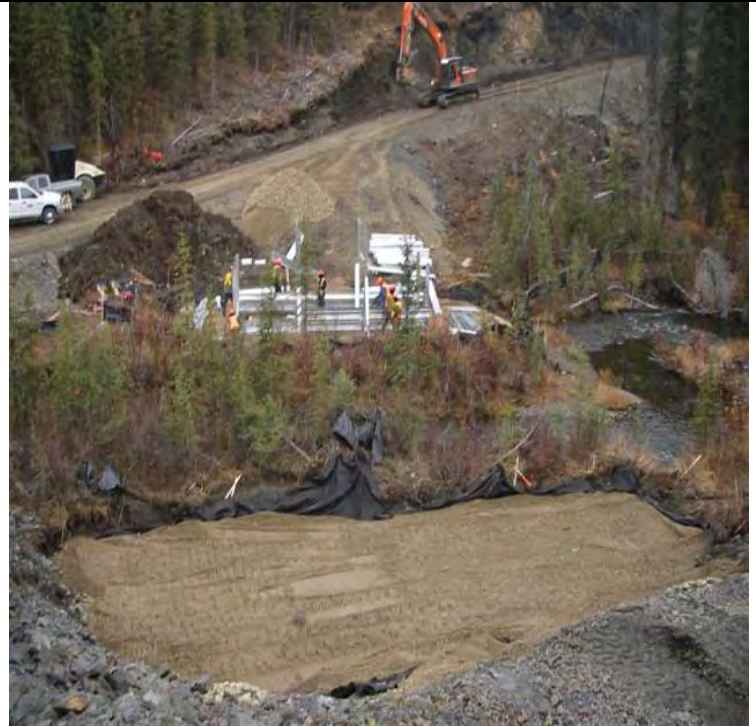
Bunker Creek: 09\_26\_08 Site over view. Ground prep work for UC bin wall. (Note: silt fence installed later.)

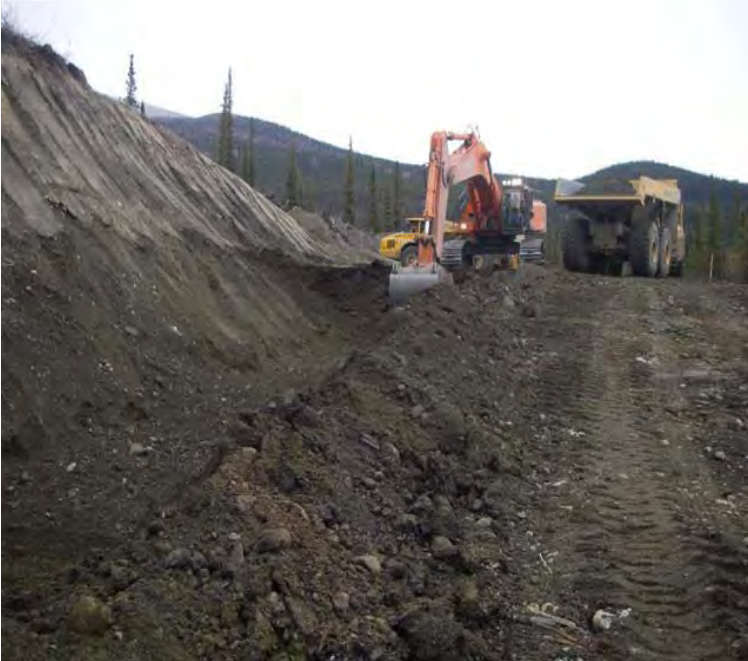
Bunker Creek: DC cut slope and re- alignment of road. 09\_26\_08 (facing DC)

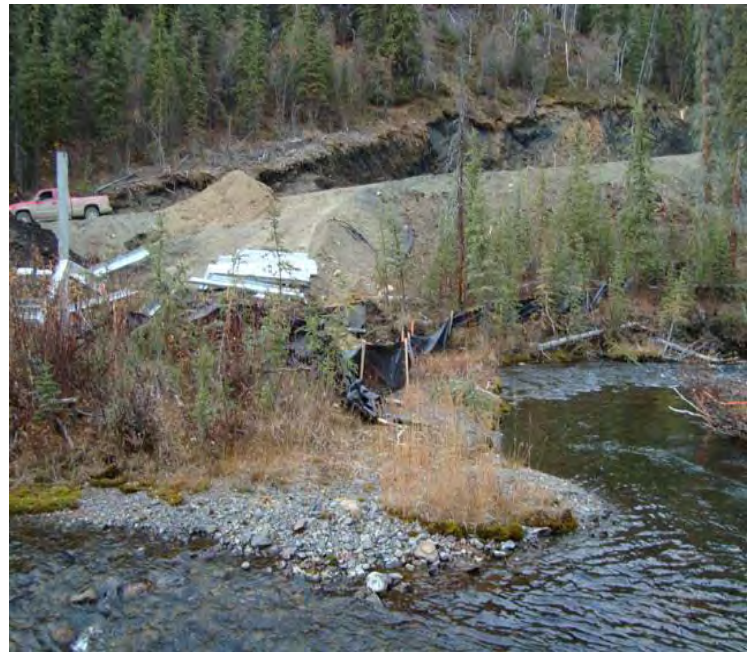
Bunker Creek: Silt fencing re-installed. 09\_26\_08 (facing DC)

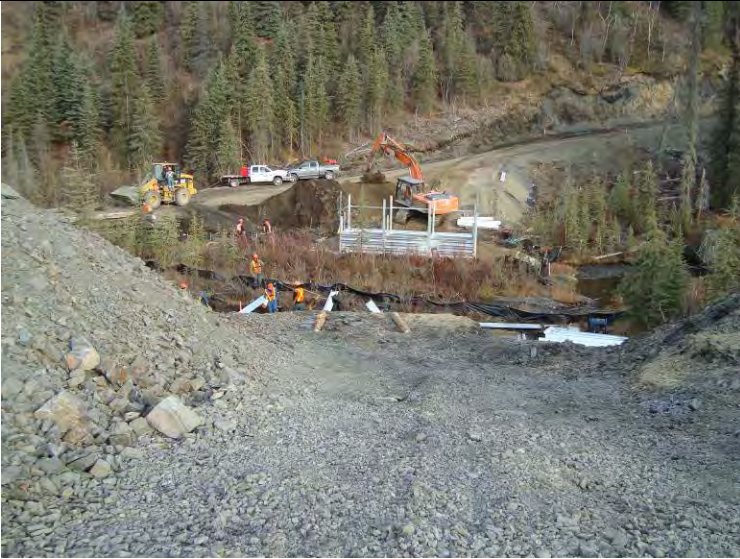
09\_27\_08 Bunker Bridge binwall installation (facing downchain (DC))

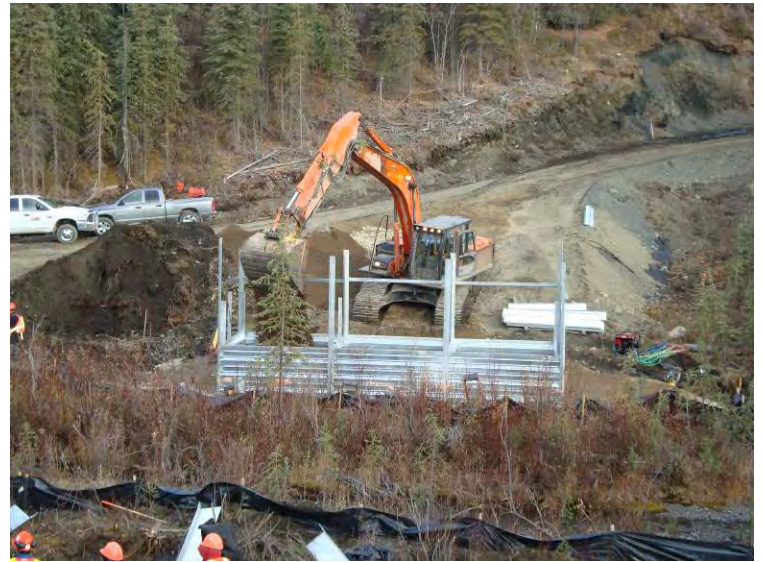
09\_27\_08 Down chain bin wall loading (facing DC)

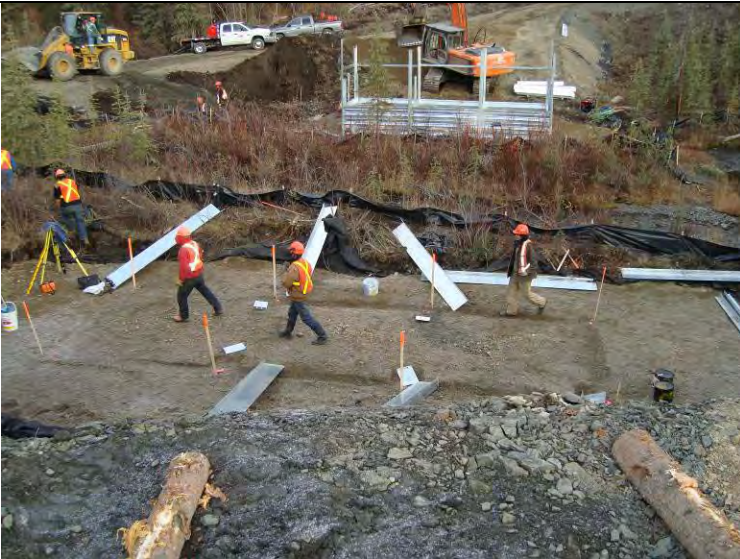
09\_27\_08 Up chain bin wall layout (facing DC)

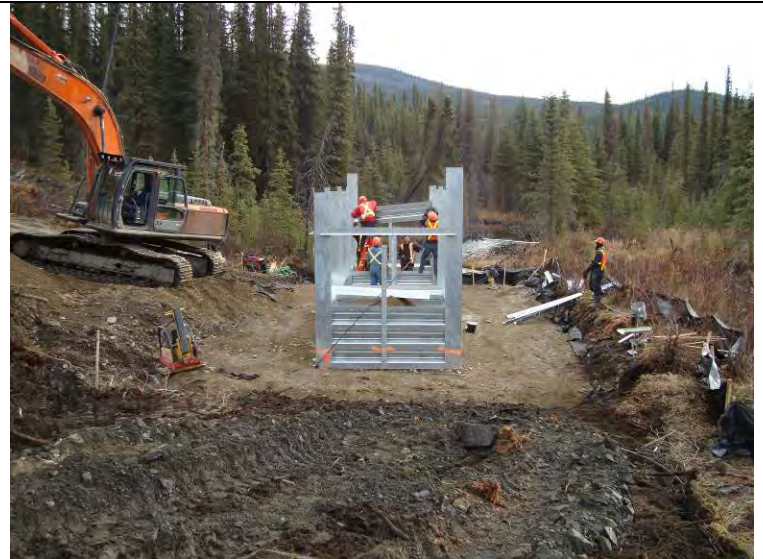
09\_27\_08 Down chain bin wall installation (facing downstream )

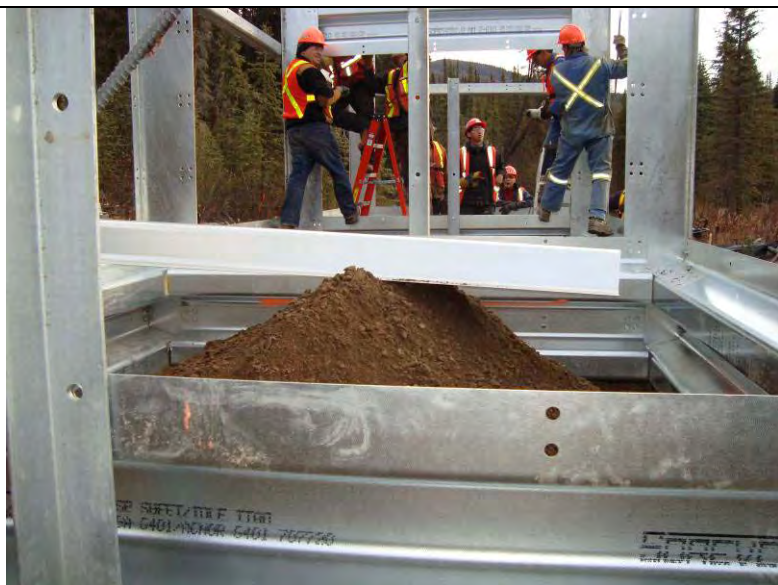
09\_27\_08 Down chain bin wall loading with material from K18 borrow source

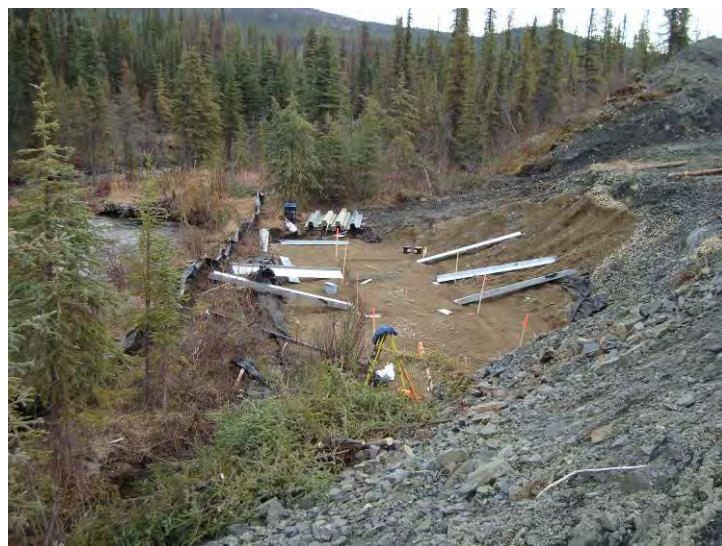
09\_27\_08 Up chain bin wall layout (facing downstream)

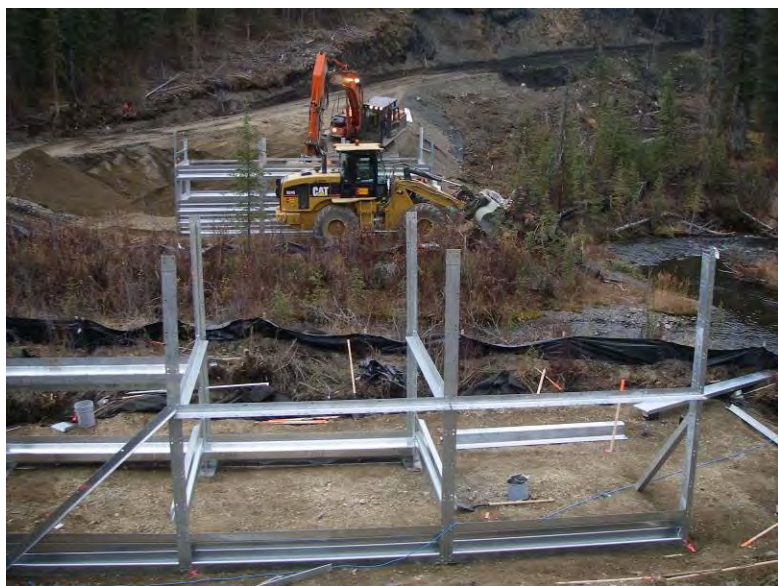
09\_27\_08 Up chain bin wall layout, and down chain install (facing DC)

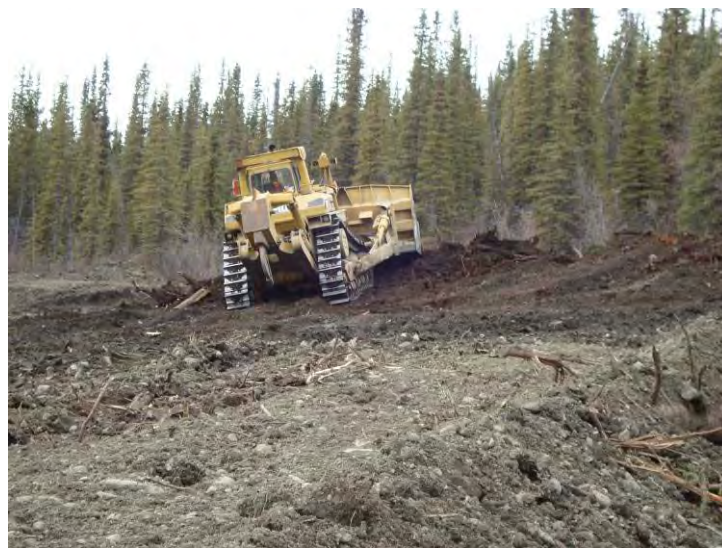
09\_28\_08 K10 waste pile

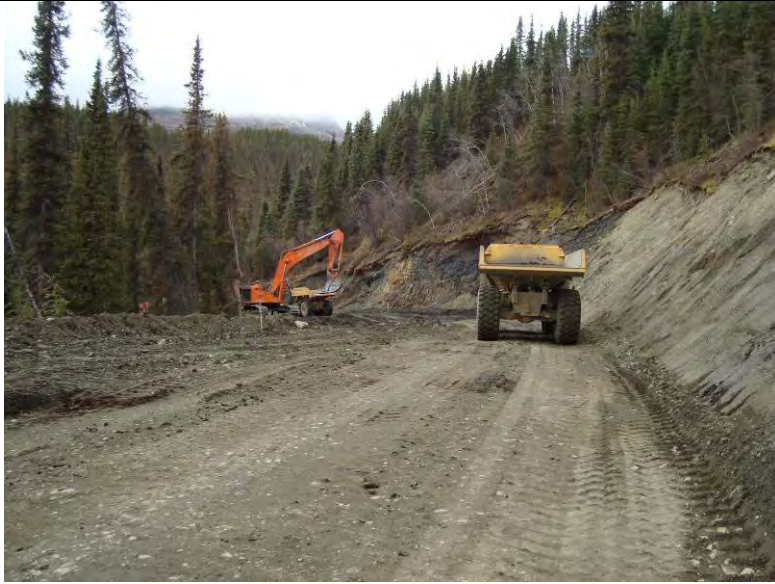
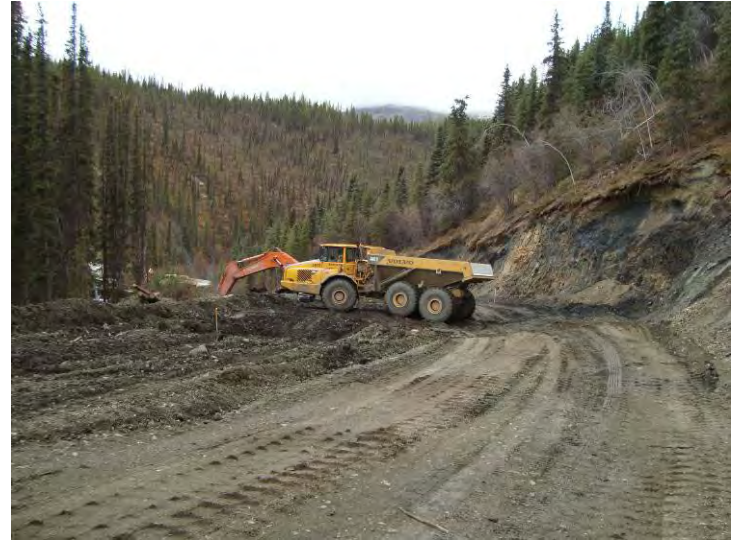
09\_28\_08 Load and haul of waste material from down chain approach to bridge (facing upchain (UC))

09\_28\_08 Load and haul of waste material from down chain approach to bridge (facing UC)

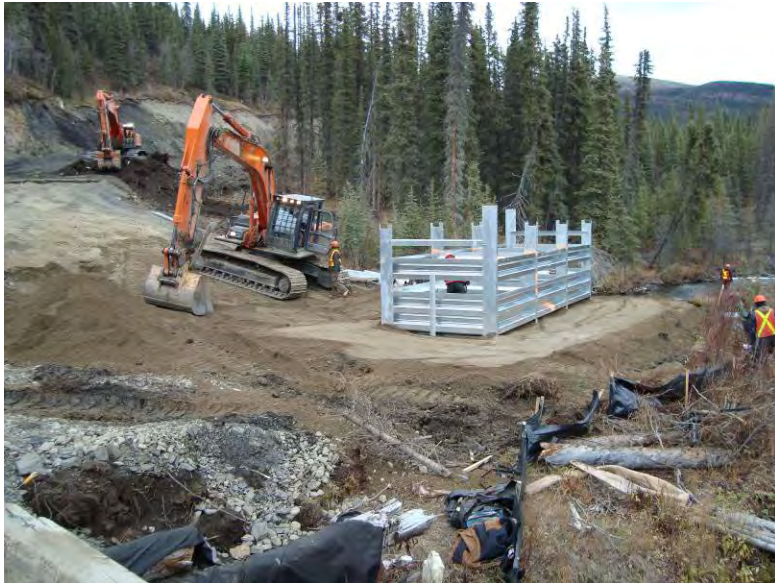
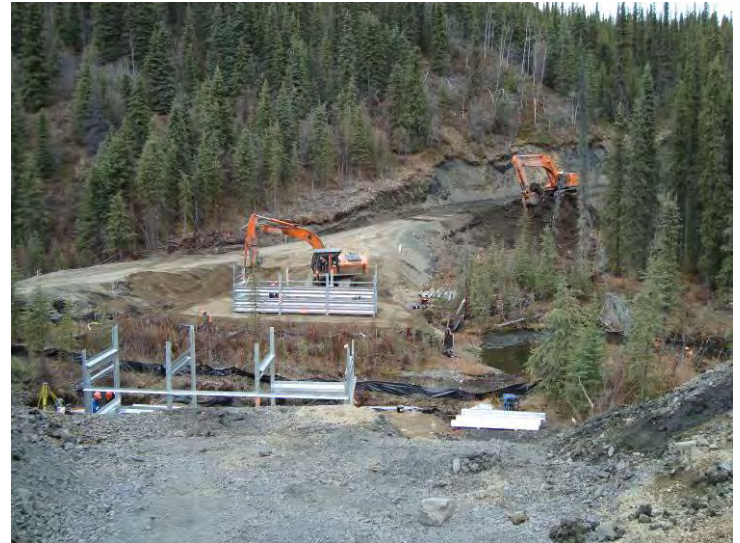
09\_28\_08 Down chain bin wall backfill and compaction in foreground, down chain approach work in background (facing DC)

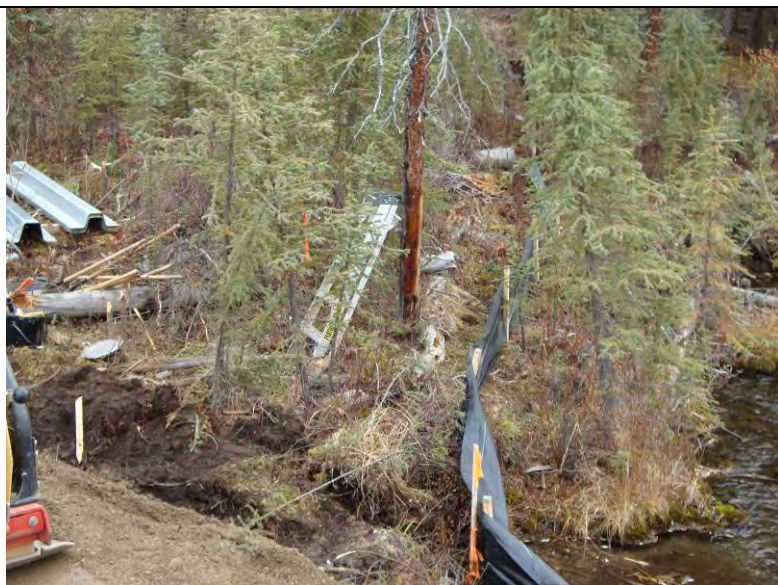
09\_29\_08 Silt fencing in place at down chain bin wall compaction nearest to creek

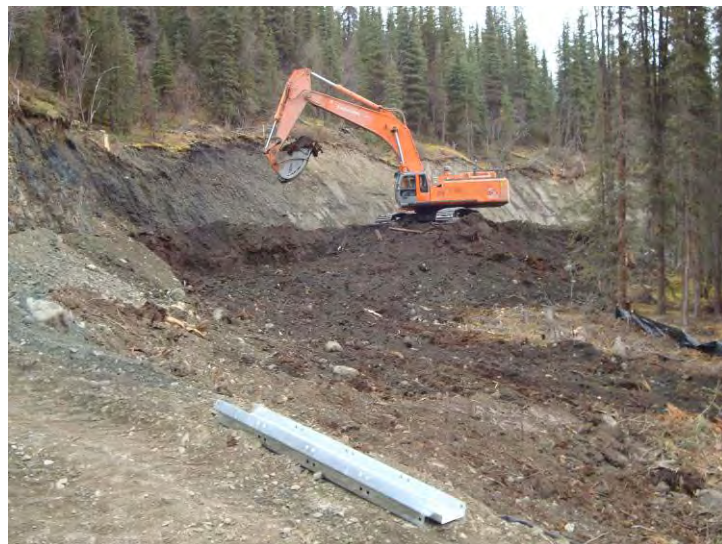
09\_29\_08 Down chain cutting and realignment for approach (facing DC)

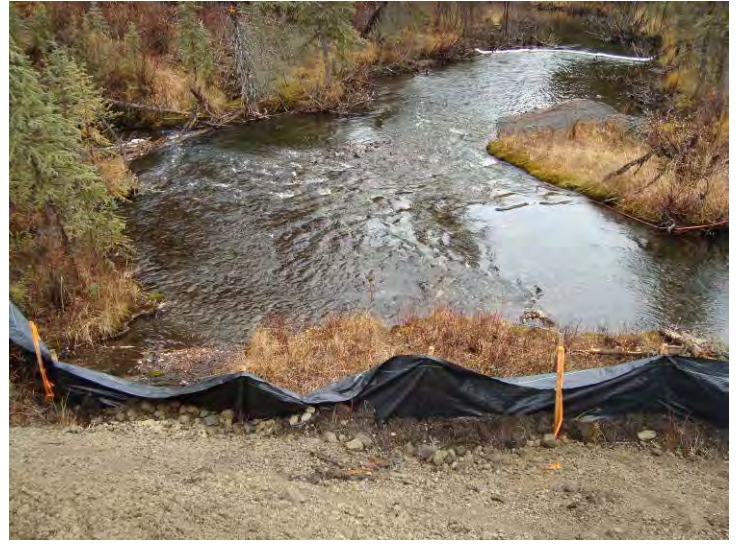
09\_30\_08 Silt fencing near creek (facing downstream)

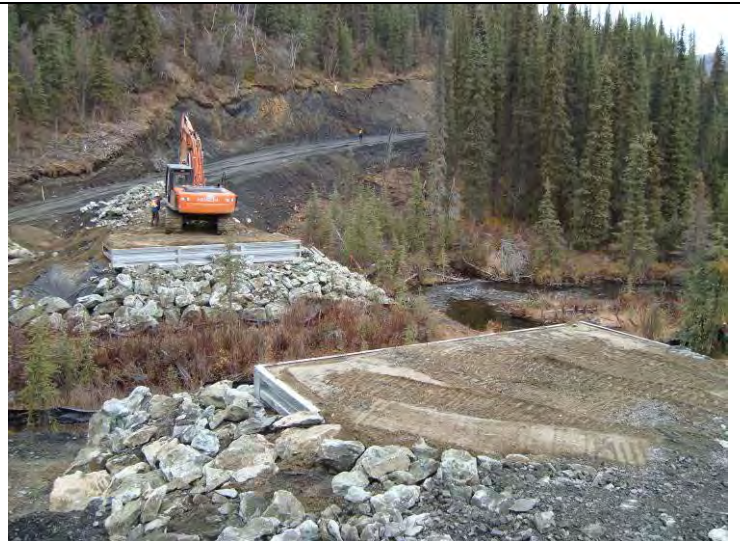
10\_02\_08 Facing DC, bin walls complete, geotech wrapped around backfilling followed by rip rap placement.

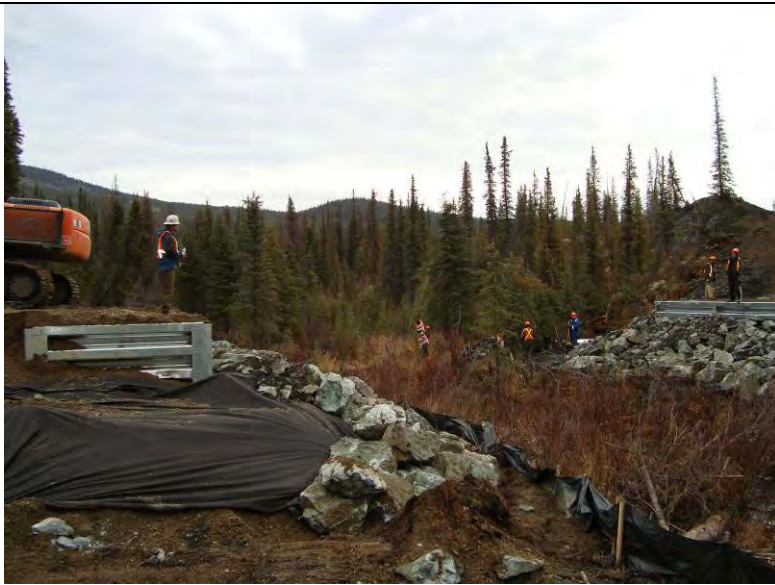
10\_02\_08 Facing UC, geotech and rip rap placement, sediment fencing in place.

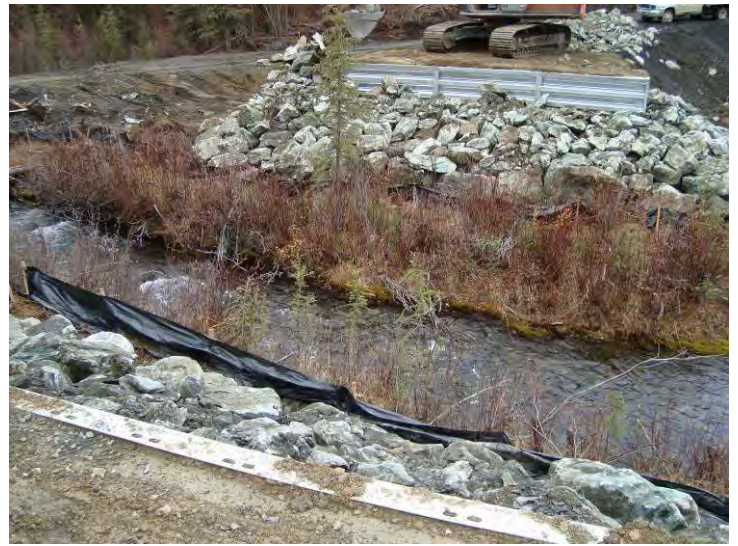
10\_02\_08 Facing DC, sediment fencing in place, no sediment in creek.

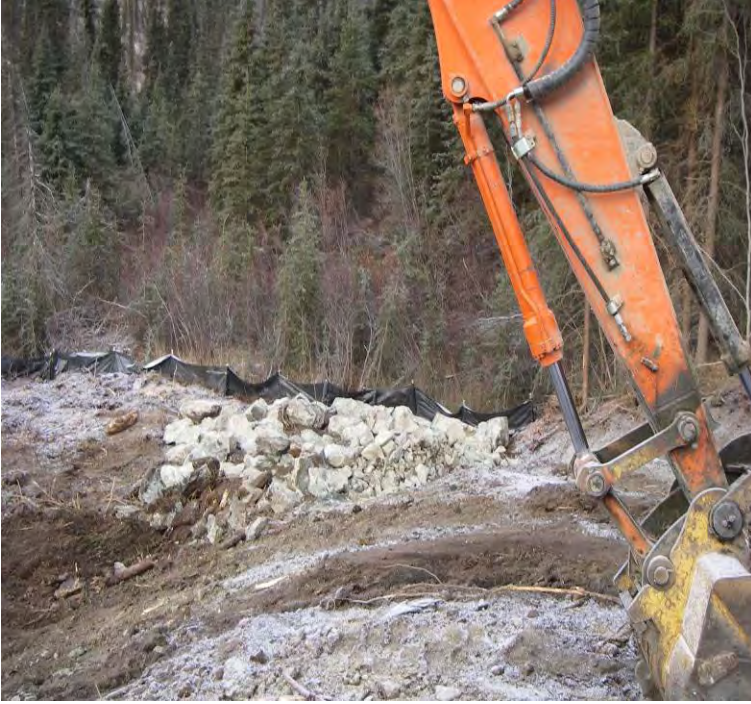
10\_08\_08 Facing UC, preparing ditch grade and energy dissipater on u/s DC side of bridge

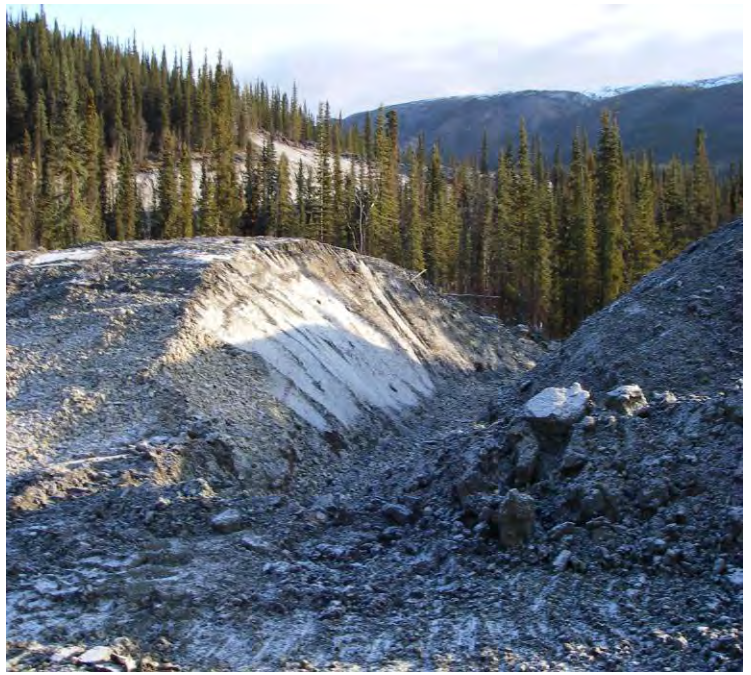
10\_08\_08 Facing DC, cross-drain for culvert and ditchblock on UC side of bridge

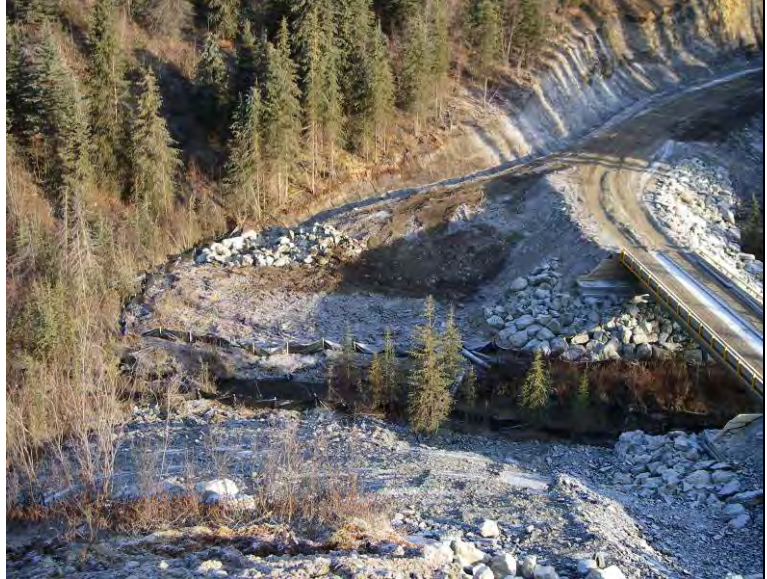
10\_08\_08 Facing DC, location of removed temporary bridge contoured and organics replaced. Pile of rip rap at location of energy dissipater

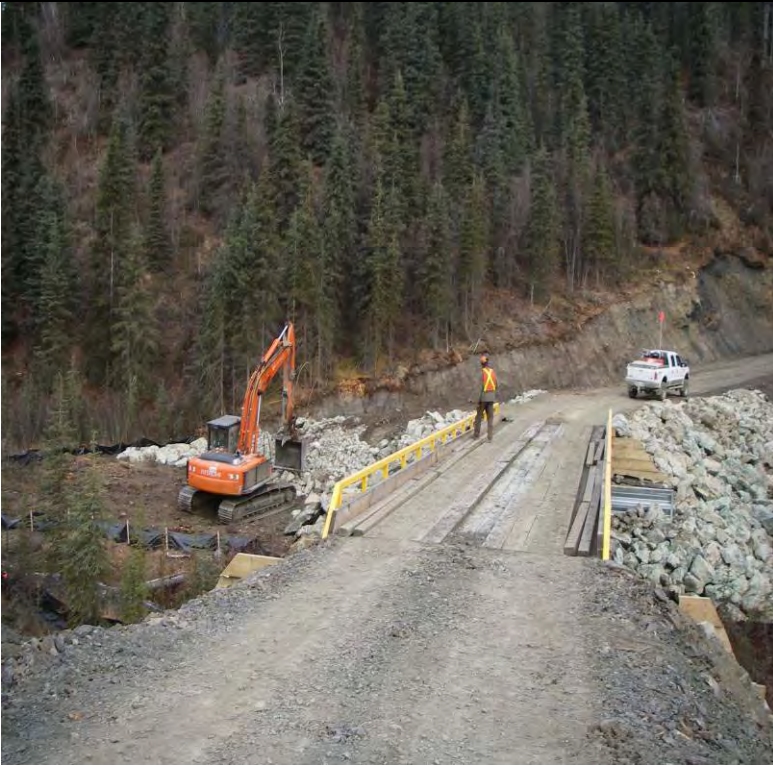
10\_09\_08 Facing DC, finishing the armouring and energy dissipater and prepping for the outflow path of the ditch to creek

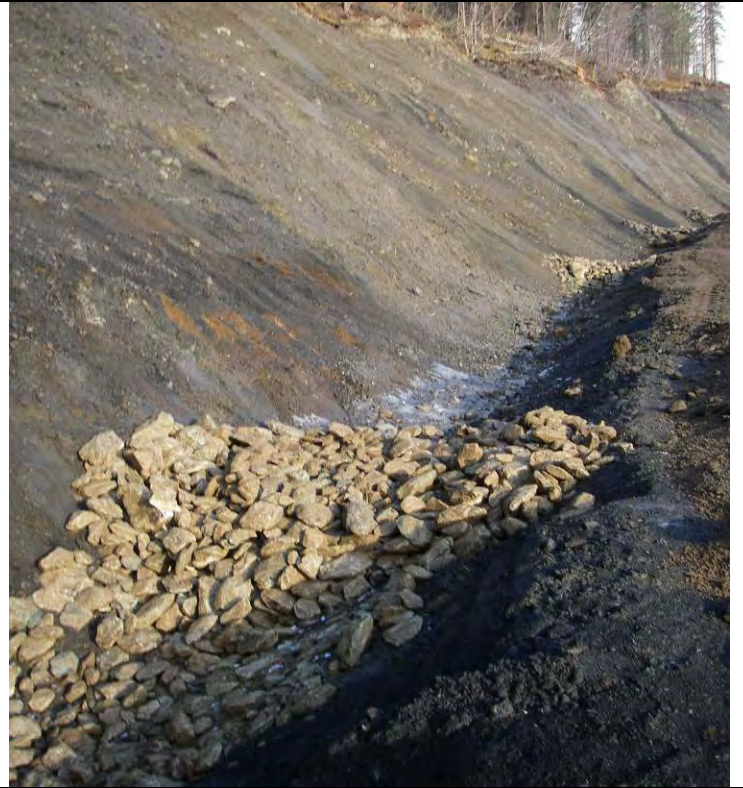
10\_11\_08 Facing DC, Ditch blocks and start of rock lined ditch on u/s DC side

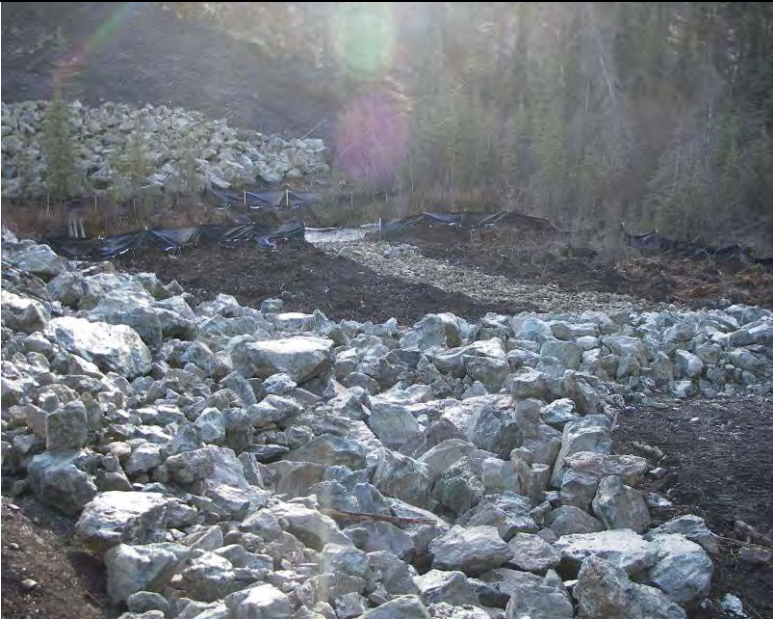
10\_11\_08 Facing UC, rocklined outflow to Bunker Creek after energy dissipater.

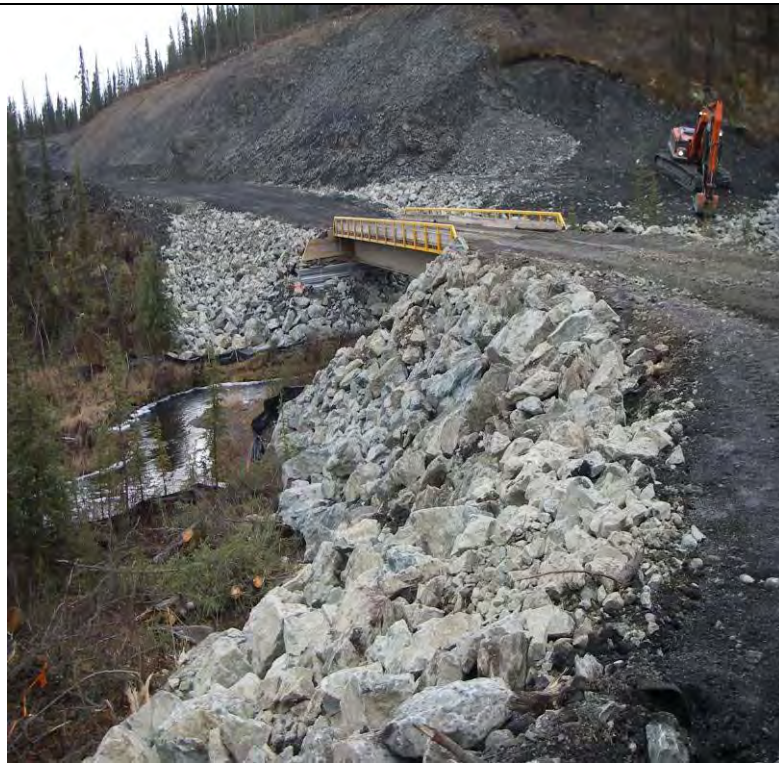
10\_13\_08 Facing UC, finishing the armouring and rock lined outflow on UC d/s side

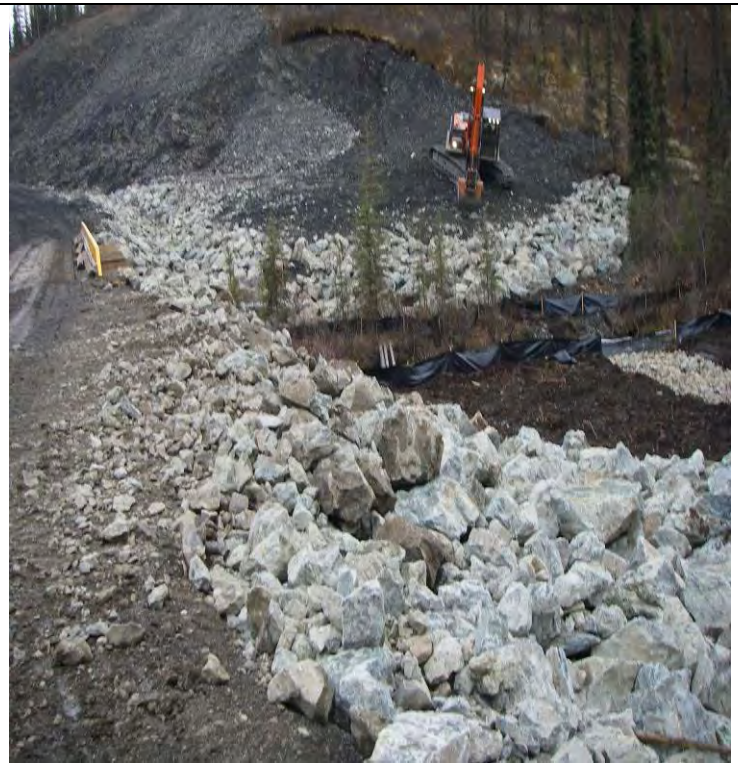
10\_13\_08 Facing UC, armouring on UC u/s bank completed rock lined ditch

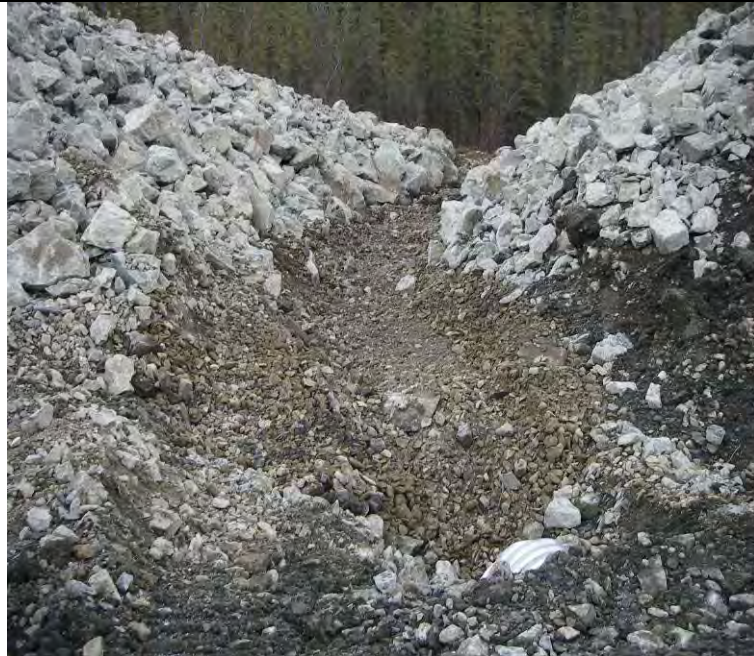
10\_13\_08 Facing d/s on UC side, Culvert outflow for cross drainage complete

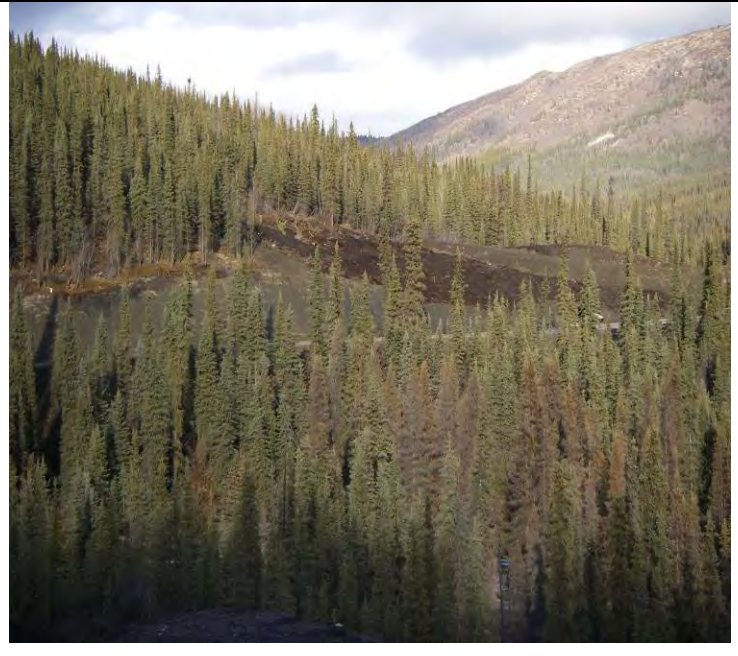
10\_11\_08 facing UC, Reclaimed borrow pit and shaped waste pile and organic stockpile on UC side

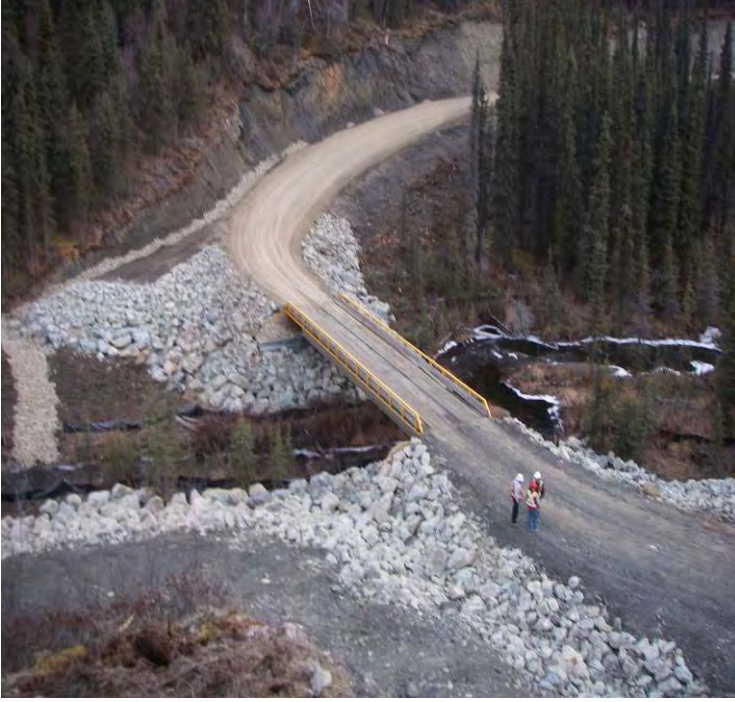
10\_15\_08 Facing DC, capped road completed on DC side
