## **Wolverine Project**

**QUARTZ MINING LICENSE QML-0006**

**2008 ANNUAL REPORT**

**Prepared by:  
Yukon Zinc Corporation  
Vancouver, British Columbia**

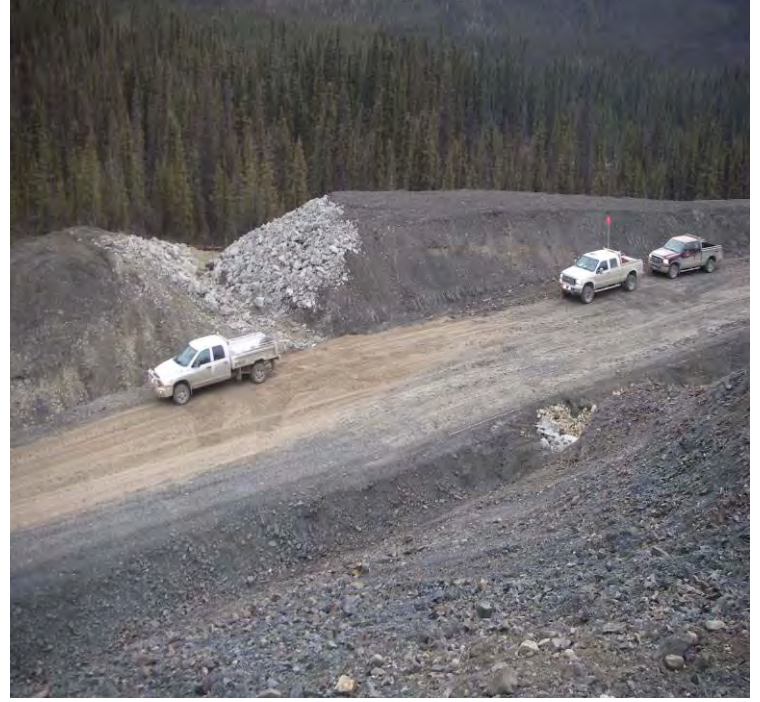
10\_15\_08 Facing d/s, cross-drain for culvert and ditchblock on UC side of bridge

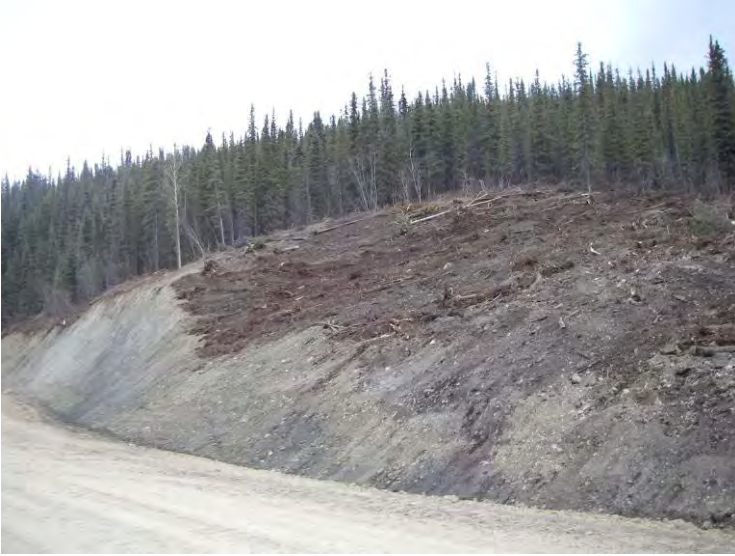
10\_15\_08 Facing UC, old borrow site at km 10+100

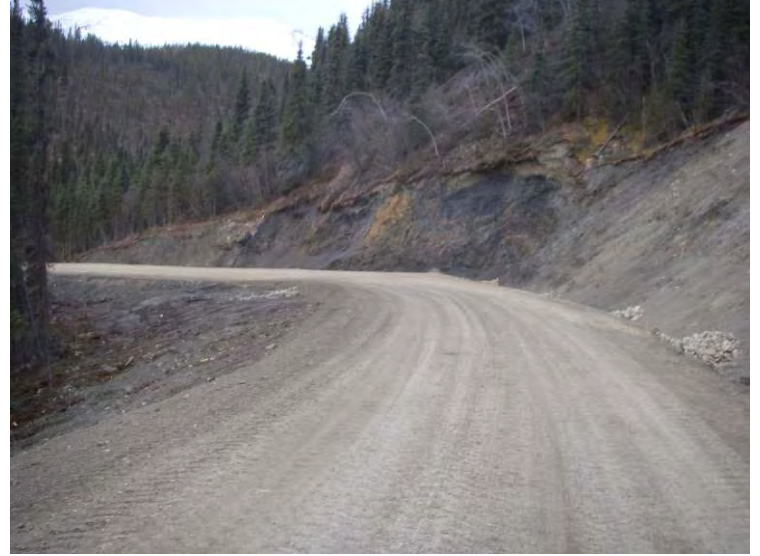
10\_15\_08 Facing UC, Bridge approach capped

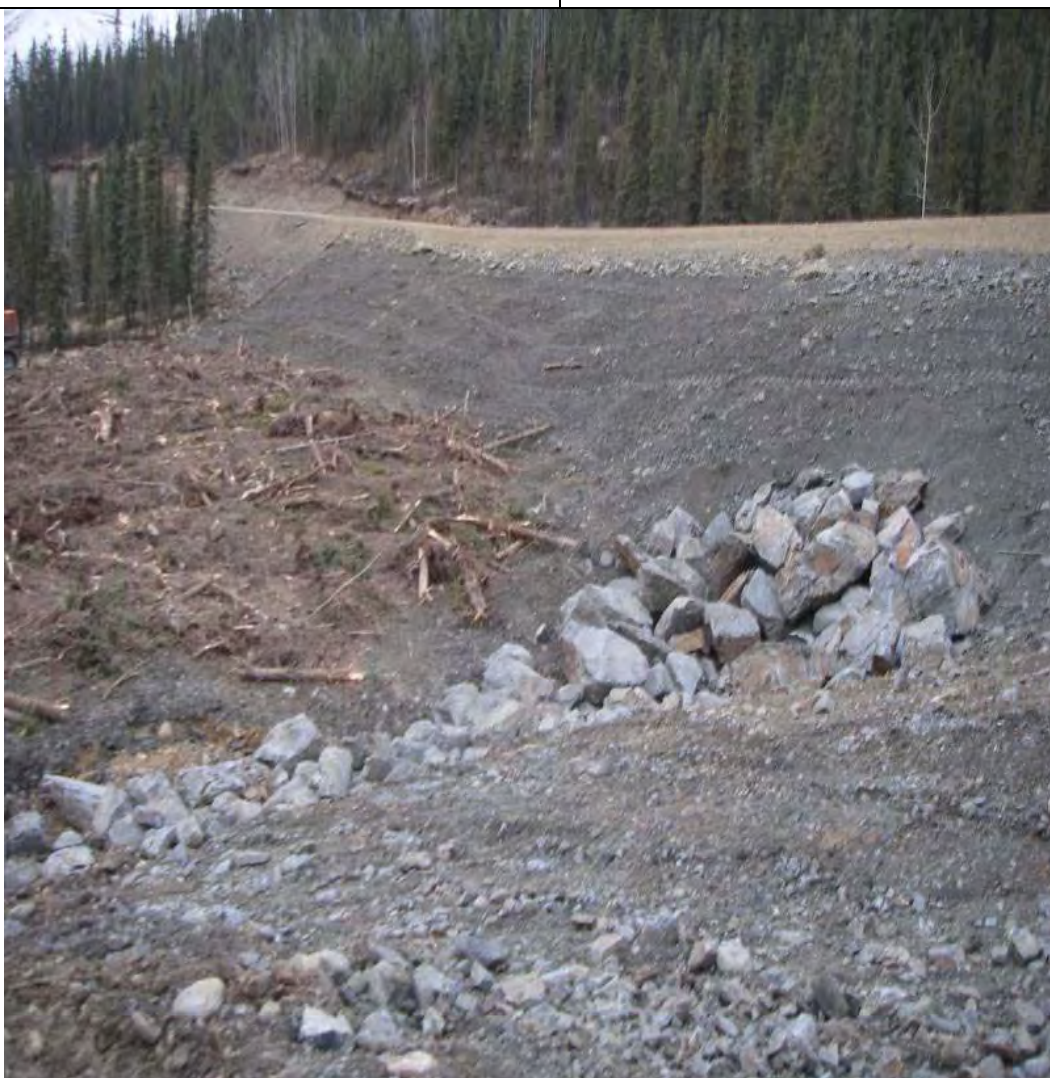
10\_15\_08 Facing UC, Road capping and completed landscaping and pulling over of organics at UC waste site

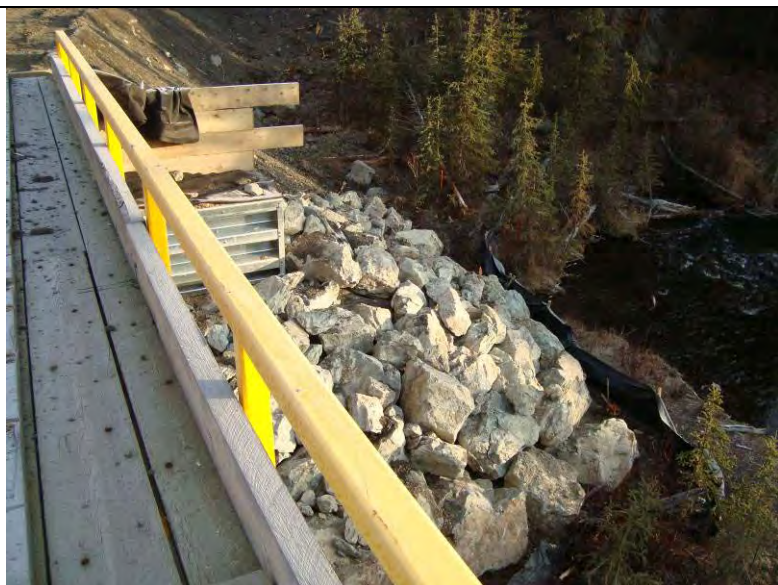
10\_04\_08 Facing US, rip rap in place, added boards for support, silt fencing in tact.

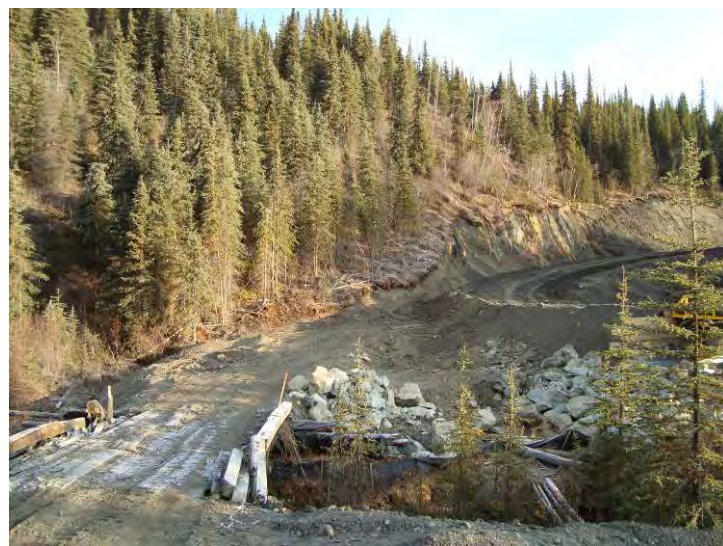
10\_04\_08 Facing DC, temporary bridge to be removed.

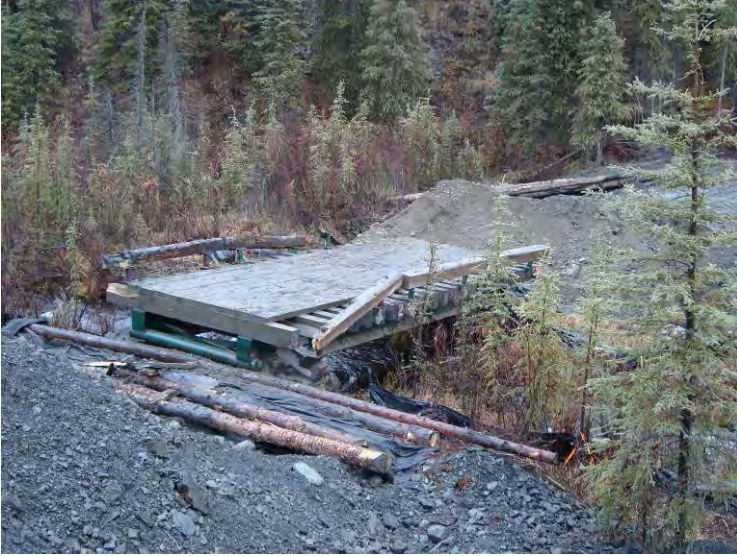
10\_05\_08 Facing DC, temporary bridge cleaned of debris, both backs with sediment pulled back from abutments and area prepped for bridge removal.

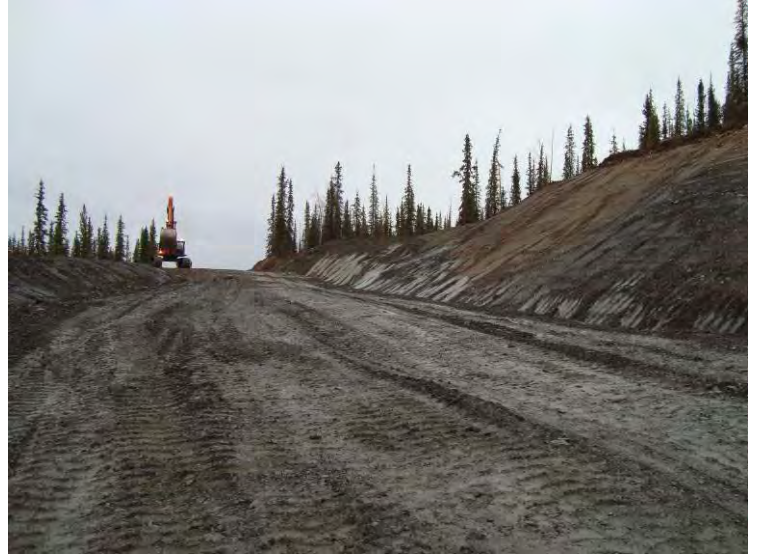
10\_05\_08 Facing UC, road re-contoured and re-sloped. Cross drain needs to be installed from slope through bank.

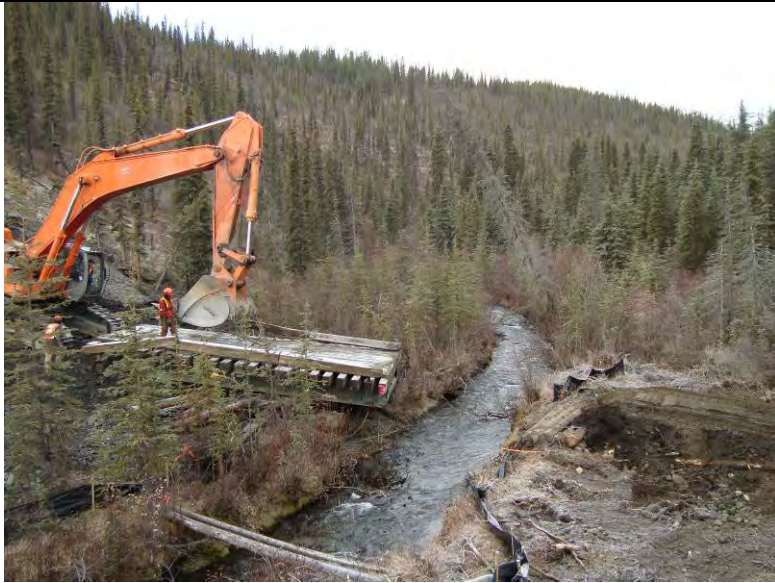
10\_06\_08 Facing upstream (US), temporary bridge pulled out towards UC, no sediment from bridge or banks reached creek.

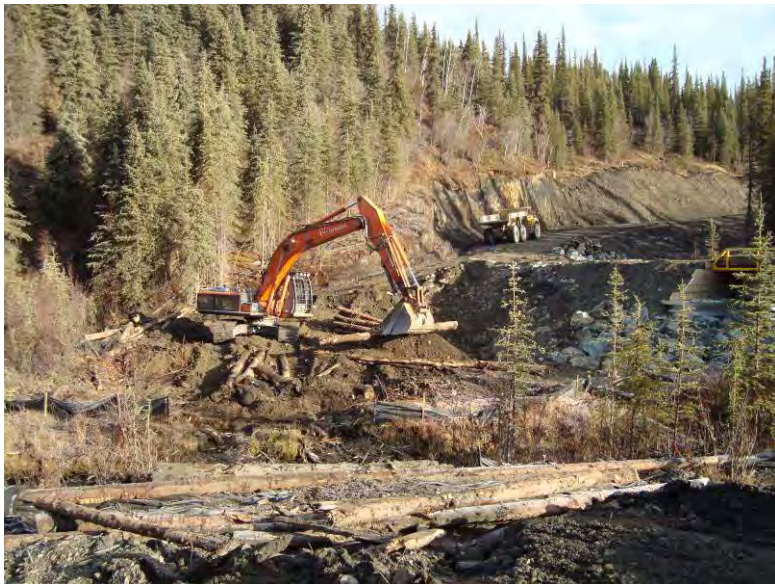
10\_06\_08 Facing DC, pulling abutments apart. Area needs to be filled, sloped. Rip rap to be continued from bin wall around base of slope. Ditching to continue on left hand side of road down along tree line (approx.). Silt fence to be continued where abutments have been removed.

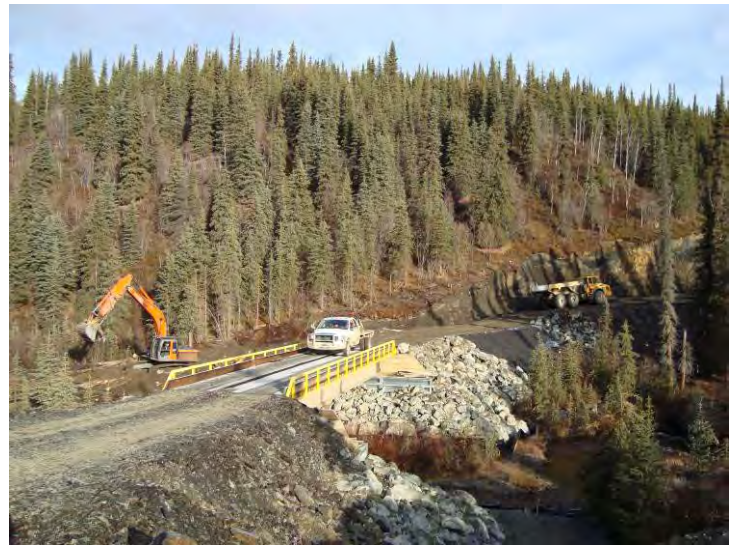
10\_06\_08 Facing DC, clean up of temporary bridge area continues, and permanent bridge in use.

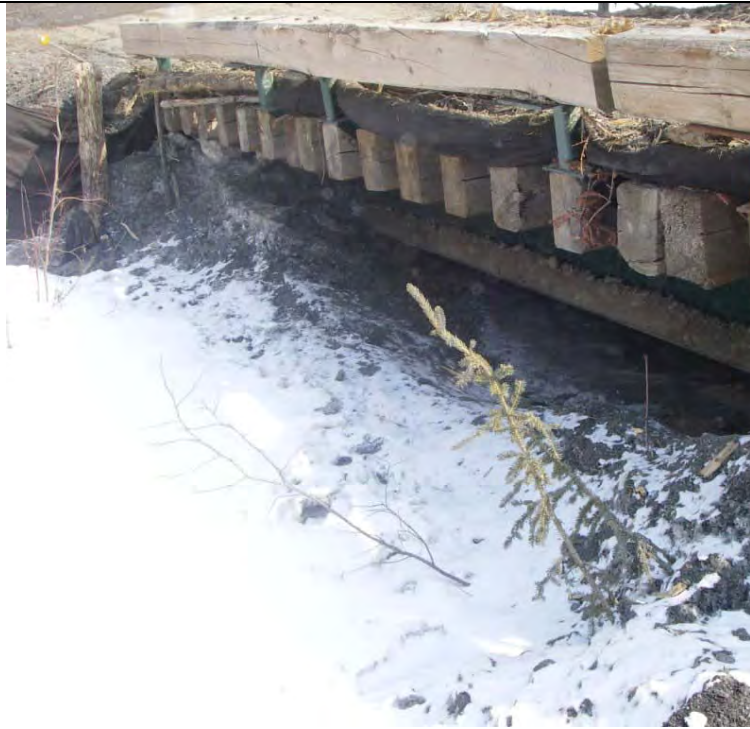
**BunkerCreek\_04\_19\_08- Looking DS-under bridge**

Assessed Risk: N/A		
Photos Attached: YES		
Samples Taken: No		
Additional Information Attached: No		
<b>Part 3 –Mitigation Requirements</b>		
Mitigation Required: Bunker Creek Ice surface from overflow is very close to the base of the bridge		
Mitigation Condition: N/A		
<b>Part 4 –Monitoring Requirements</b>		
Follow-up Monitoring: Will monitor general condition and progress of the melt as the season progresses		
Monitoring Frequency: Weekly		
Reporting Requirements: Weekly, individual reports will be issued for problem areas.

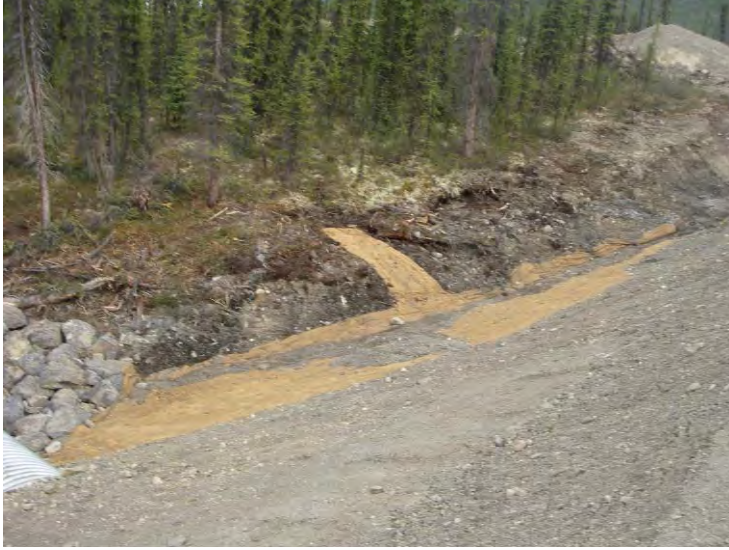
**Putt Creek downslope ditch (re-seeded May 25<sup>th</sup>)**

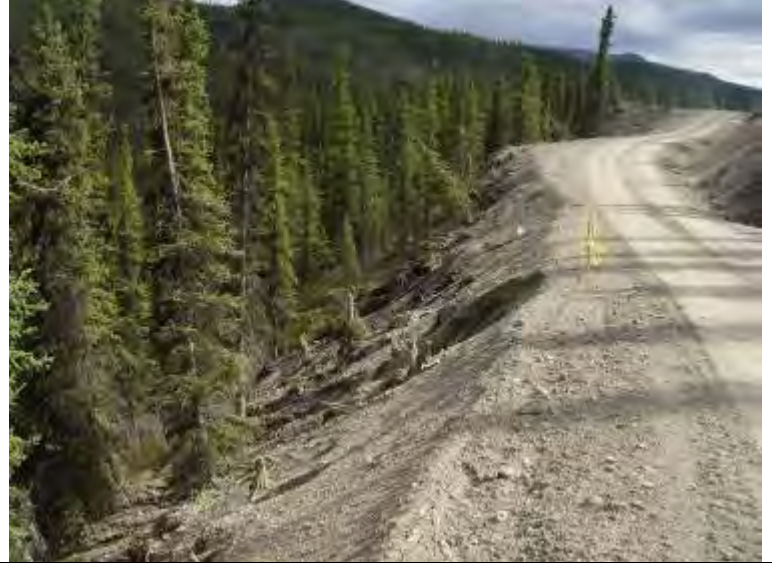
**Km 9 sloughing; facing south-west**

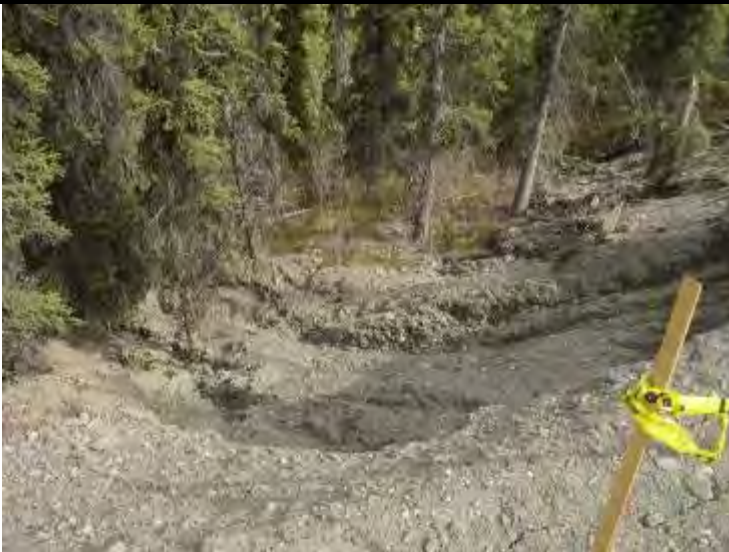
**Km 9 sloughing; facing east, downslope**

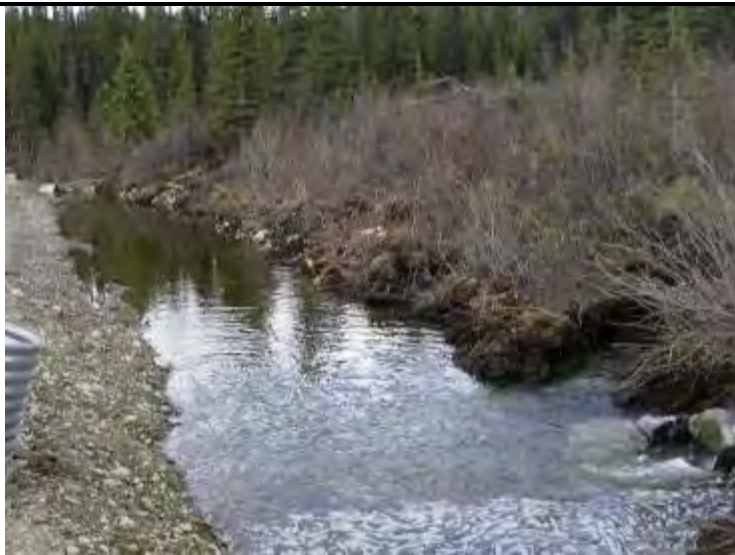
**Hawkowl Creek – 24” culvert at left of photo; ditch plug just beyond culvert**

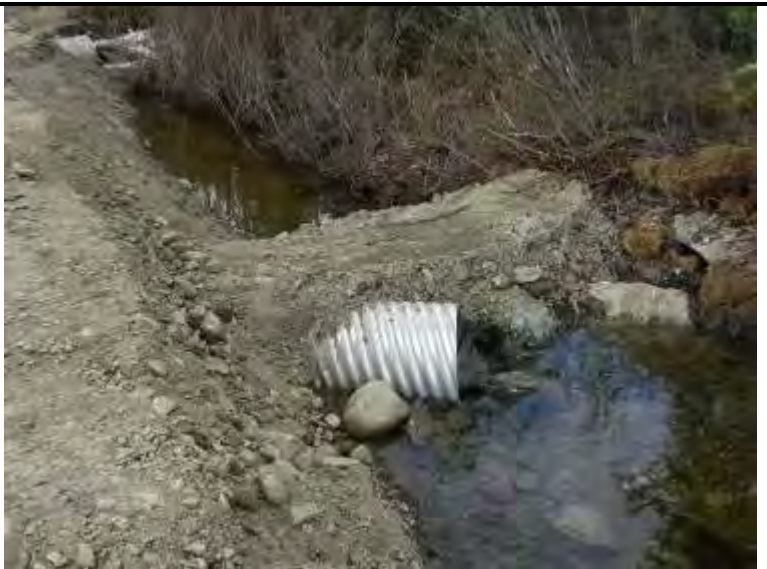
**Hawkowl Creek – 24” culvert with ditch plug**

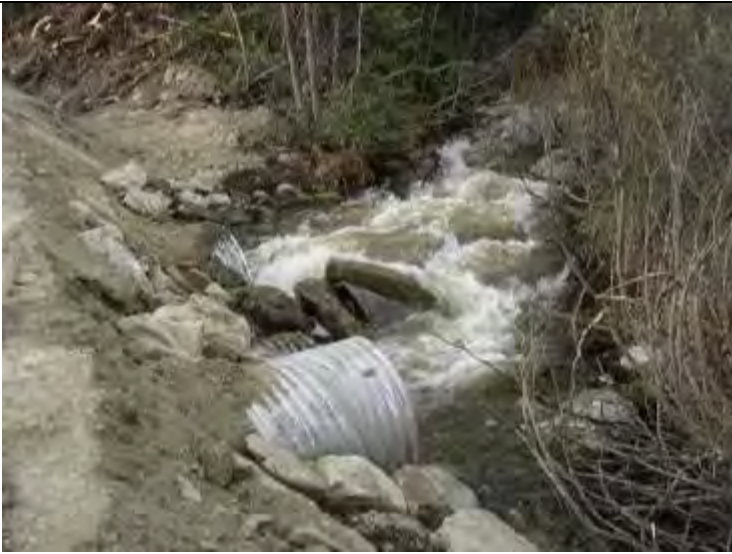
**Hawkowl Creek – main stream following 36” overflow culvert installation and cobbling of stream**

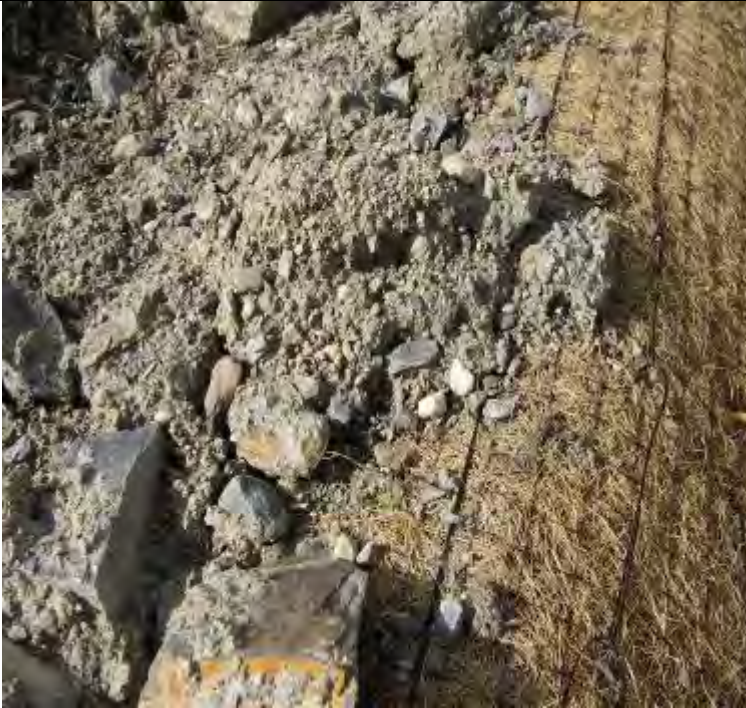
**Putt Creek downslope ditch (seed from fall sprouting)**

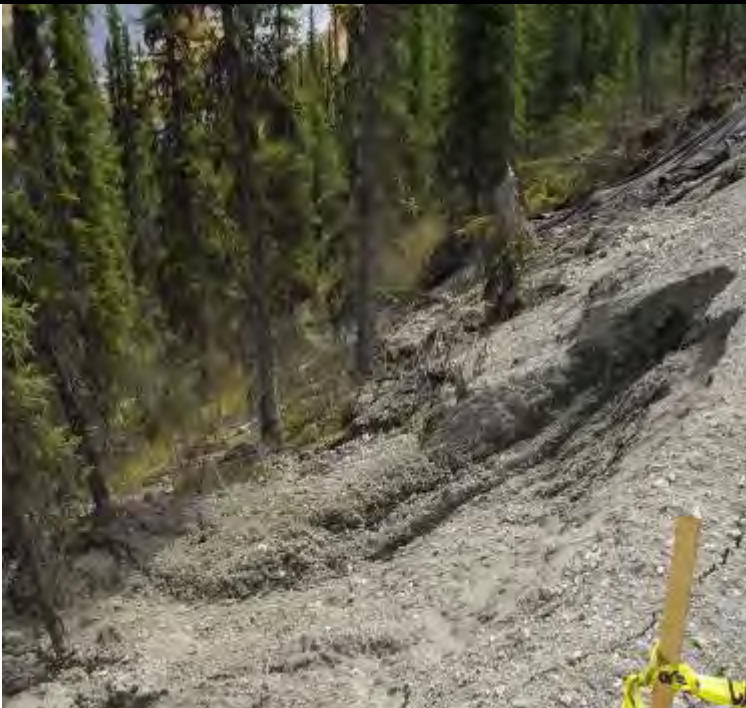
**Km 9 sloughing; facing south-west**

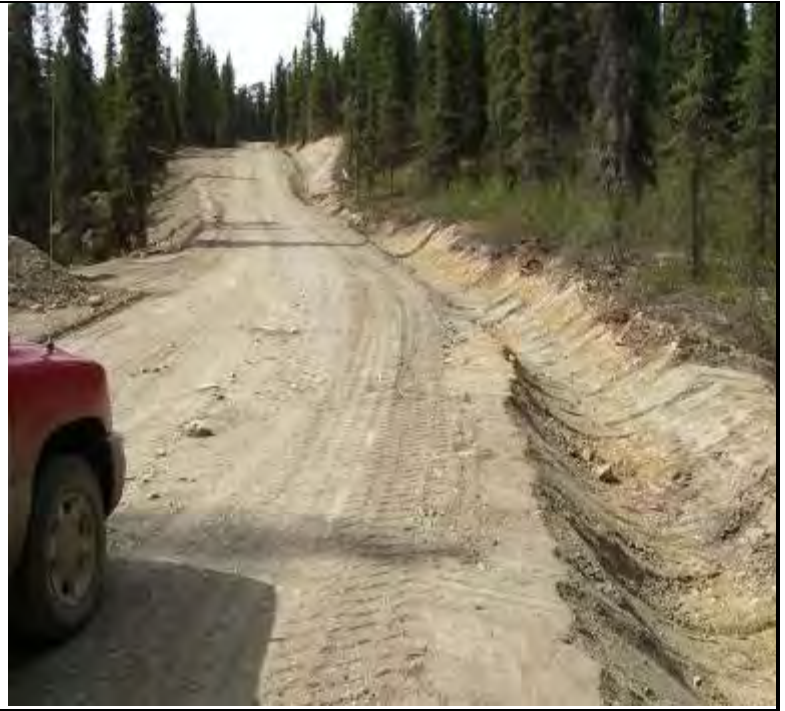
**Km12 looking empty ( notice no flow from km 12.5 culvert install)**

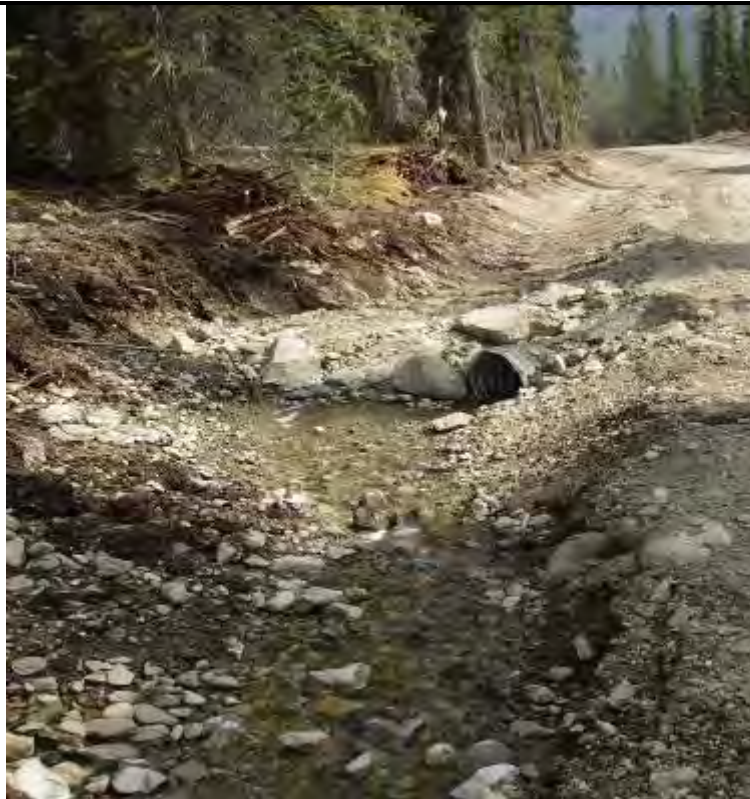
**Km 12.5 – Culvert with ditch block ( to mitigate km 12)**

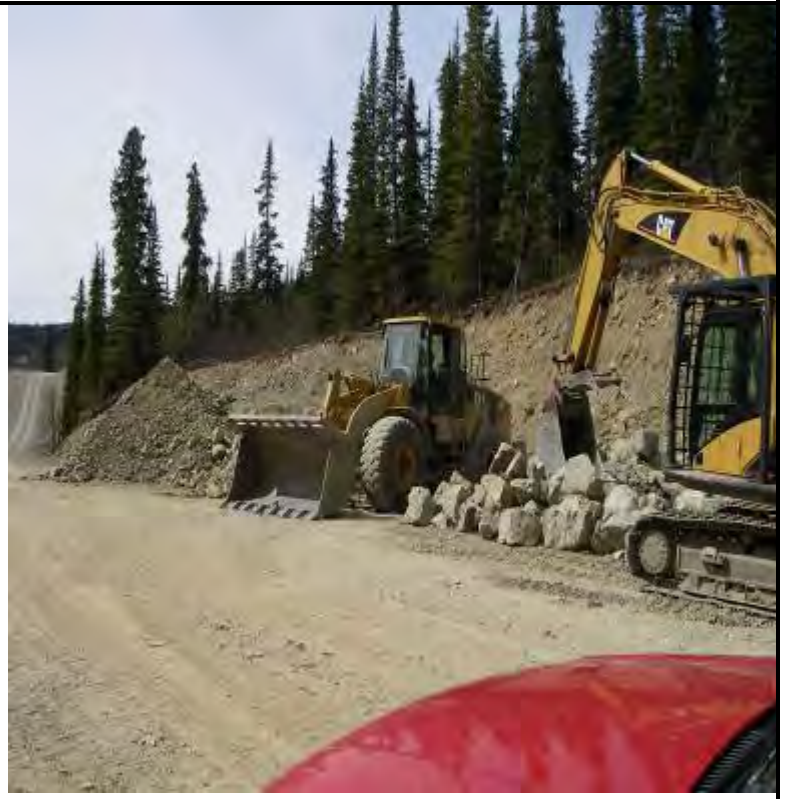
**Km 14 – Gathering/sorting material for km 9 repair**

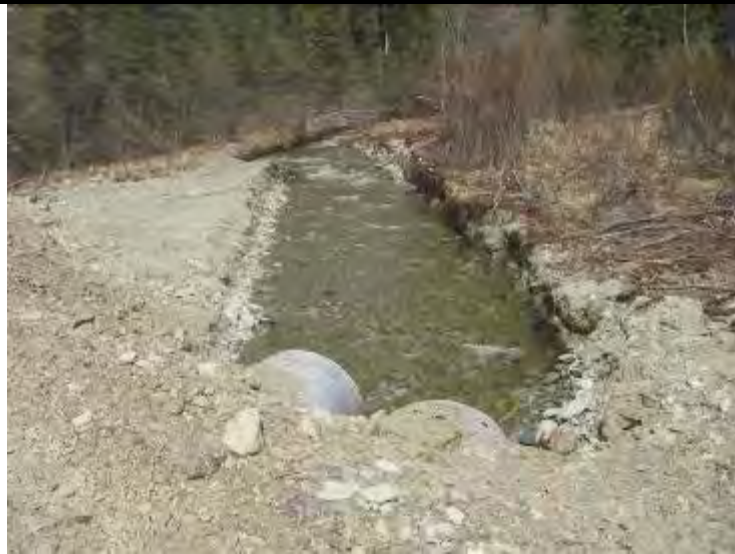
**Hawkowl looking u/s ( flows subsiding)**

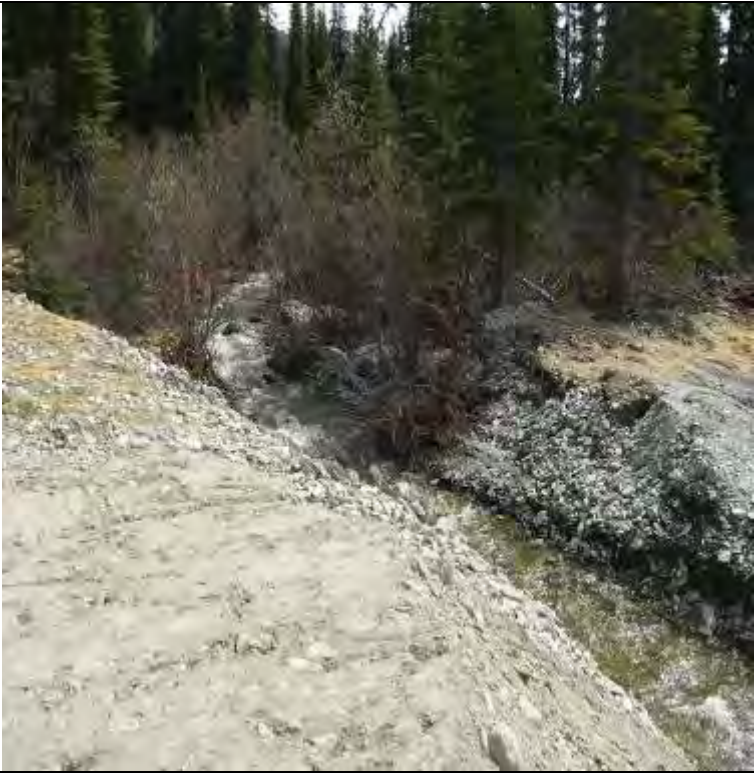
**Go Creek Airstrip – culverts pulled looking d/s ( more rip/rap and cobble needed on outside turn of bank)**

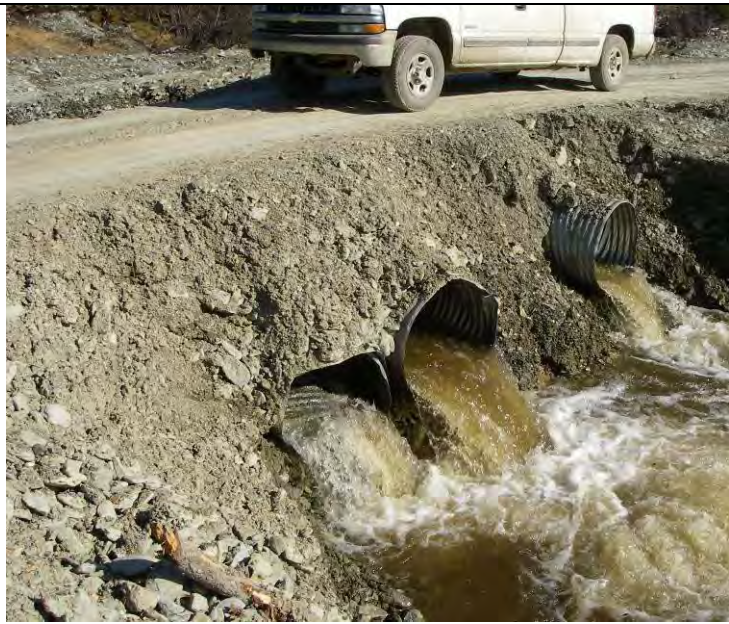
<p><b>Photo 1 - 24/05/08 – Go Creek Culverts discharge</b></p>	<p><b>Photo 2 - 28/05/08 - Culverts removed looking u/s</b></p>

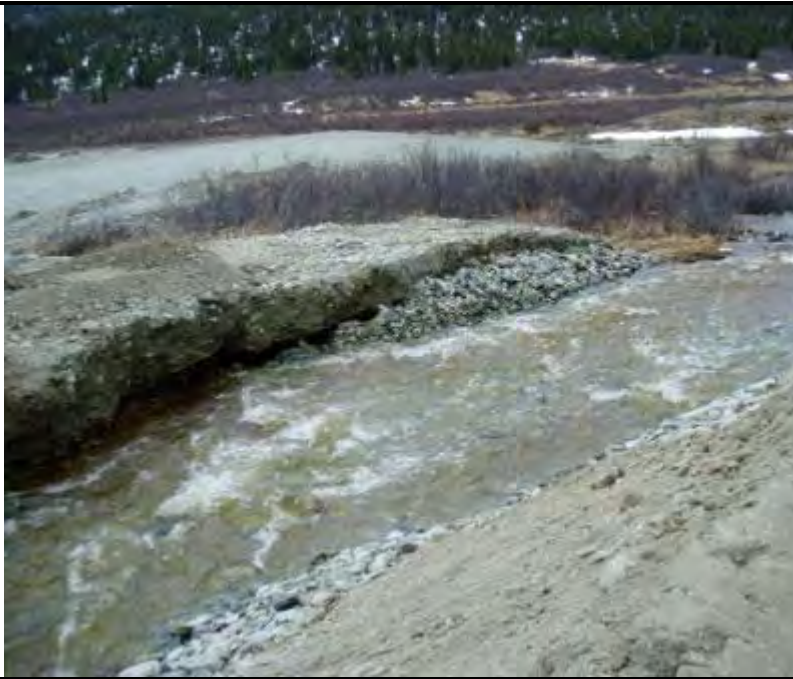
<p><b>Photo 3 - 28/05/08 – Culverts removed see undercut bank on Southside bank</b></p>	<p><b>Photo 4 - 28/05/08 - Mound of cobble placed on south side bank ( bank stabilization)</b></p>

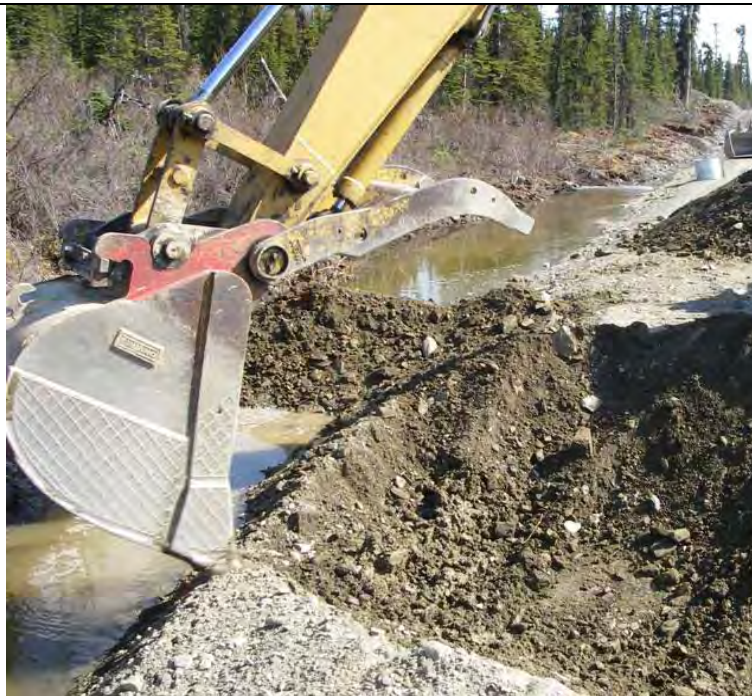
**Photo 1 - 05/27/08 – Looking south insert 24” culvert**

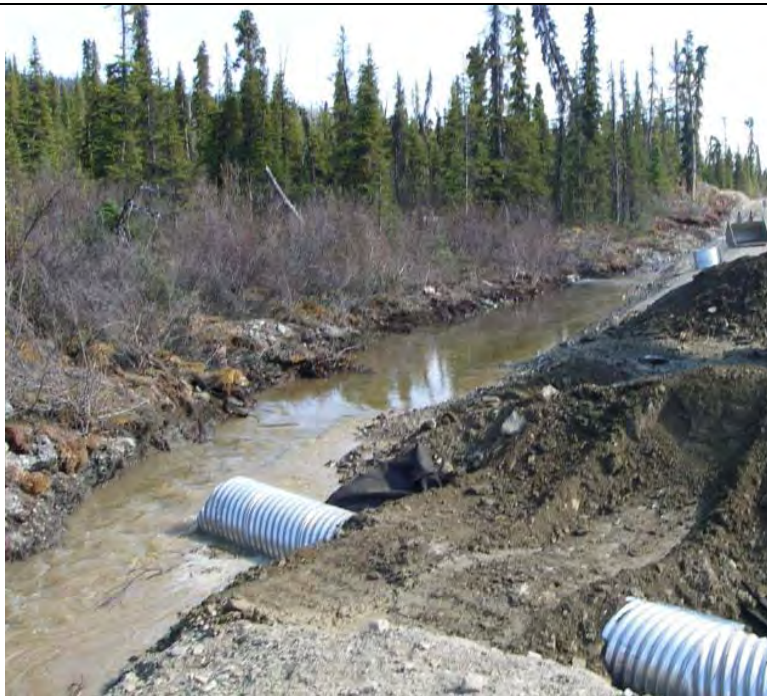
**Photo 2 - 05/27/08 - Placing Culvert 24” to handle ditch flow**

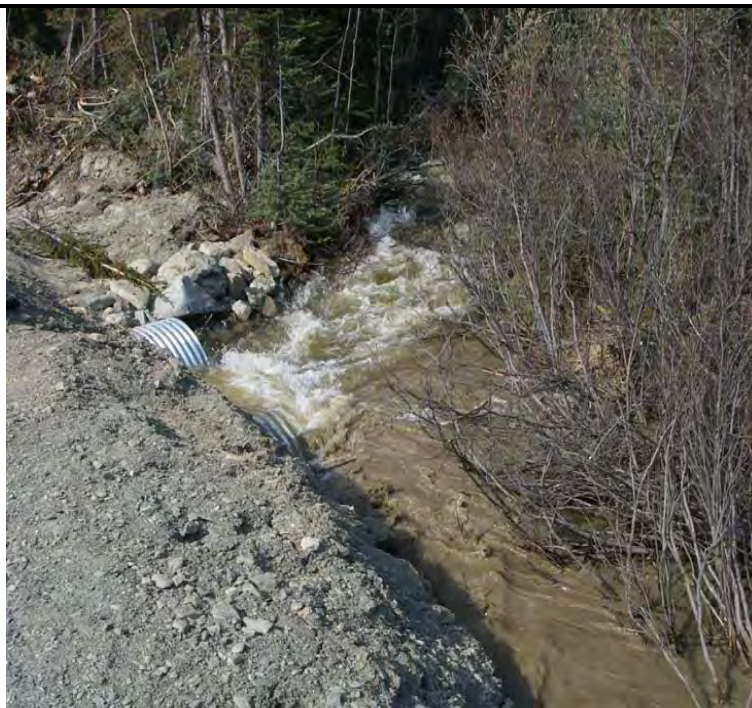
**Photo 3 - 05/27/08 - Hawkowl Looking U/S waiting for ditch flow to clear**

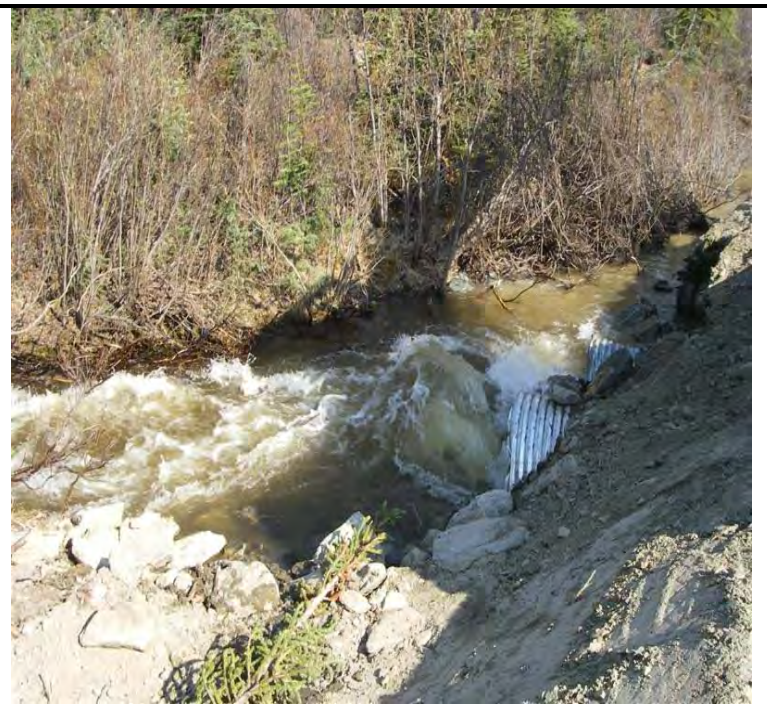
**Photo 4 - 05/27/08 - Placing Cobble to align stream to 48” culvert.**

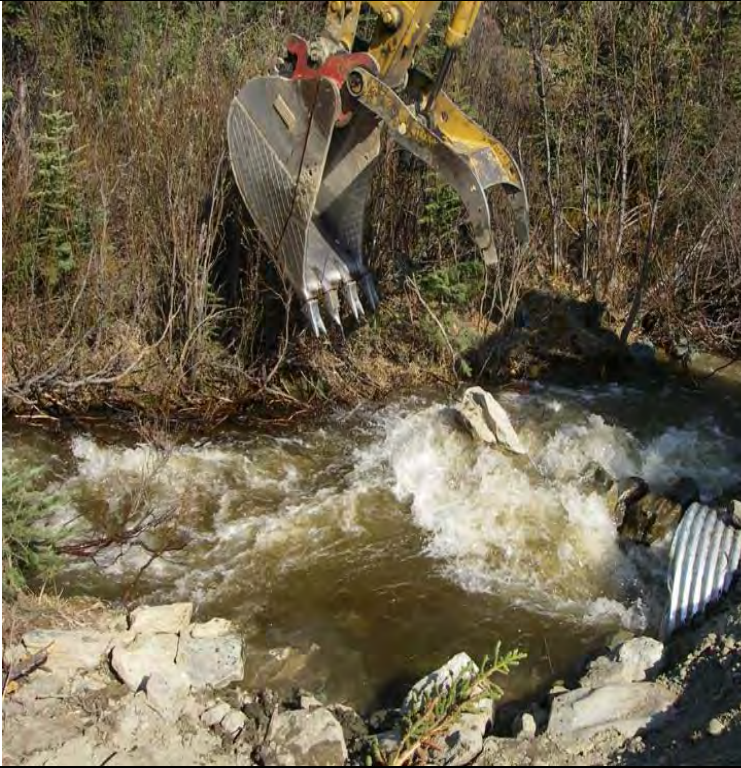
**Photo 5 - 05/27/08 - Placing Cobble to align stream to 48" culvert. Looking u/s**

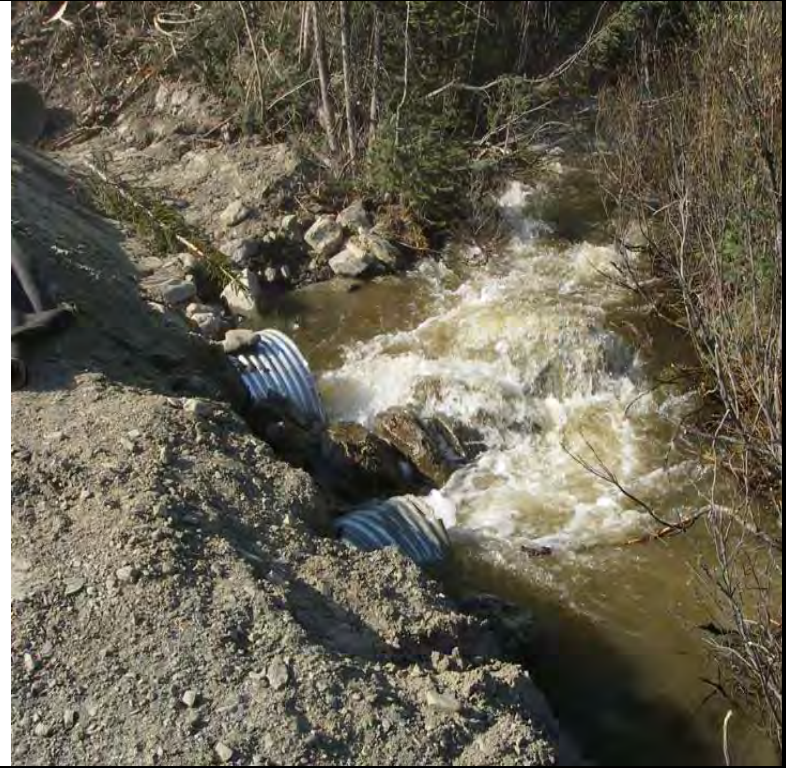
**Photo 6 - 05/27/08 - Placing Cobble to align stream to 48" culvert complete, headwall protected. Looking u/s**

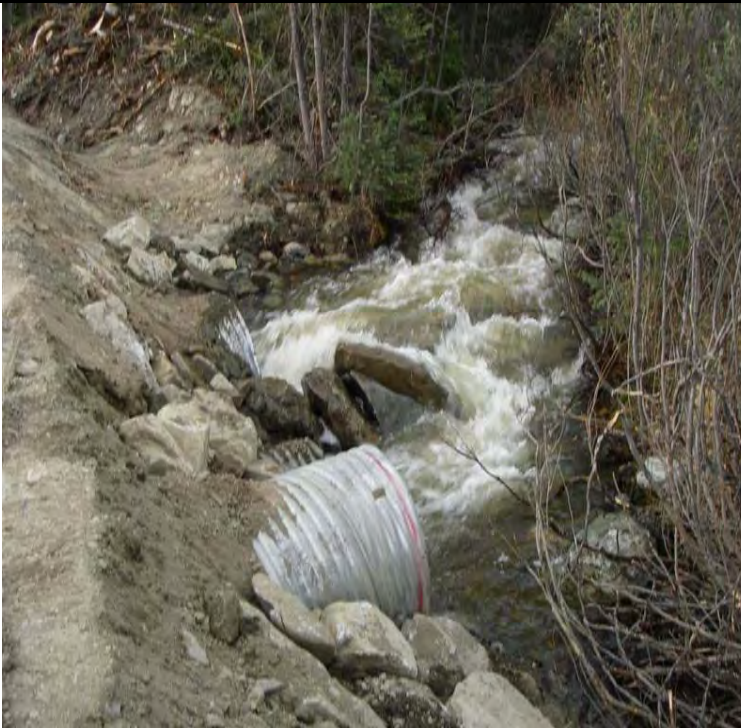
**Photo 7 - 05/28/08 – 36" overflow installed, and flows peaking, some armouring added looking u/s**

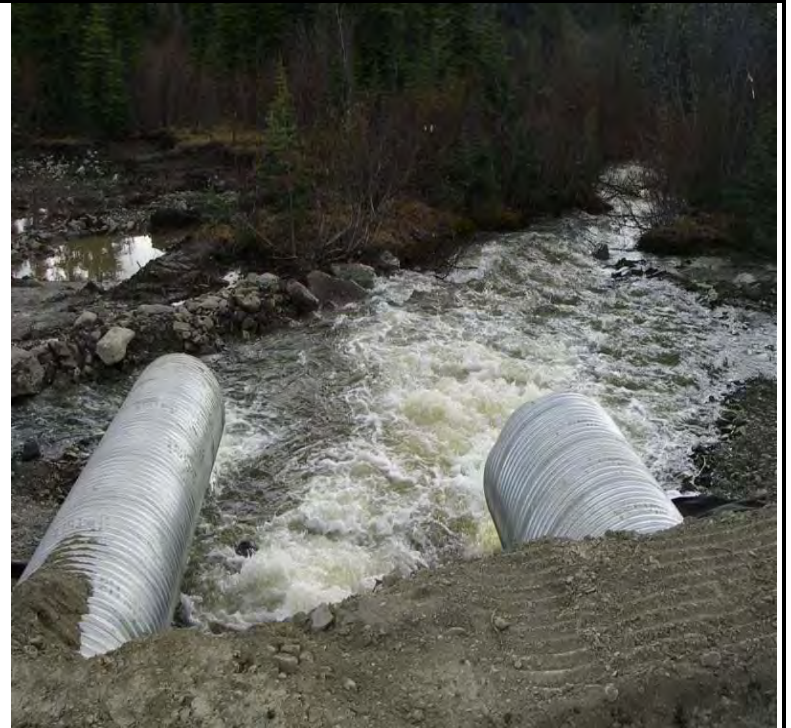
**Photo 8 - 05/28/08 – 36" overflow installed, and flows peaking, some armouring added looking d/s**

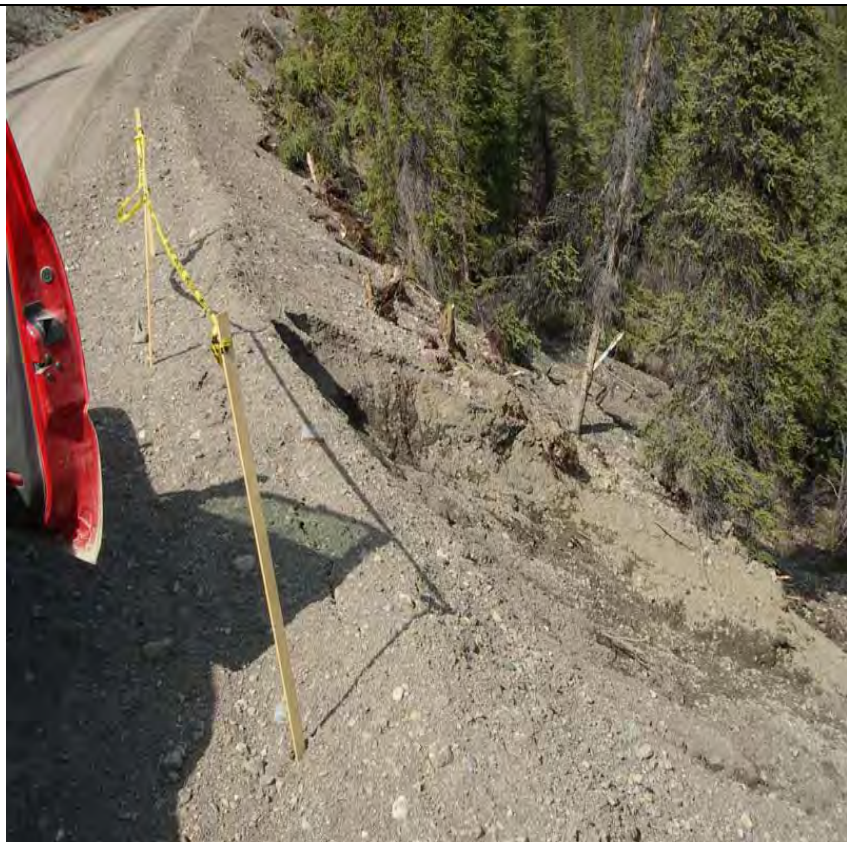
<b>Part 1 – Site Description</b>	
Date and Time: May 21 – June 9	Inspector(s): James Spencer
Site Name: stn 9+500	Location/Co-ordinates: Slope above lake
Site Location Description: A steep slope with a natural grade of 1.5 :1. With standing timber and willows, shrubs. Road was cut minimally and lots of fill that extends downslope 15m+ to where it settles on existing ground. Intermittent permafrost zone. Old Fred Magnum Lake at toe of slope which drains in to and joins Bunker Creek.	
Weather Conditions: Mixed, very dry spring and average melt, no excessive flows.	
<b>Part 2 – Site Assessment</b>	
Activity: The result of cutting a road through steep permafrost ground with lots of fill and minimal cut. No bench for the material to stabilize steep bank and fill slope.	
Site Description: The fill slope is through intermittent permafrost and dry gravelly soils at a grade of between 1.25:1 and 1.06:1. Well beyond a prescribed 1.5:1 slope that will hold. The area has experienced a sloughing of a slab of fill material Approx. 20' wide that slid off the shoulder of the road and slid approx 15 m downslope. This area shows stress cracking near the fracture. The fill slope has the same issues with steepness and in addition has exposed permafrost but appears to be holding.

6\_21\_08 Fill Slope Sloughing, looking Loaded

Work done on June 3, 2007 to repair the sloughed section. An entire 20' section of the road was removed. A bench was cut in to existing ground at a 90 degree angle to the natural repose of the slope. This bench was stabilized with angular Rip-Rap (5' + diam.) The base layer was driven in to the bench and then built up. Material (pulled out from the road) was re-packed in sequential lifts. The angle of the fill slope in this location was reduced slightly and the tighter packing of material should help stabilize this section.	
Assessed Risk: High	
Photos Attached: Yes	
Samples Taken: None	
Additional Information Attached: None	
<b>Part 3 –Mitigation Requirements</b>	
Mitigation Required: <b>Cut Slope:</b> Permafrost areas need to be left alone as much as possible and left as steep or vertical cuts allowing the moss and organic mat to cover the slope as the frost melts and under cuts the bank.	
<b>Fill Slope:</b> This area has been pushed downslope due to the large fills required here. May need additional ESC practices to stabilize area if problems persist. Phase 2 may have to involve a realignment and engineered stabilization, Gabions, Shotcrete etc. to prevent washouts and manage the haul truck weights.

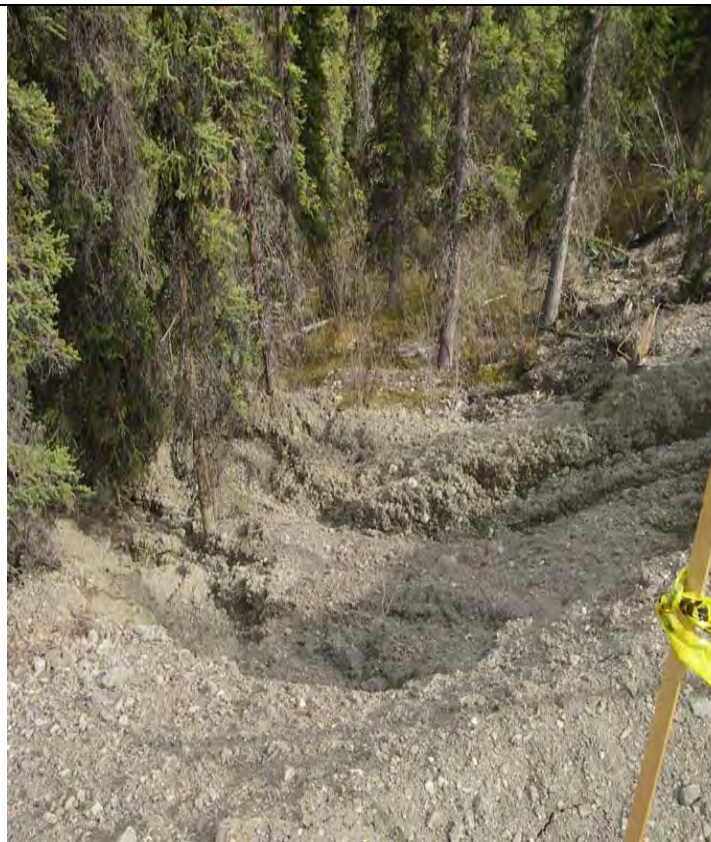
06\_21\_08 Fill slope Sloughing, looking Empty

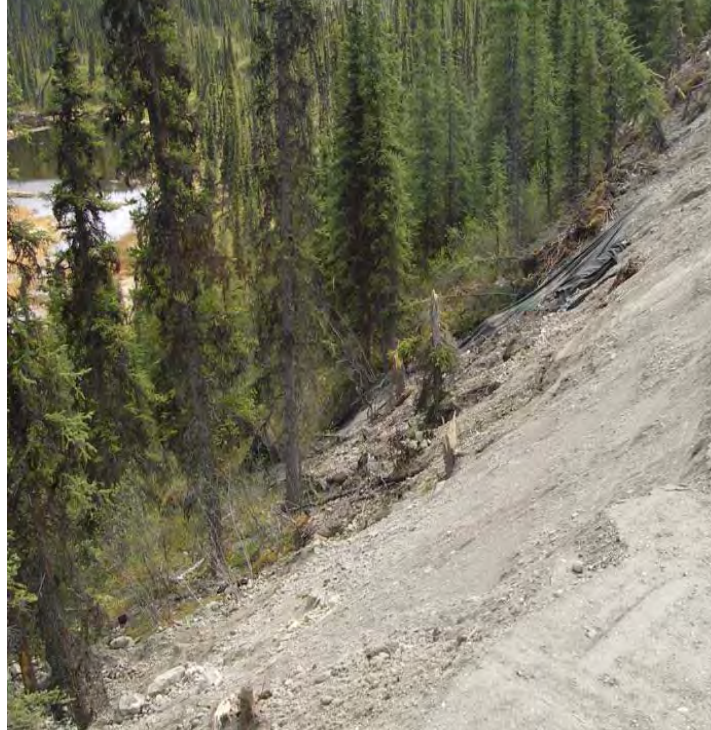
06\_06\_08 Compacted and repaired section looking empty

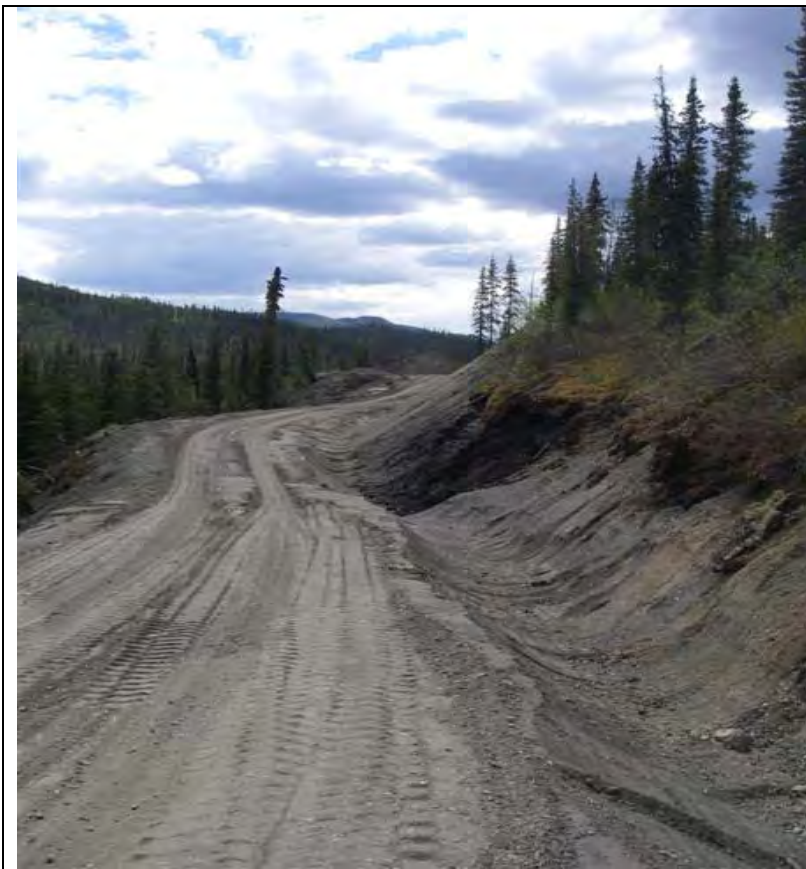
06\_06\_08 Cut Slope shaping looking empty

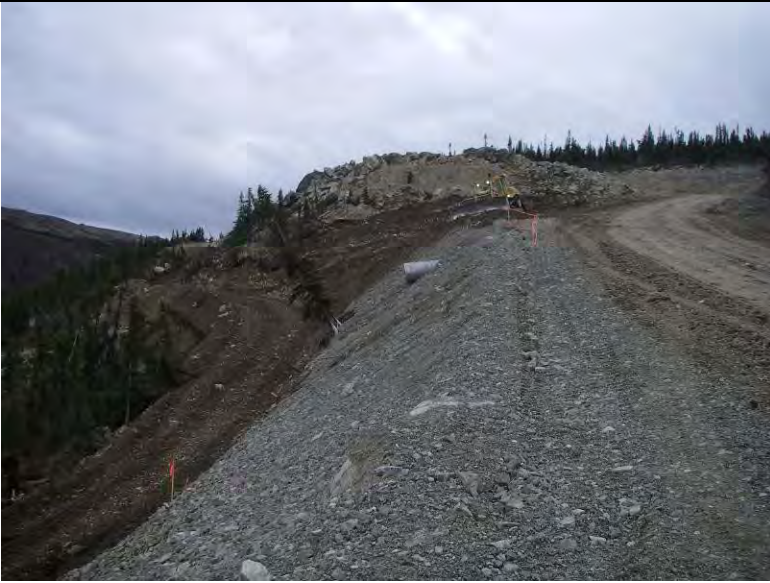
09\_27\_08 Culvert blocked, clearing and stripping in works (Facing upchain (UC))

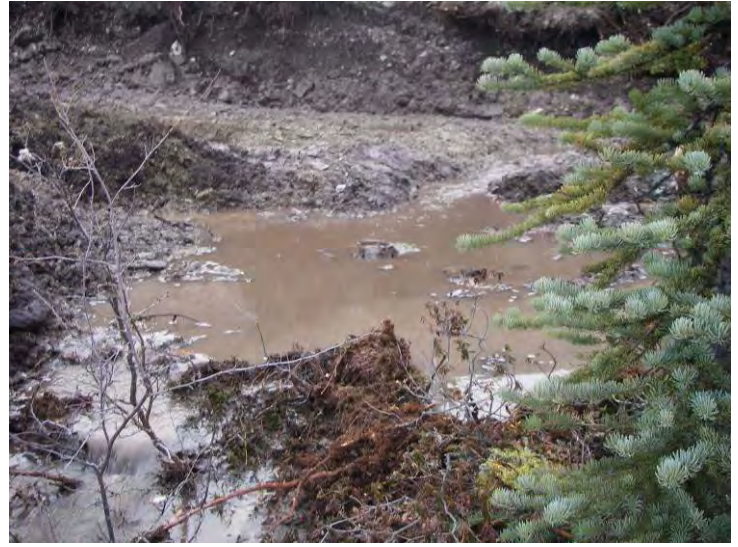
09\_27\_08 Down slope cut, water coming under road into work area and picking up sediment
