## **Wolverine Project**

**QUARTZ MINING LICENSE QML-0006**

**2008 ANNUAL REPORT**

**Prepared by:  
Yukon Zinc Corporation  
Vancouver, British Columbia**

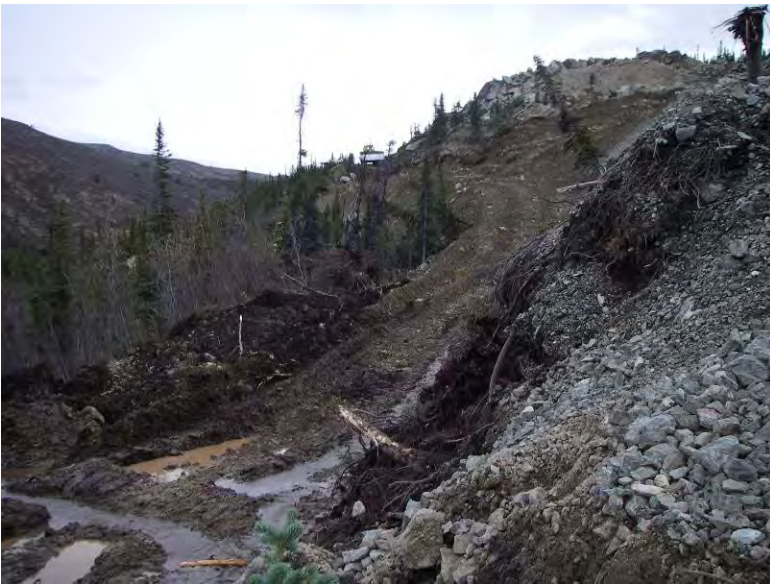
09\_27\_08 Down slope cut, Trough cut to minimize sediment loading (Facing UC)

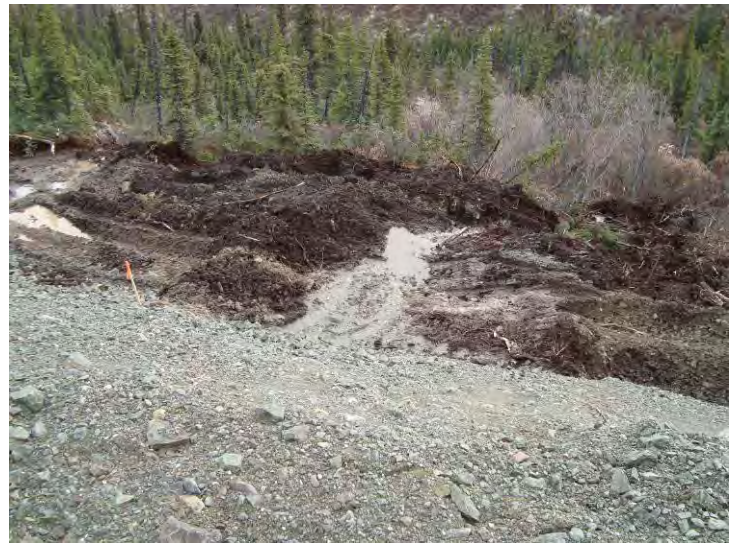
09\_28\_08 Water running under road before upslope ditch improvements

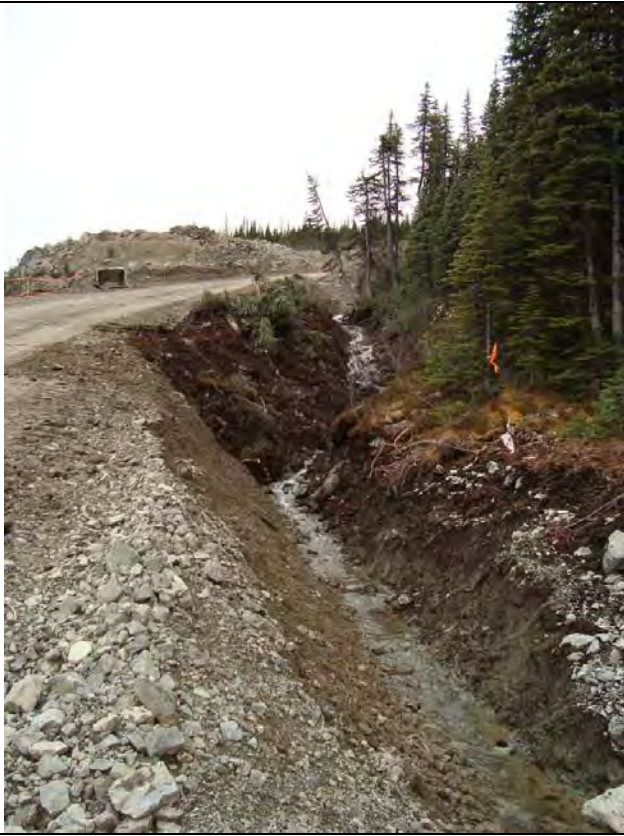
09\_28\_08 Deeper ditching upslope to intercept surface flow (facing UC)

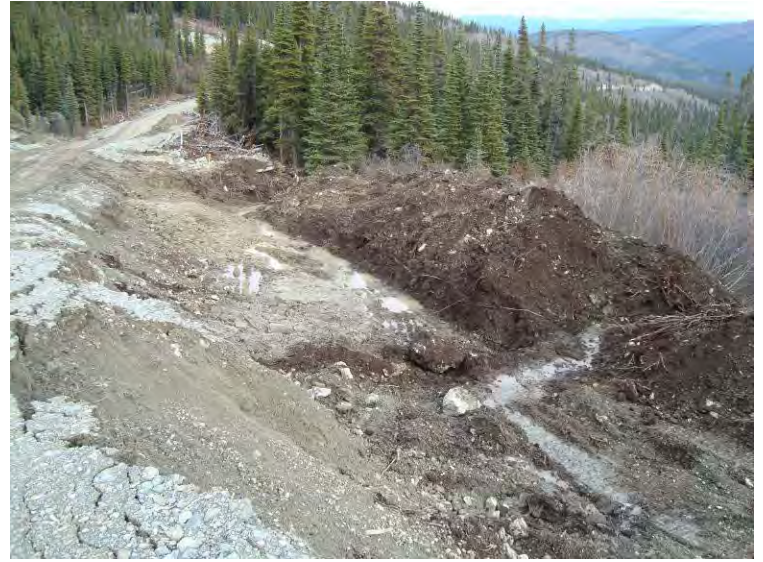
10\_01\_08 Wetted area showing standing water and flow under road surface ( Facing DC)

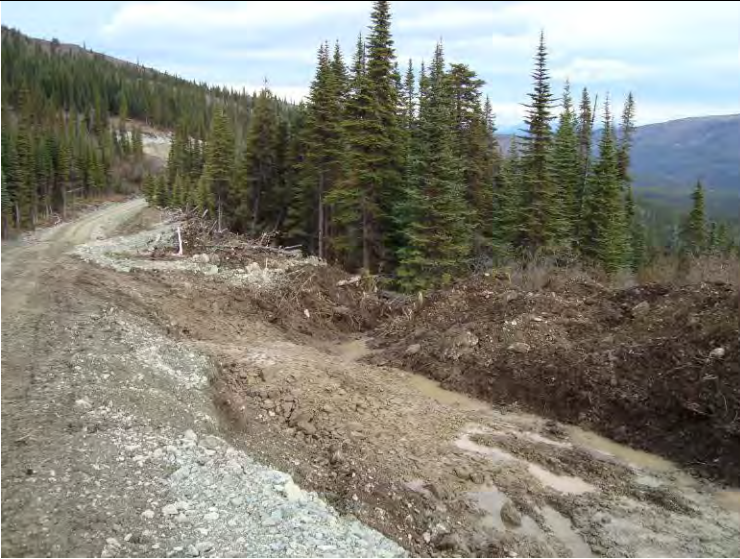
10\_01\_08 Wetted area showing standing water (facing DC)

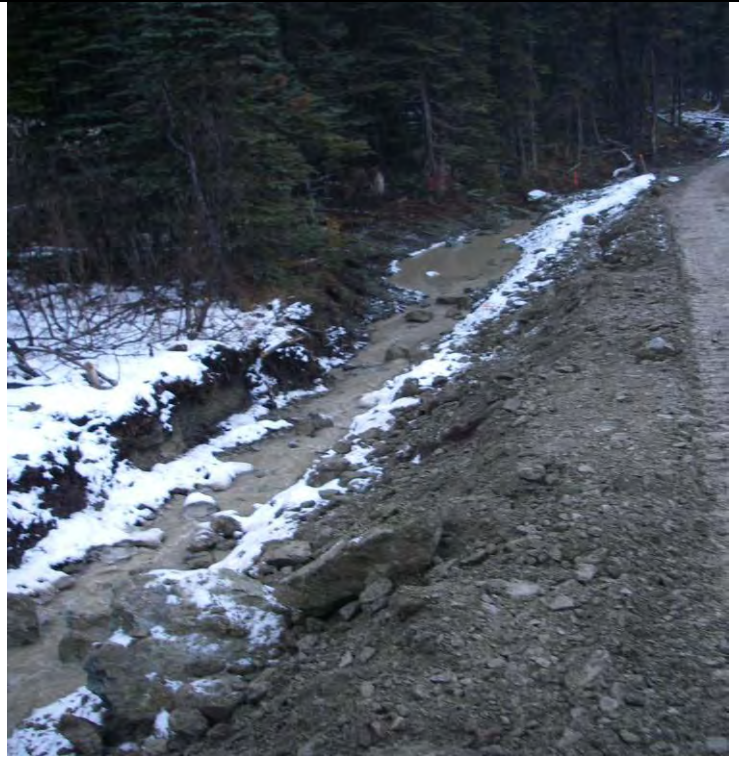
10\_11\_08 Looking DC at cutslope ditch heavy siltation from earthworks no immediate d/s effects after culvert crossing after pool in background

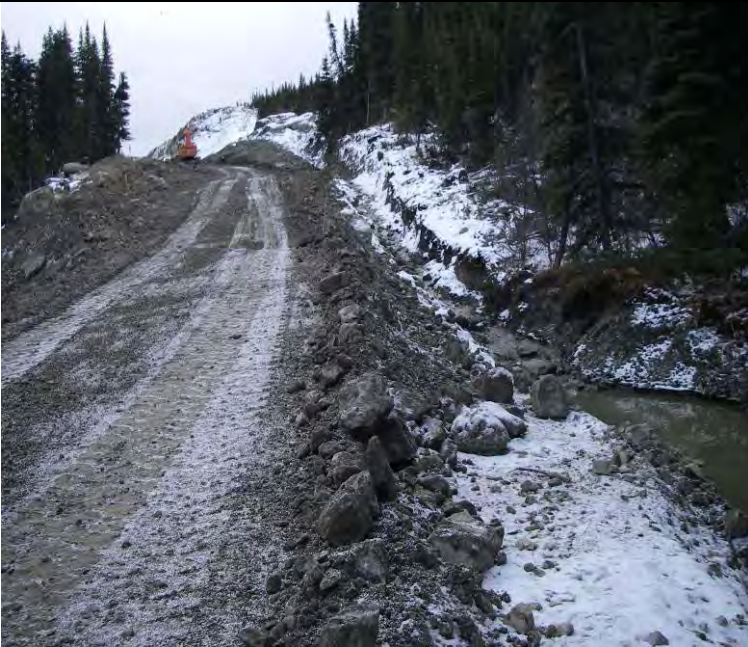
10\_13\_08 Facing UC @ km 15+200 looking at cutslope ditchpool was dredged out to improve settlement before culvert inlet

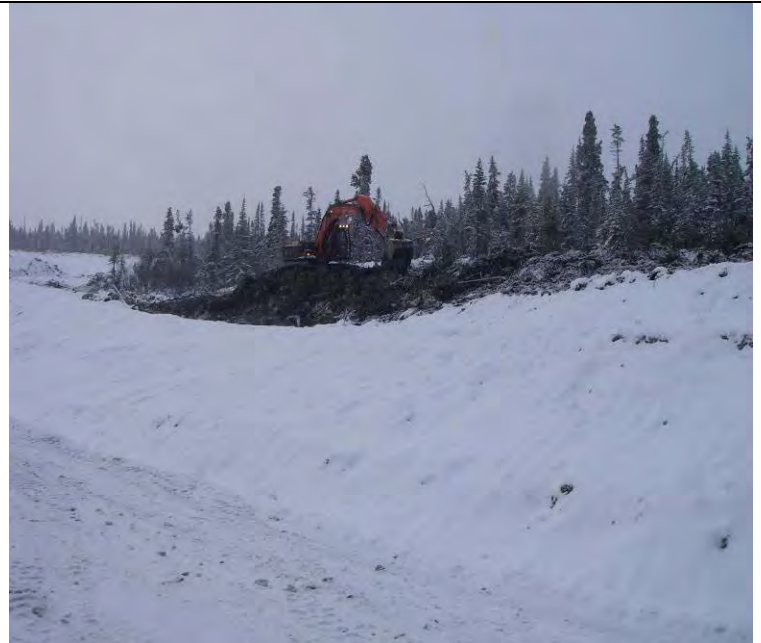
10\_17\_08 Facing fill slope km 15+100 20m stripping swath above glaciation seep through the bank below excavator

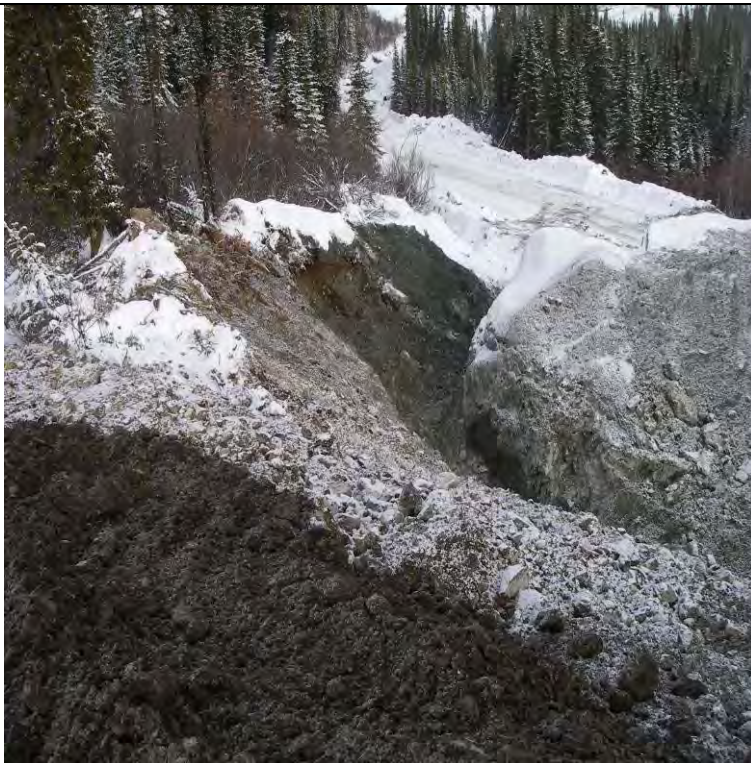
10\_19\_08 Looking DC at km15+100 cutting down the permanent ditch to capture groundwater seepage

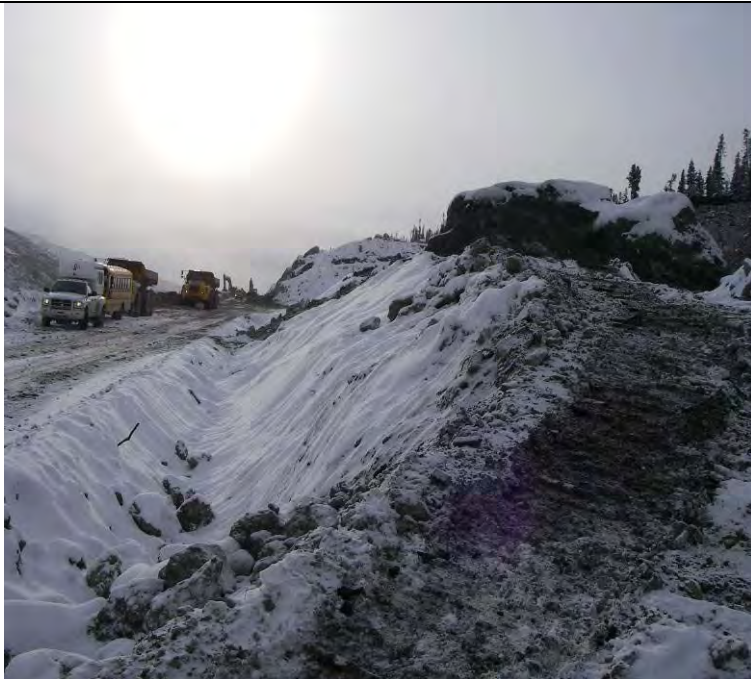
10\_19\_08 Facing UC km 15+100 looking at the roadside ditch which will not carry any water. Useable ditch runs behind (upslope) of rock outcrop on horizon

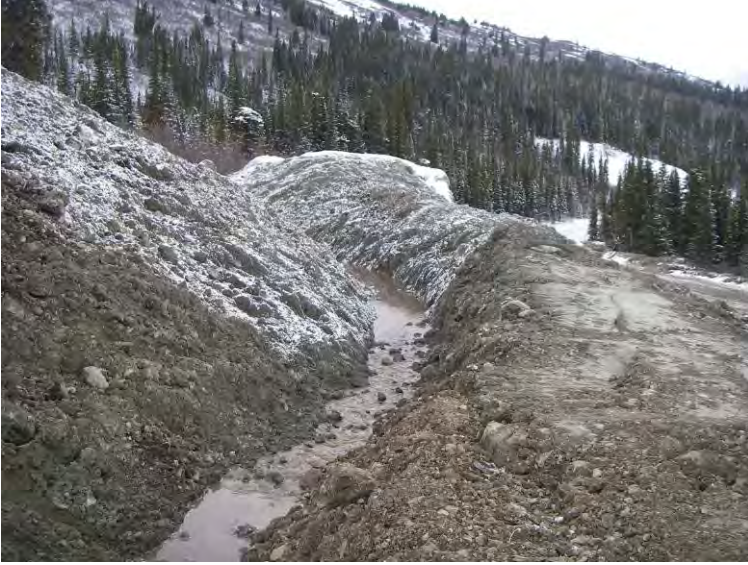
10\_21\_08 Looking downchain (DC) towards highway at re-diverted ditch

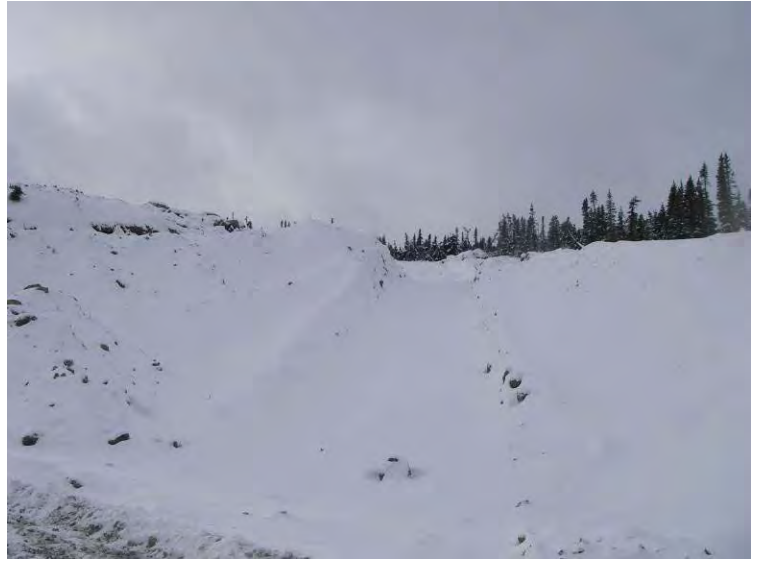
10\_27\_08 looking UC at original road laid last year

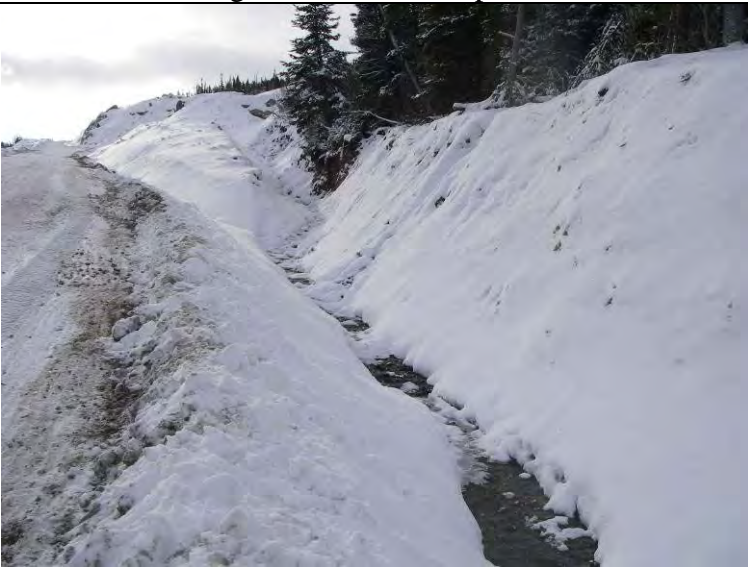
10\_27\_08 Facing UC at ditch flow

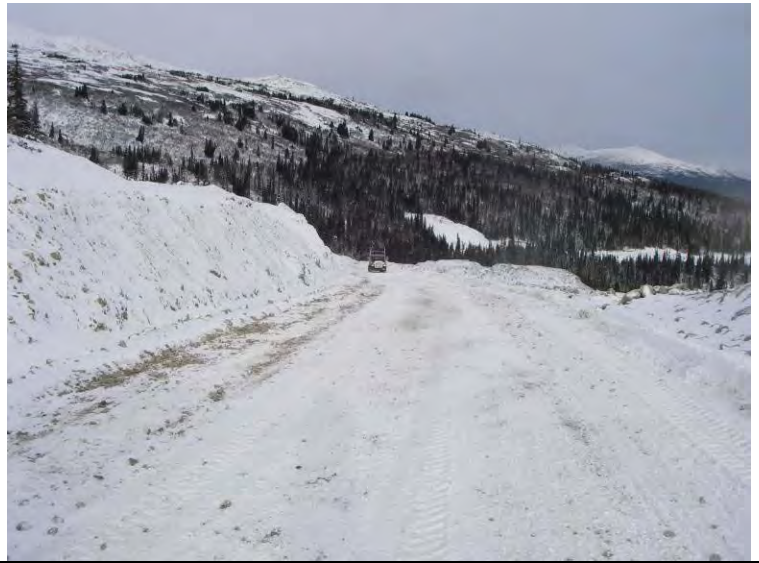
10\_27\_08 Facing DC: final grade complete

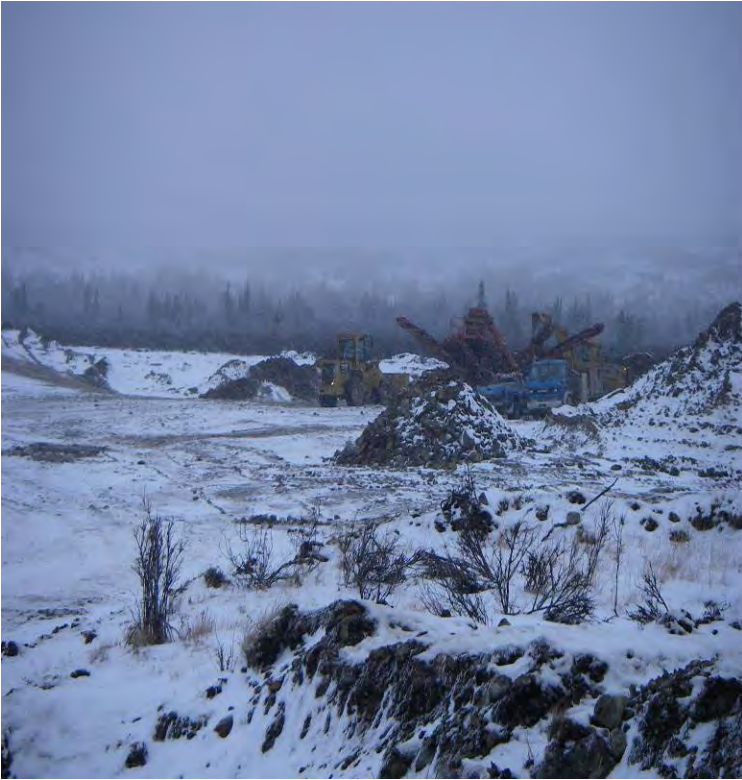
10\_11\_08 Looking North at screen set-up on North side of road

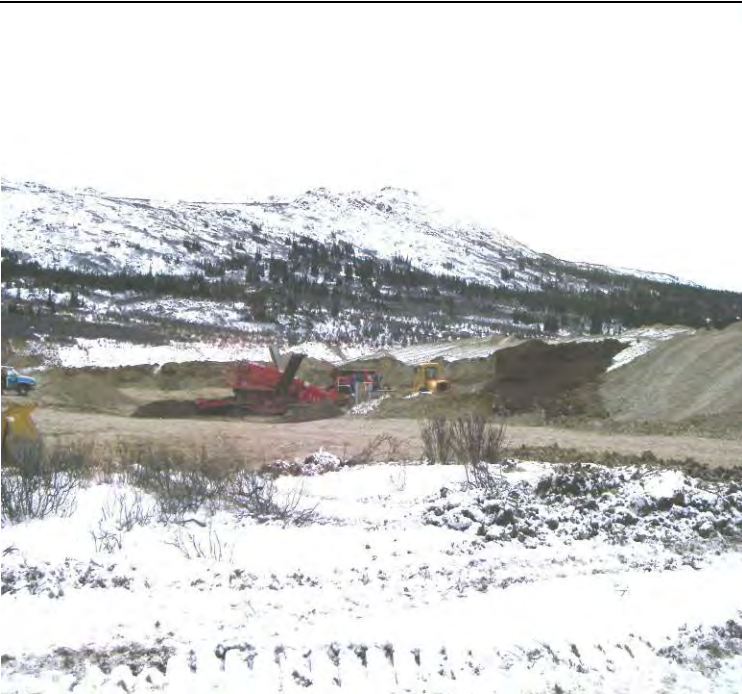
10\_15\_08 Looking South at screening plant set-up on south side of road

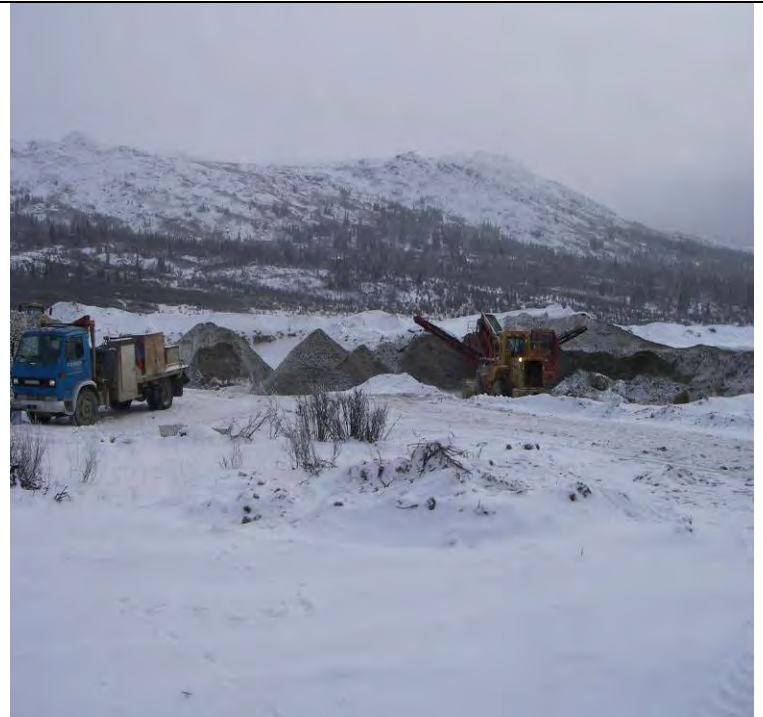
10\_19\_08 Looking South at screening plant set-up on south side of road shutting down.

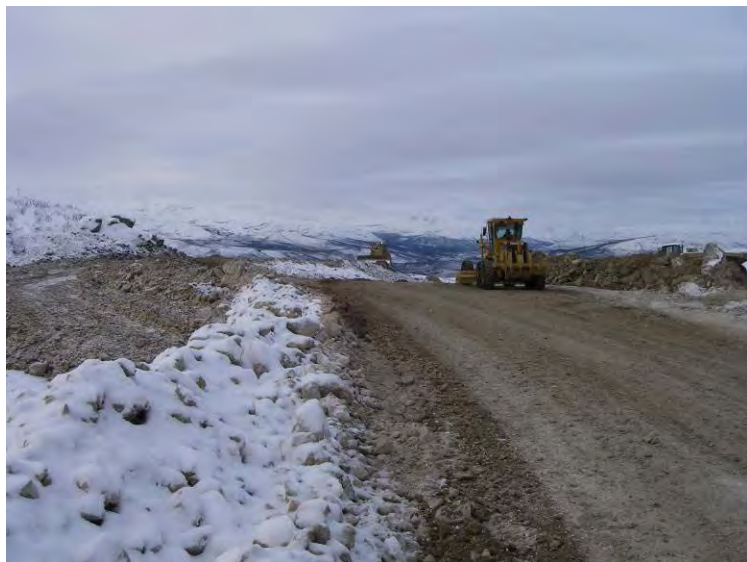
10-31-08 Detour nearing completion (facing d/c)

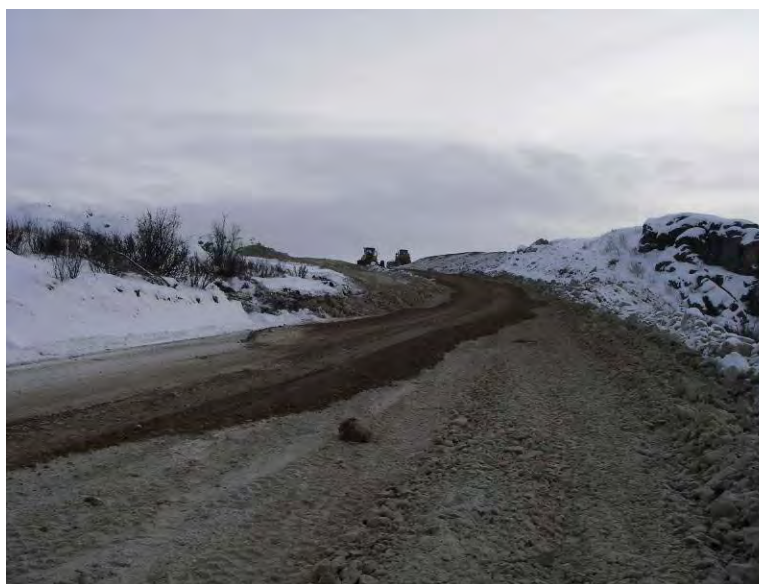
10-31-08 Detour nearing completion (facing u/c)

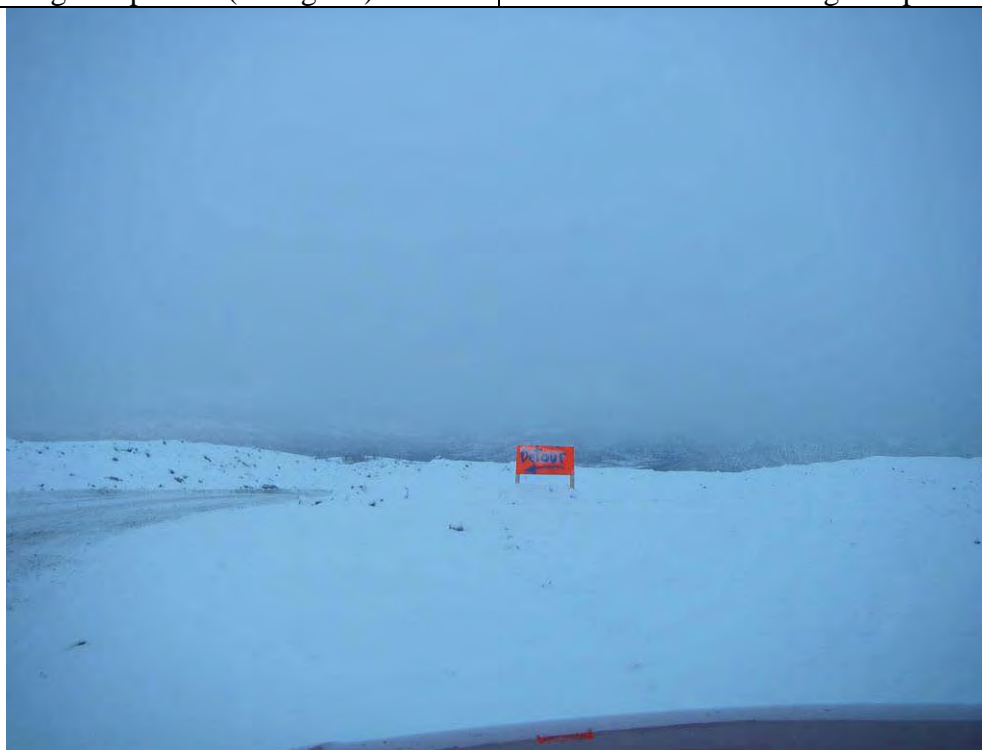
11-02-08 Completed road works – facing u/c

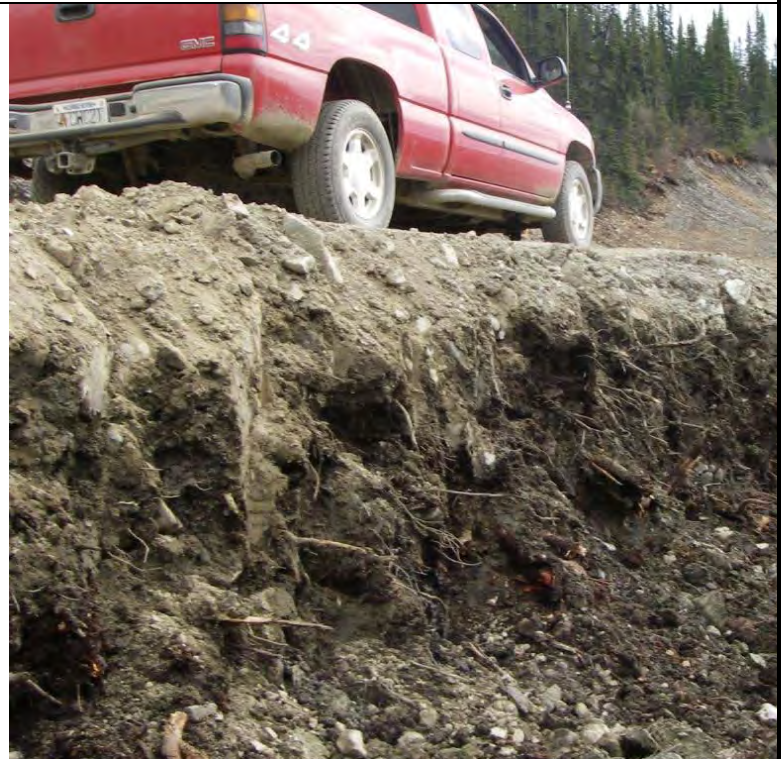
**06/06/08 Layer of organics under initial road**

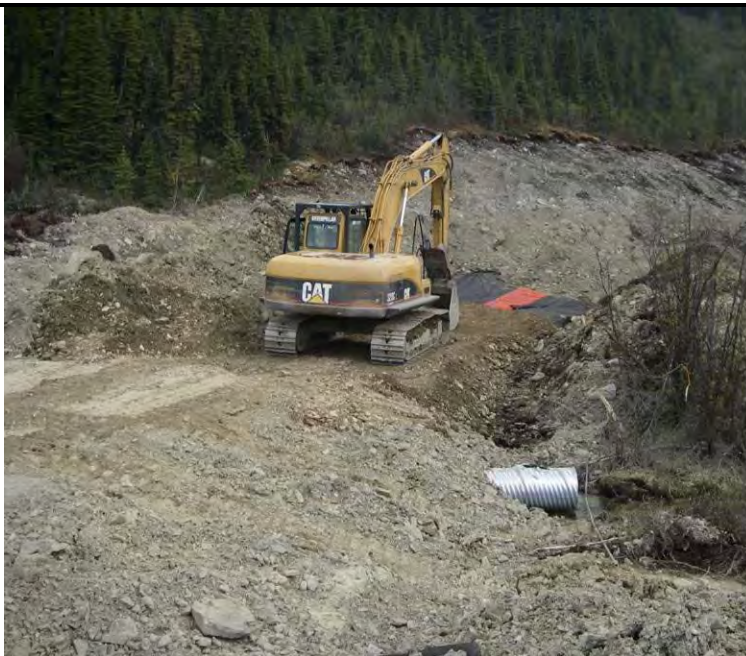
**06/07/08 – Facing SE – Filling over snow fence and geotextile**

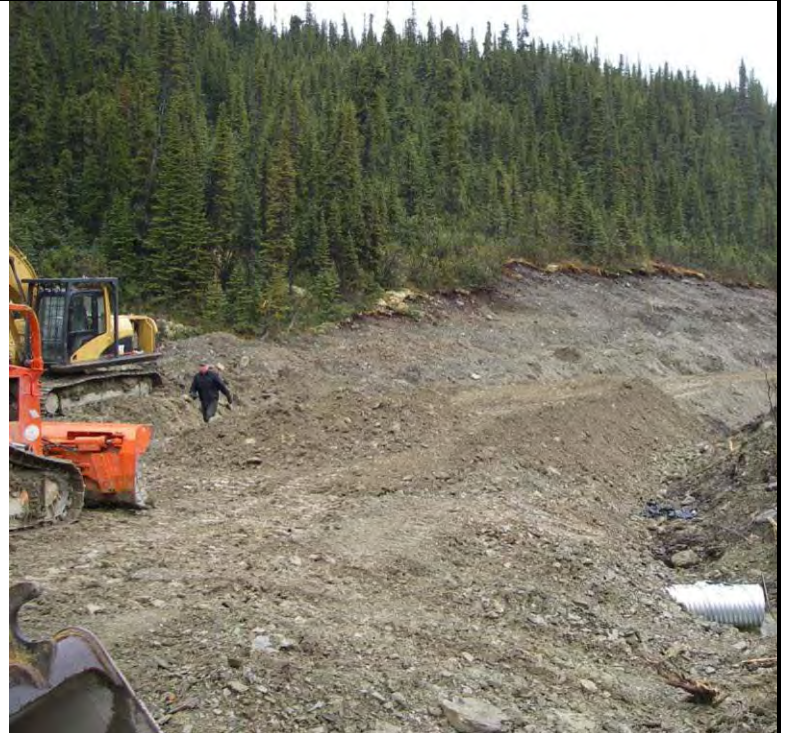
**06/08/08 – Facing SE – 2<sup>nd</sup> layer of fill**

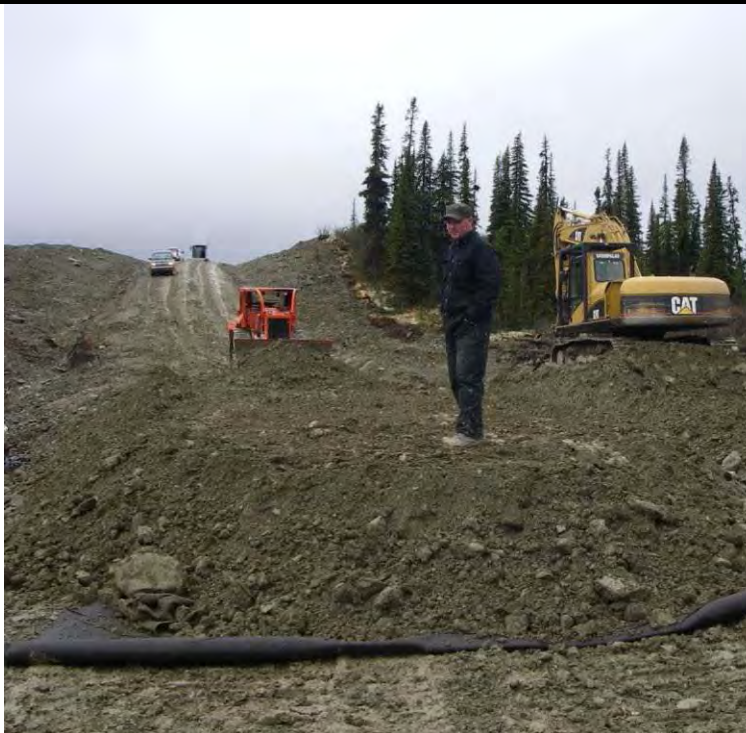
**06/08/08 –Facing NW 2<sup>nd</sup> layer of geotextile and fill**

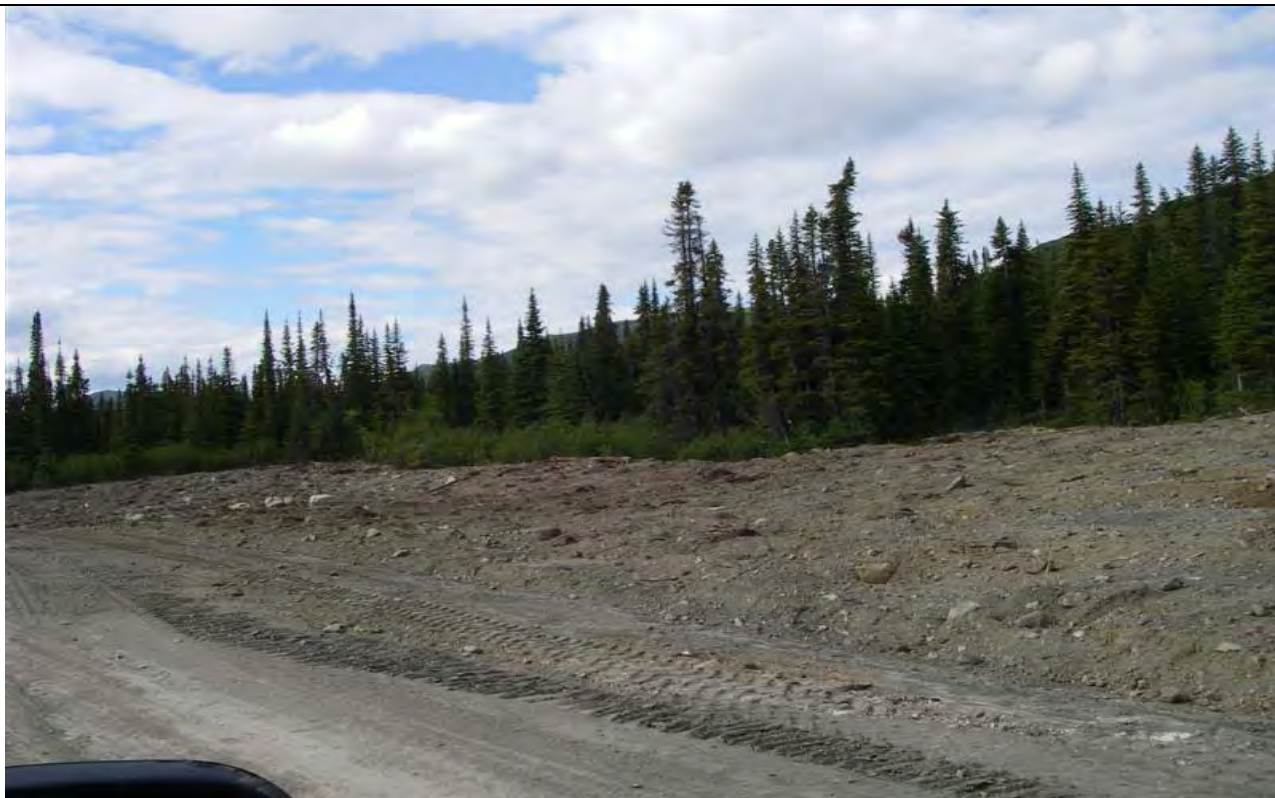
Photo 1 08/04/08 Reclaimed fuel cache area looking NE

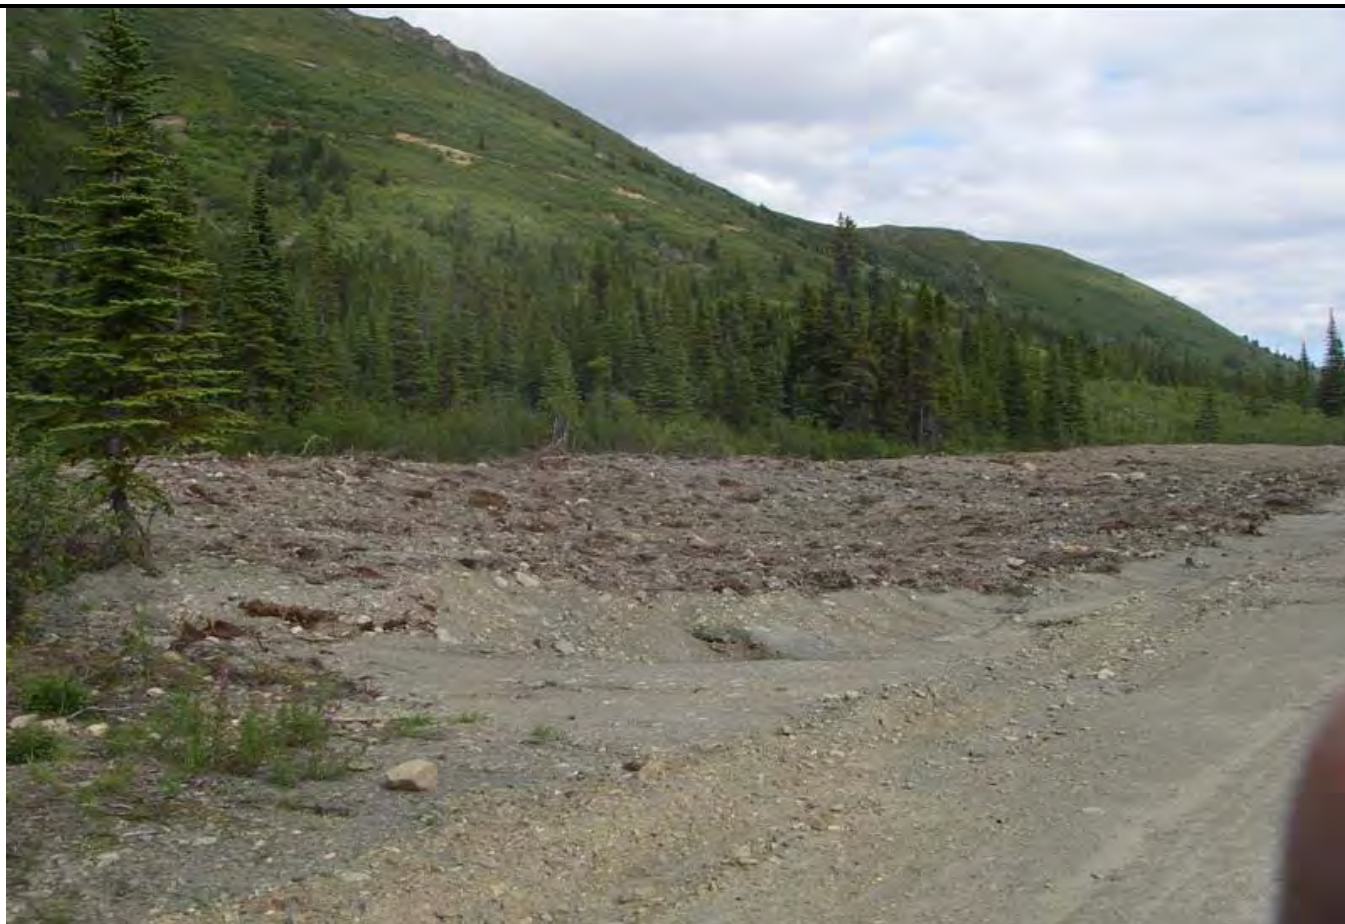
Photo 2 07/15/07 Reclaimed fuel cache area looking SE

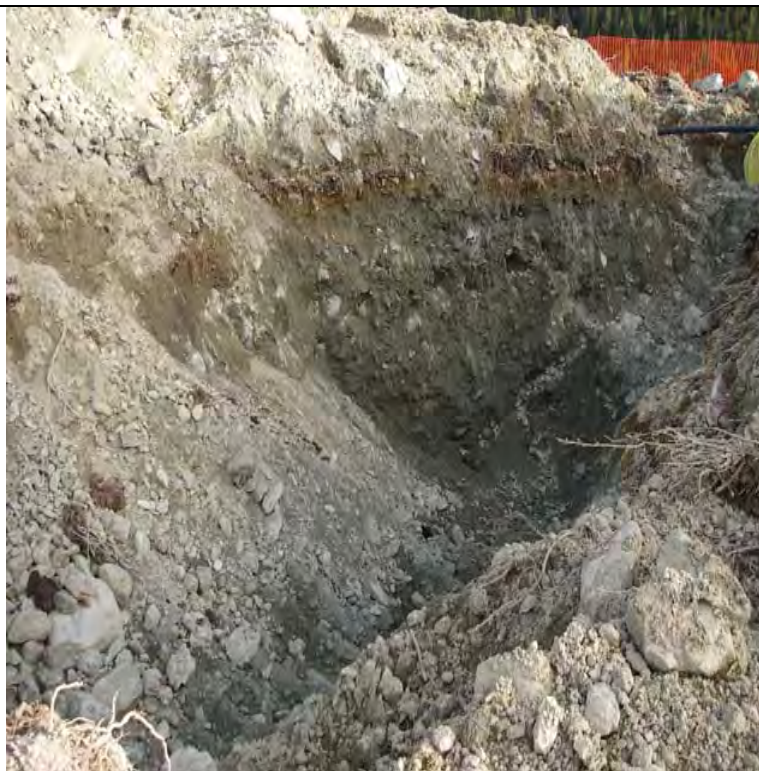
Trench between primary and secondary tanks 09\_05\_08

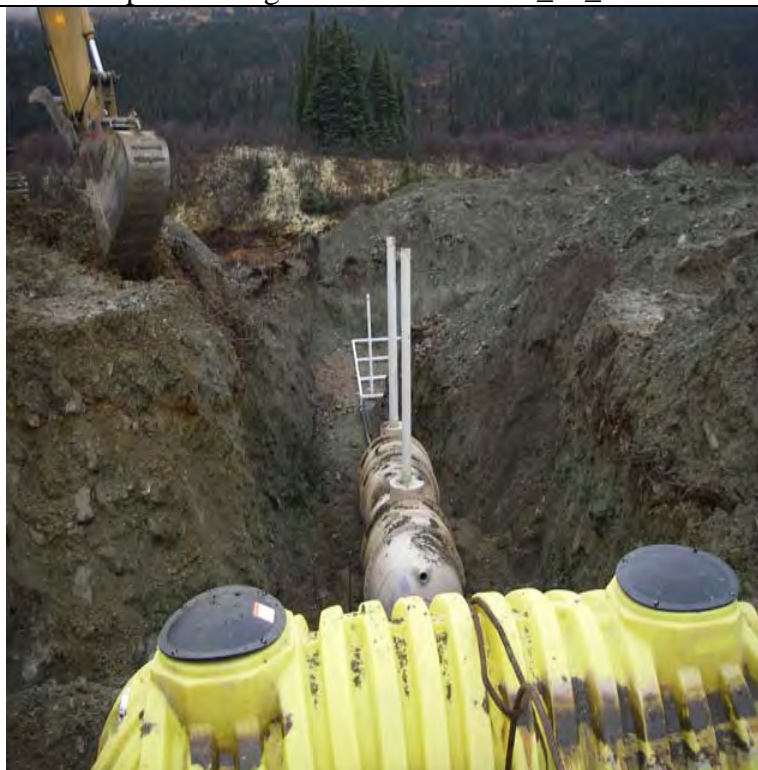
Old primary (yellow), new primary to secondary ( cream tanks) and field in background 09\_19\_08

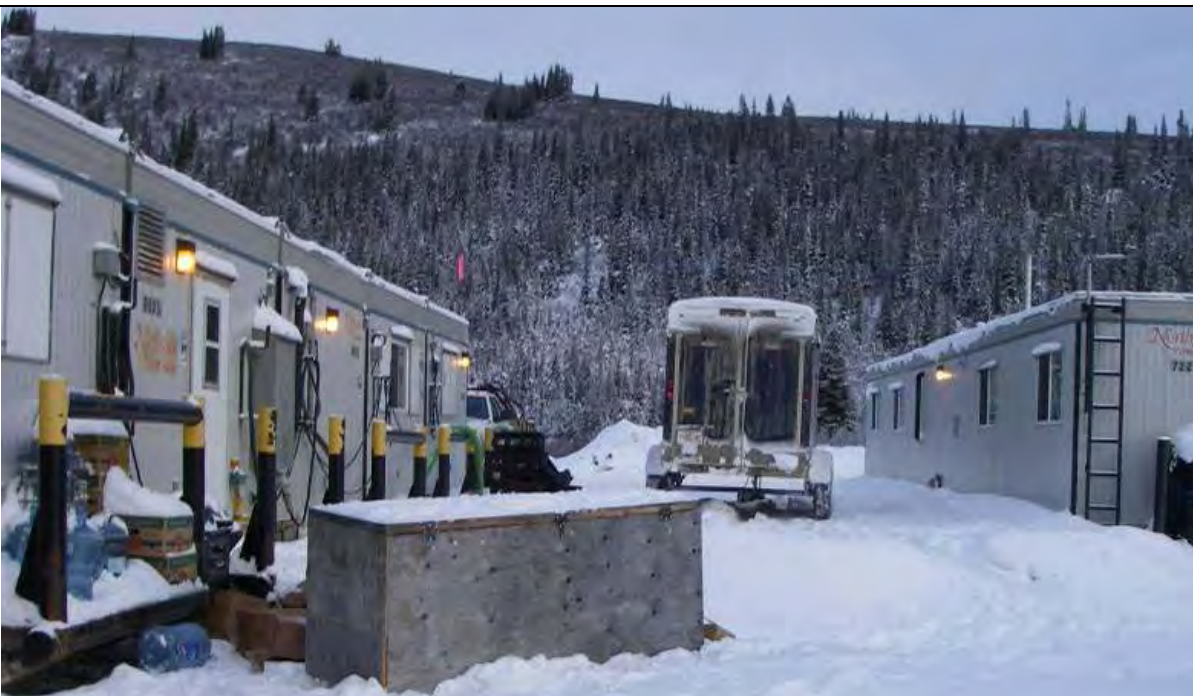
10-29-08 Trailer is in location of planned potable well (facing W) main camp on right, Arctic office on left

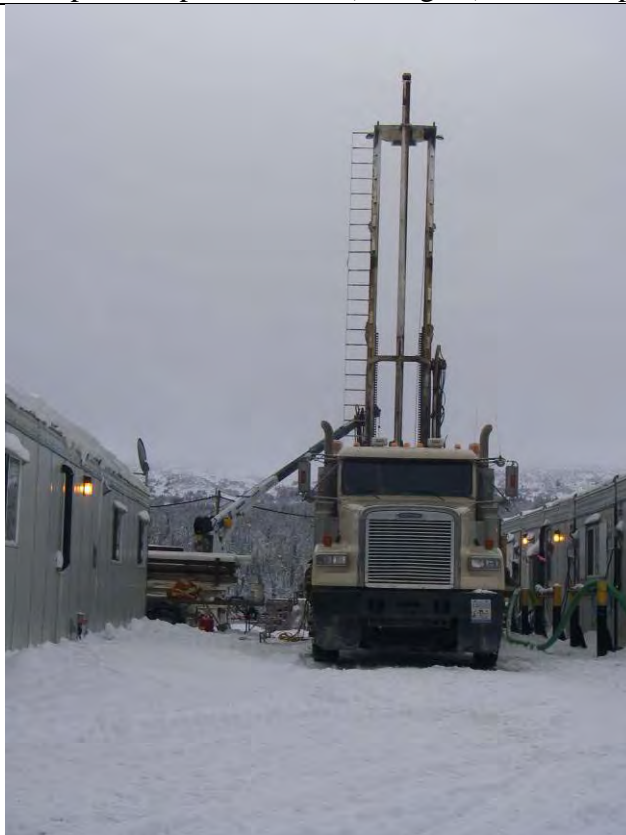
11-03-08 Drilling of the potable water well – facing W

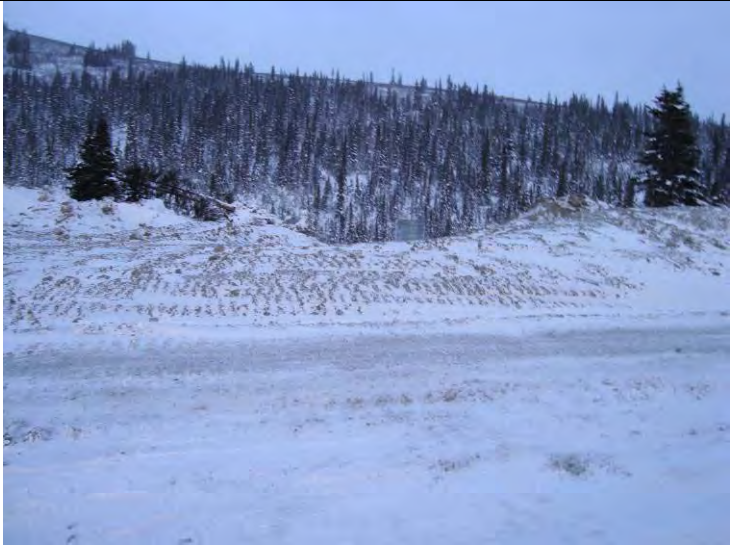
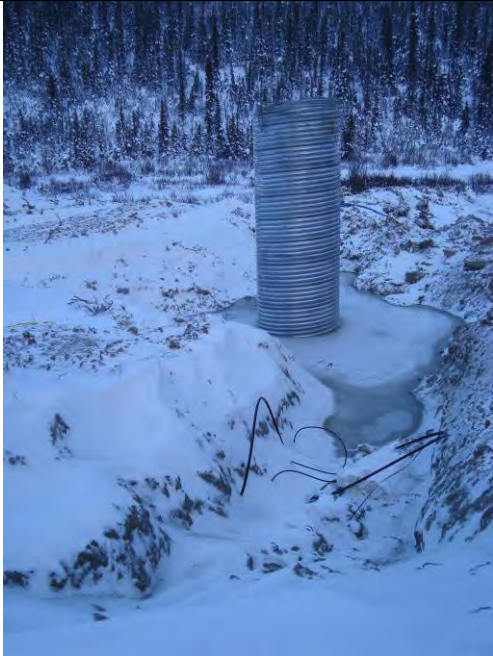
<b>12/01/08 Backfilled trench for waterlines (facing E)</b>	<b>12/01/08 30ft culvert installed, before trimming. Can see pump and piping electrical and heat trace (facing E)</b>

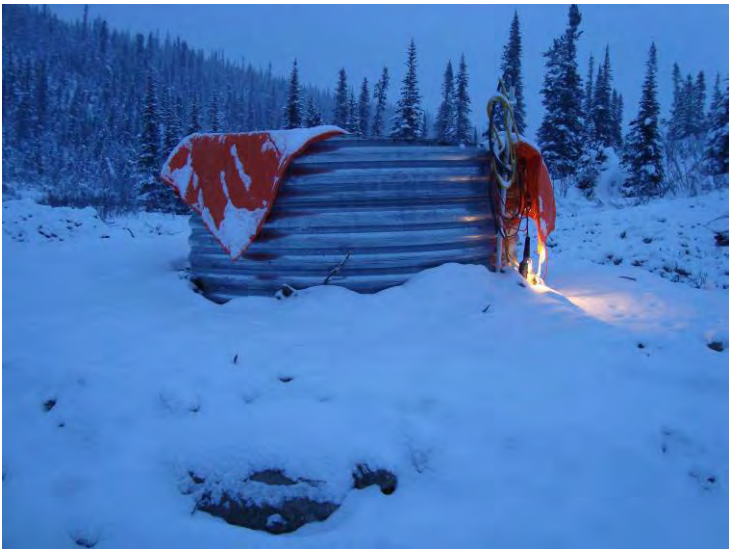
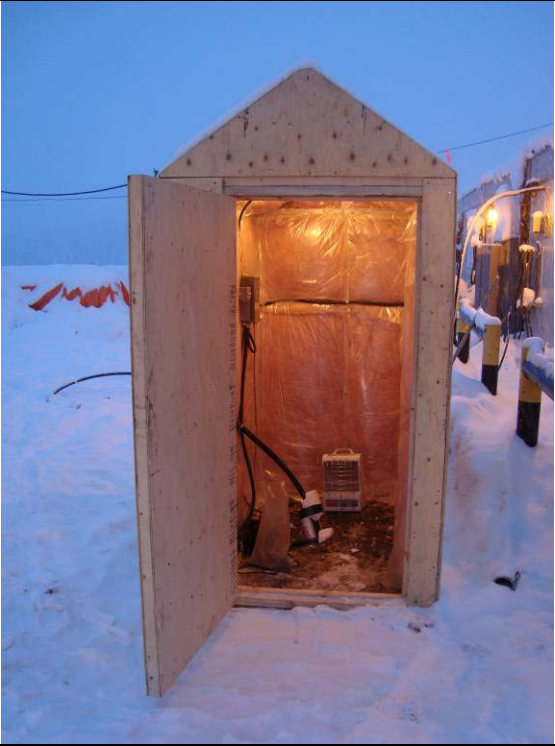
<b>12/07/08 Well cribbing remaining at surface after back fill (facing E)</b>	<b>12/07/08 Pump control/electrical shack at Arctic camp</b>

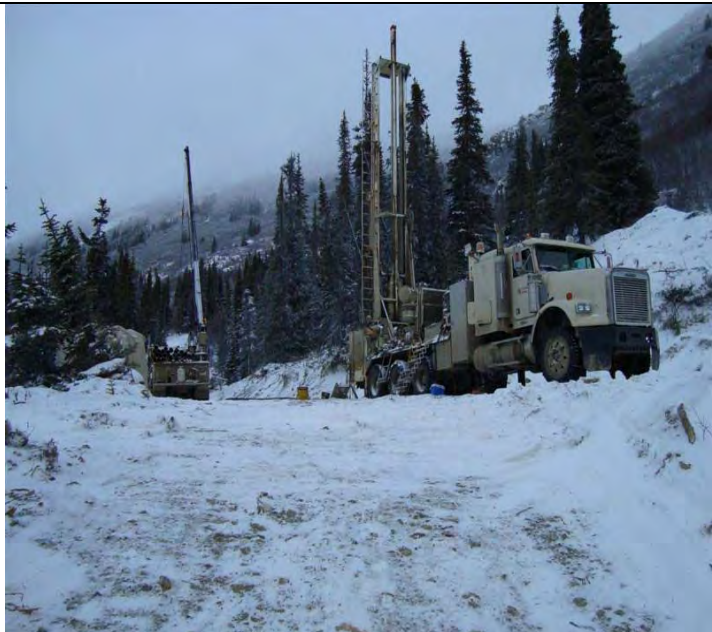
**Photo 1: 10/22/08 Drill site facing U/C looking toward new camp site.**

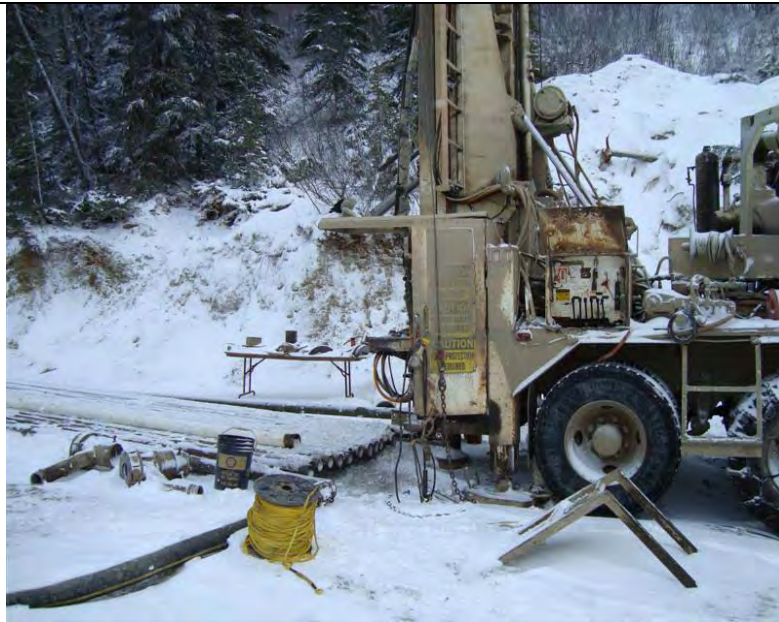
**Photo 2: 10/22/08 Drill site A.**

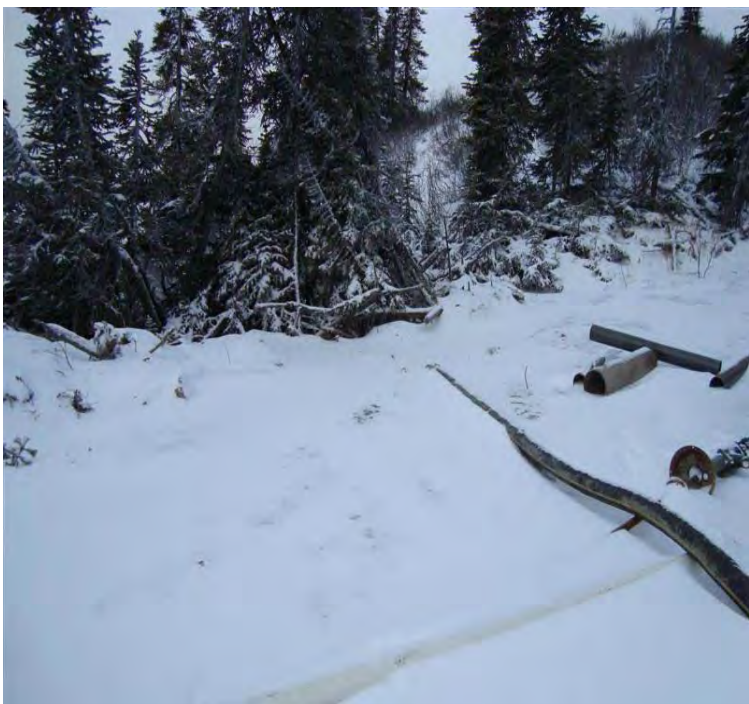
**Photo 3: 10/22/08 End of pipe looking towards new campsite.**

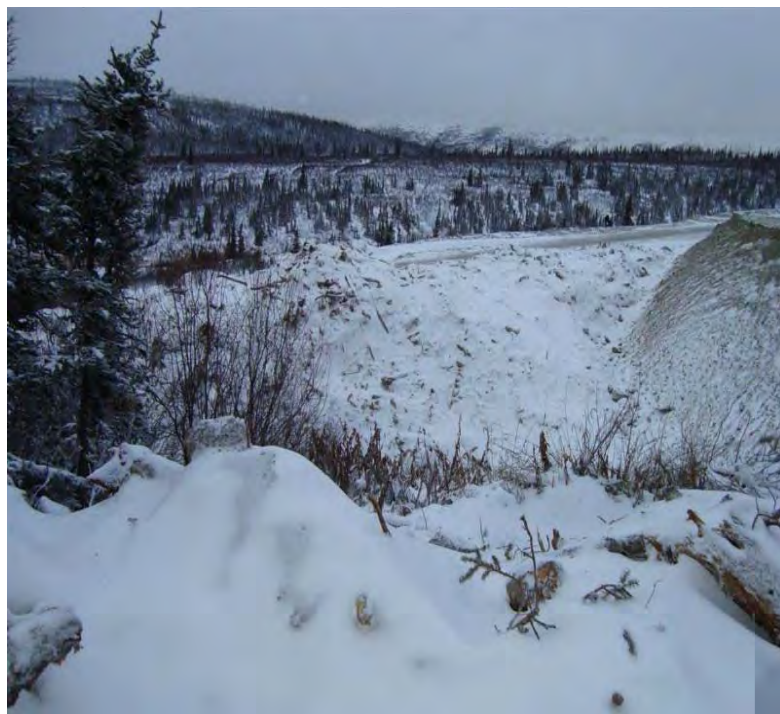
**Photo 4: 10/22/08 Natural sump. Looking at new camp road.**

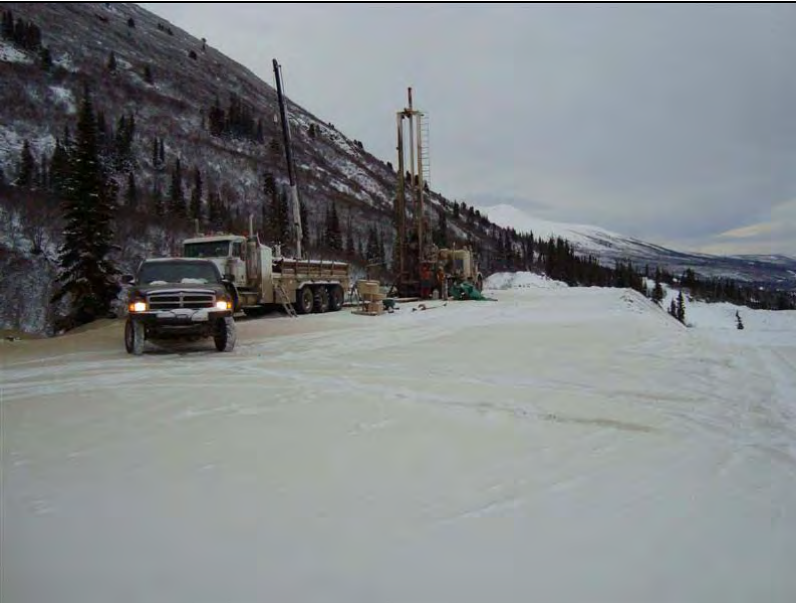
**Photo 5: 10/23/08 Drill site B located above new camp pad. Road up to drill site located on the right side of photo.**

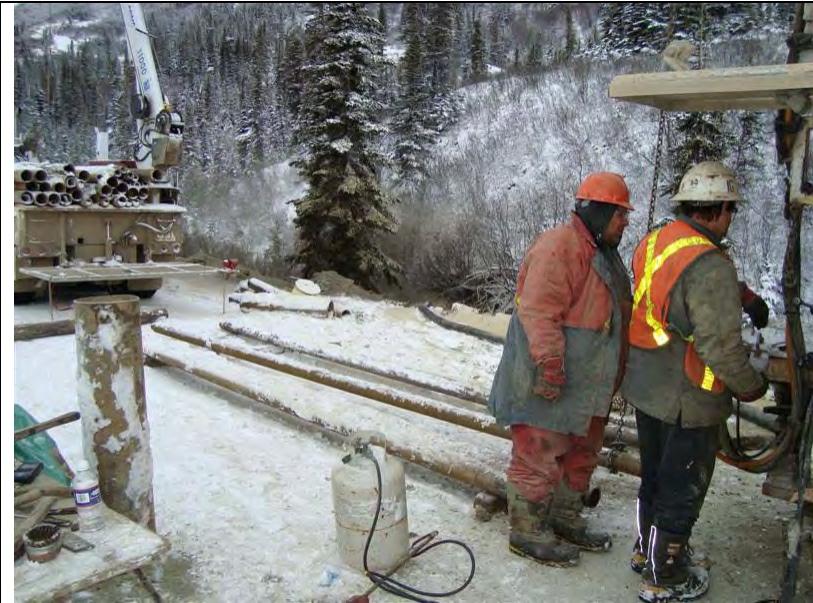
**Photo 6: 10/23/08 Drill site B looking at drill hole and end of pipe.**

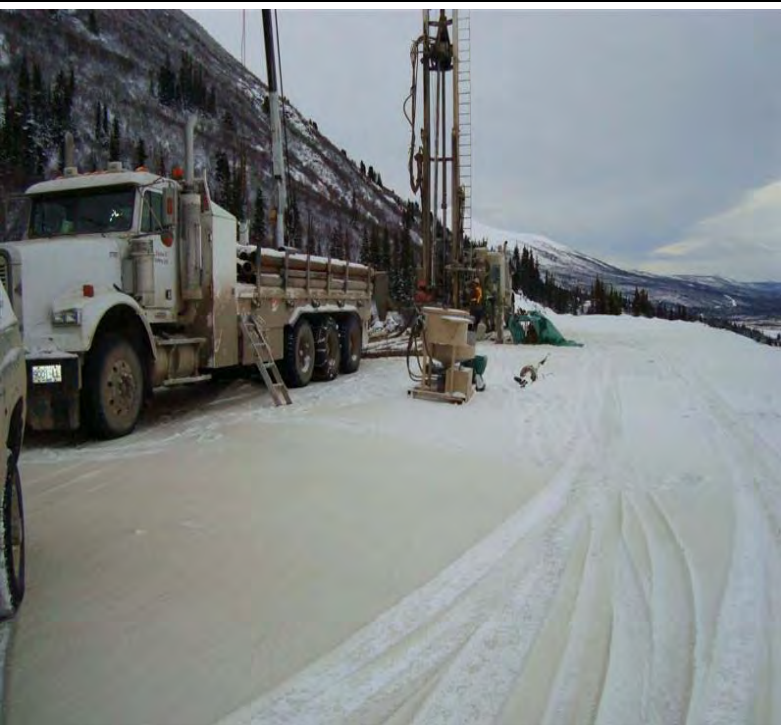
**Photo 7: 10/23/08 Overview of drill location.**

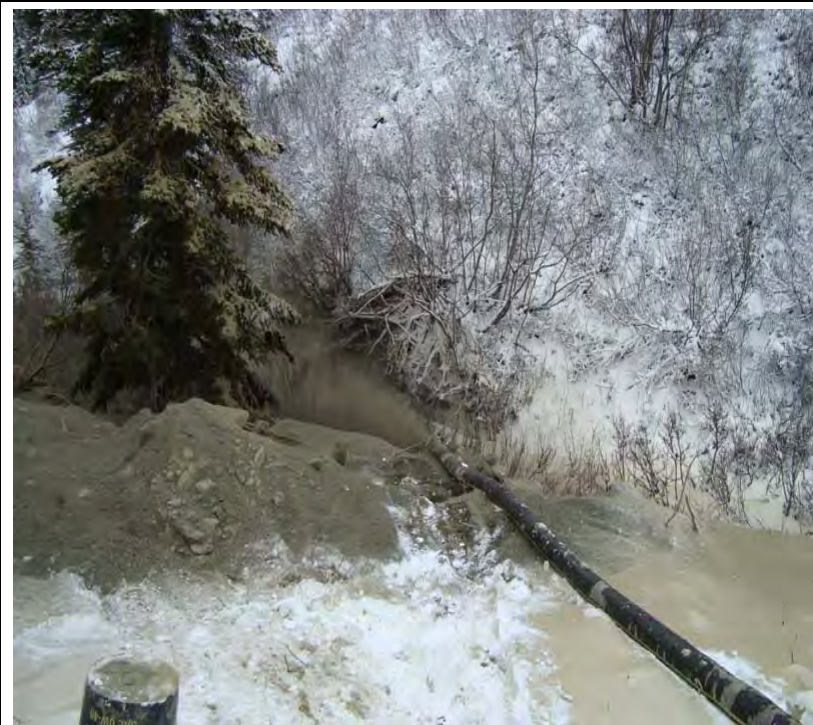
**Photo 8: 10/23/08 Natural sump. Looking away from camp pad.**
