## **Wolverine Project**

**QUARTZ MINING LICENSE QML-0006**

**2008 ANNUAL REPORT**

**Prepared by:  
Yukon Zinc Corporation  
Vancouver, British Columbia**

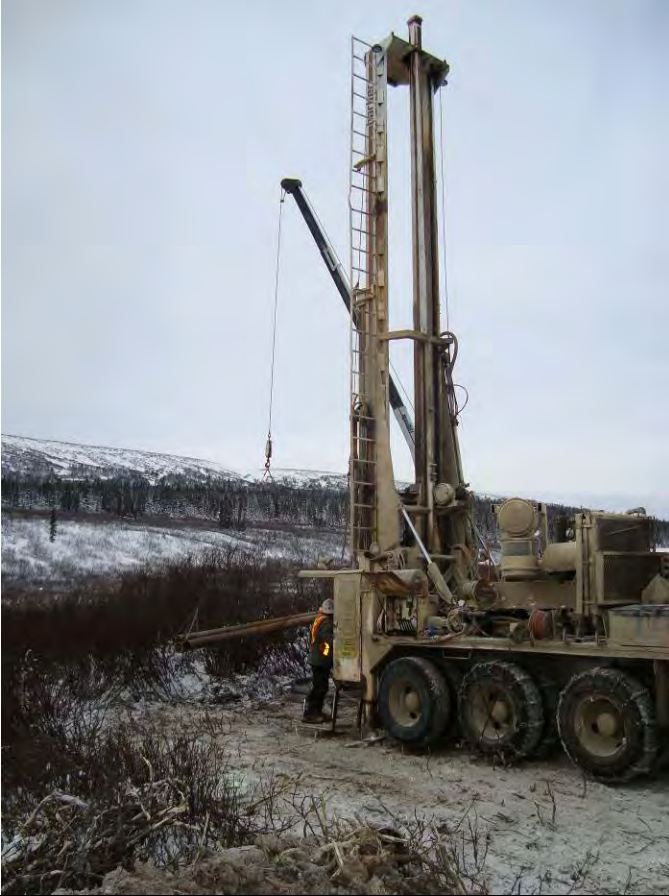
10\_28\_08 MW08-13 drilling (facing W)

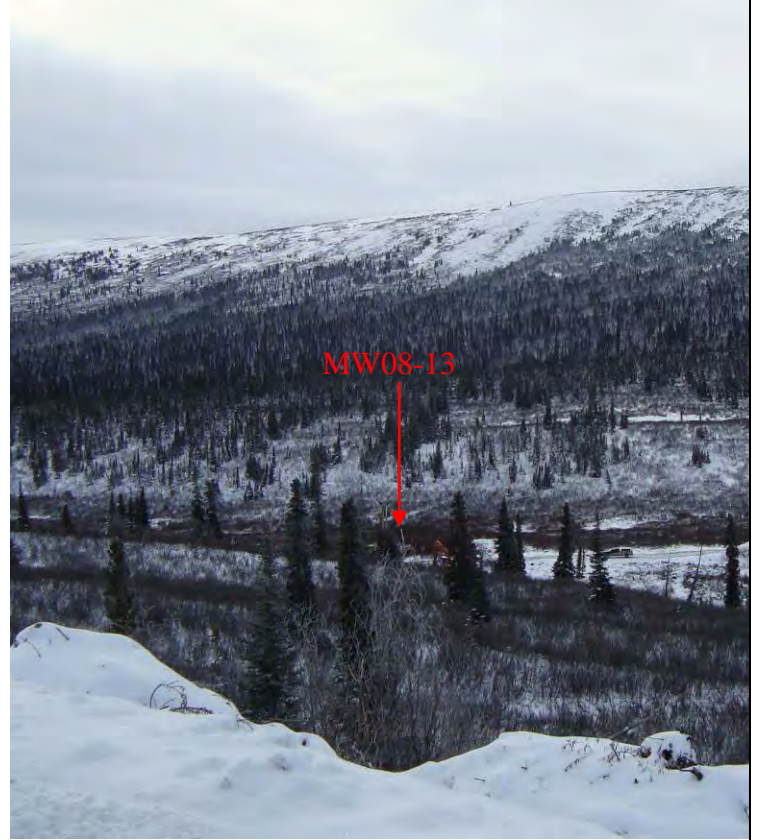
10\_28\_08 MW08-13 drilling (facing S)

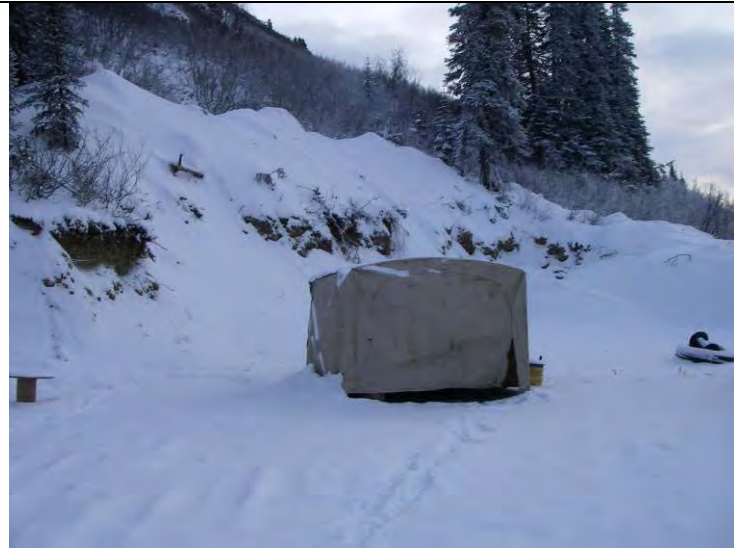
10-29-08 PW08-1 (under brown tent) (facing E)

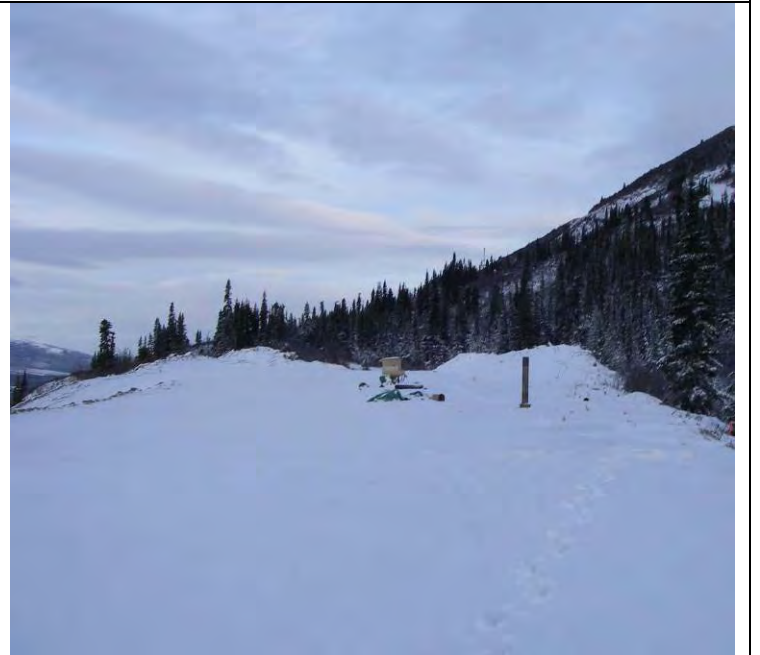
10-29-08 PW08-2 on upper camp pad (facing N)

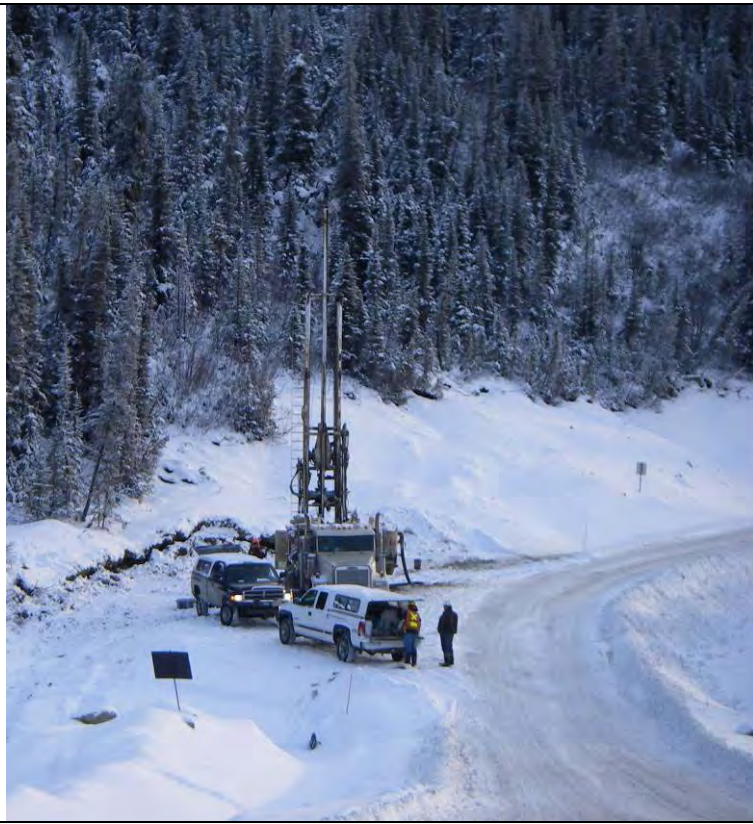
10\_29\_08 MW08-14 drilling (facing E)

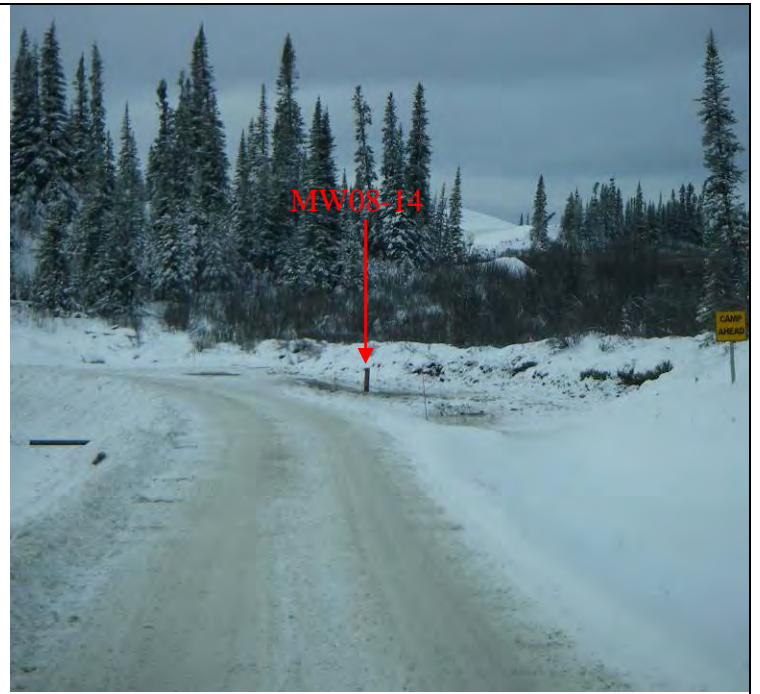
10\_29\_08 MW08-14 complete (facing N)

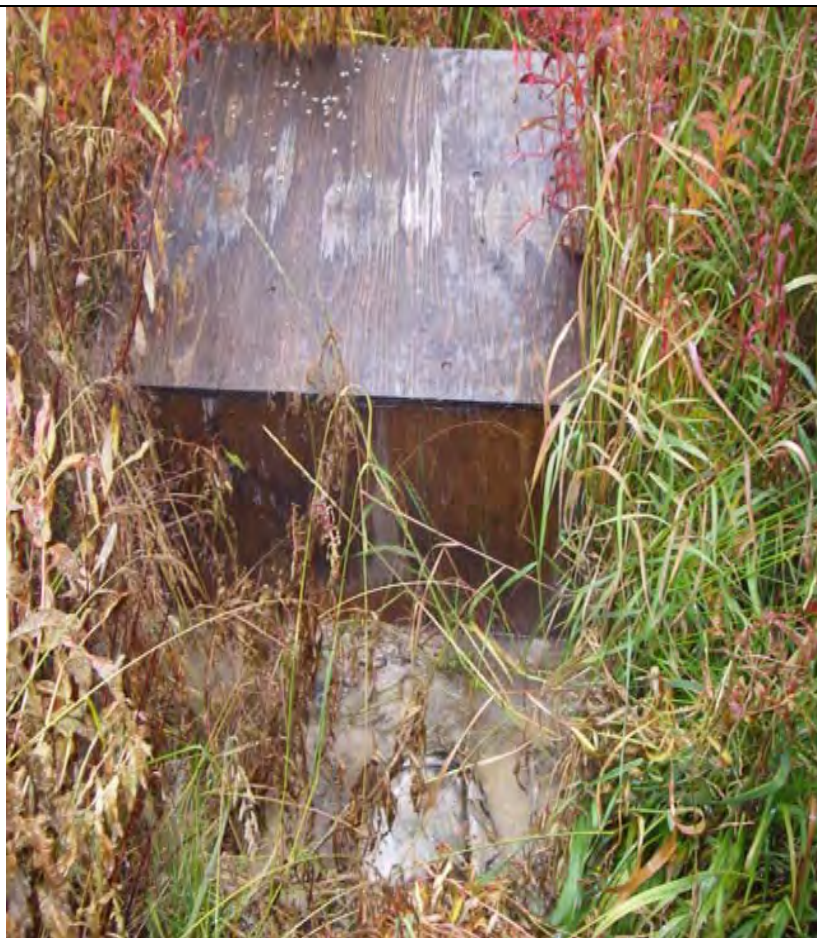
Camp Greywater Kitchen Overflow 09\_14\_08

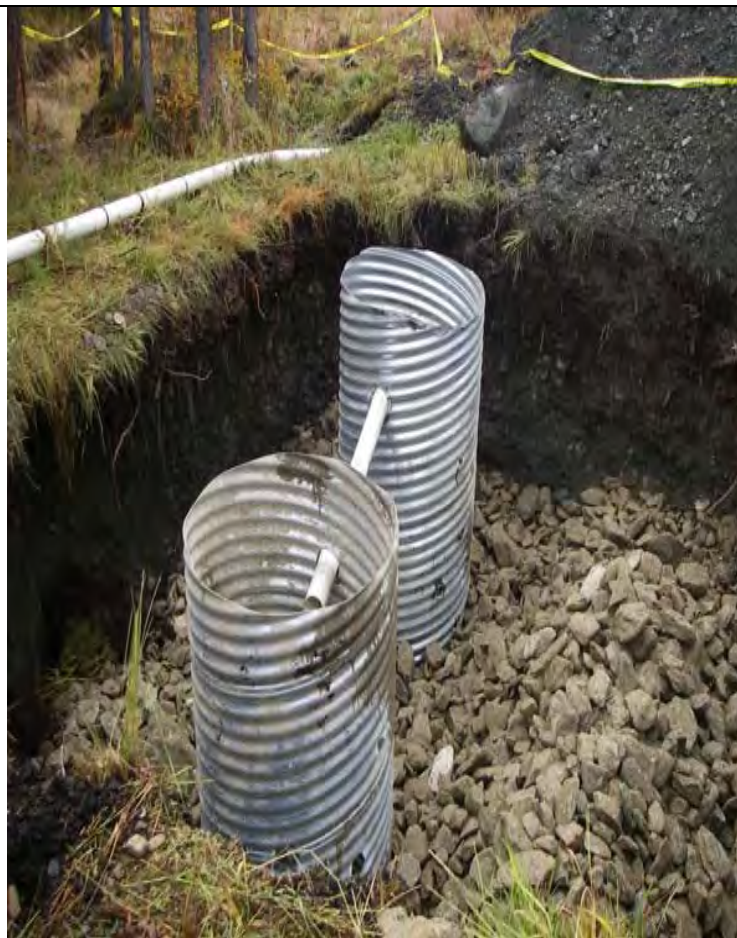
Drys New Greywater Field 09\_19\_08

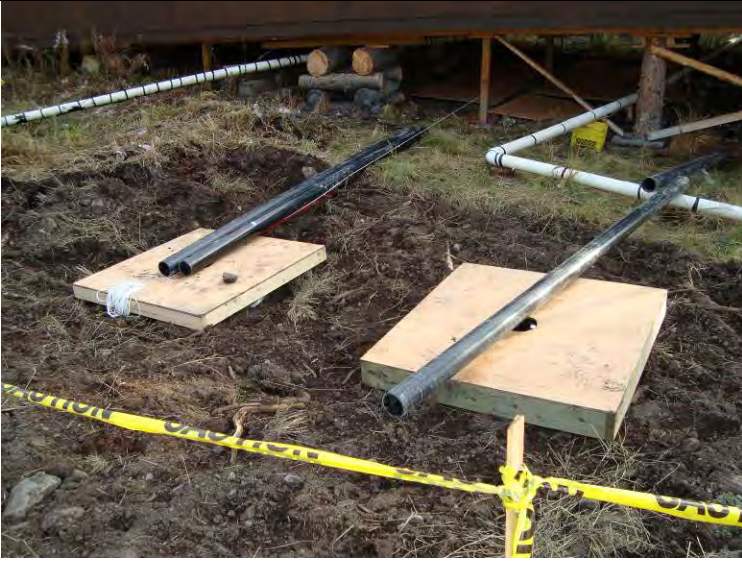
09\_26\_08 backfilled "Dry" field

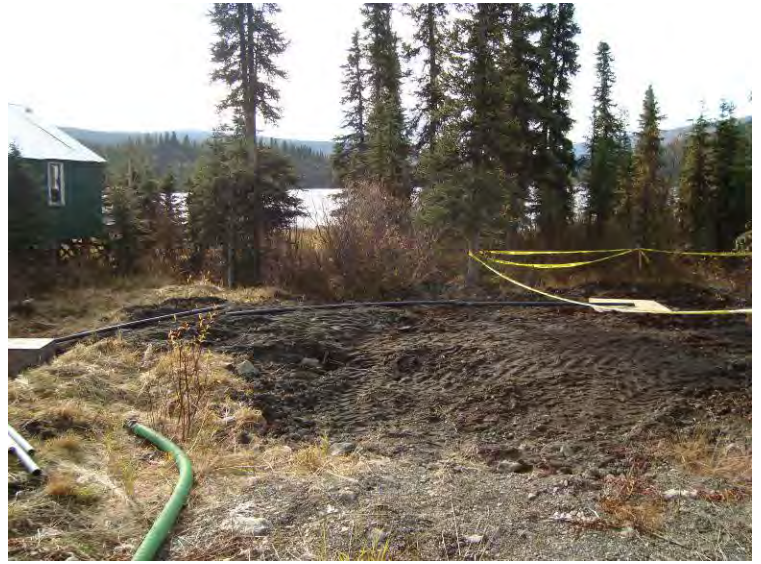
09\_26\_08 backfilled "kitchen" field

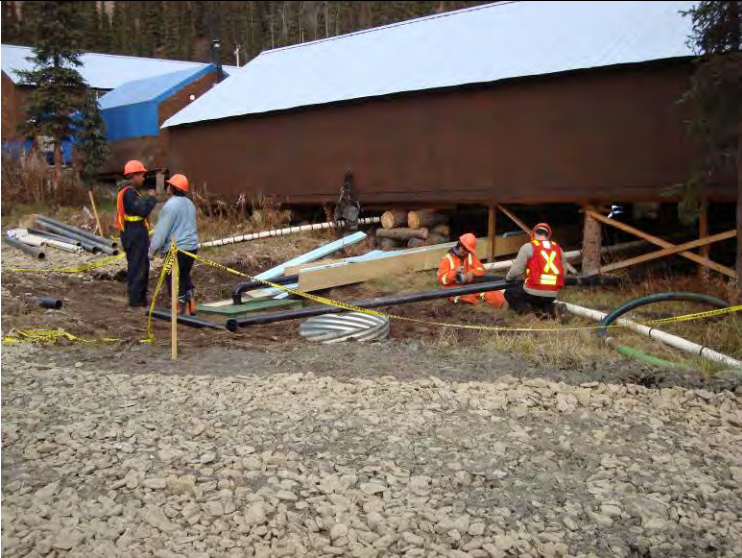
09\_27\_08 Insulating and heat tracing discharge lines

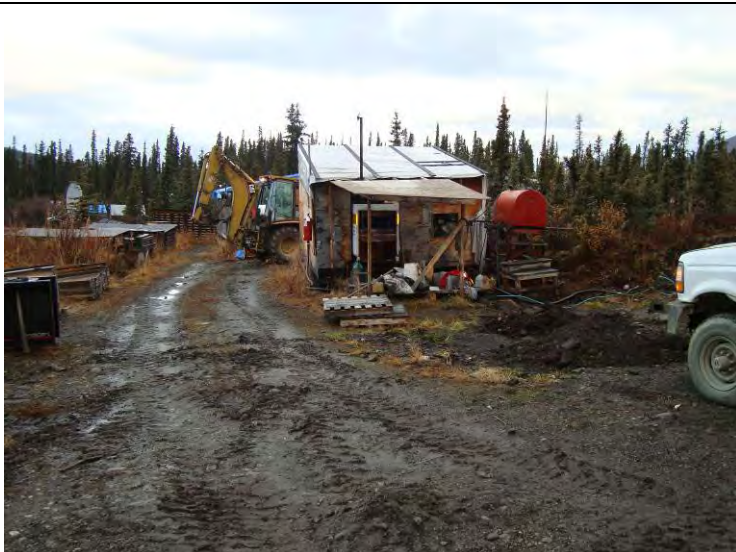
**10/02/08 Location with possible contamination due to genset removal. Before excavation (facing NW)**

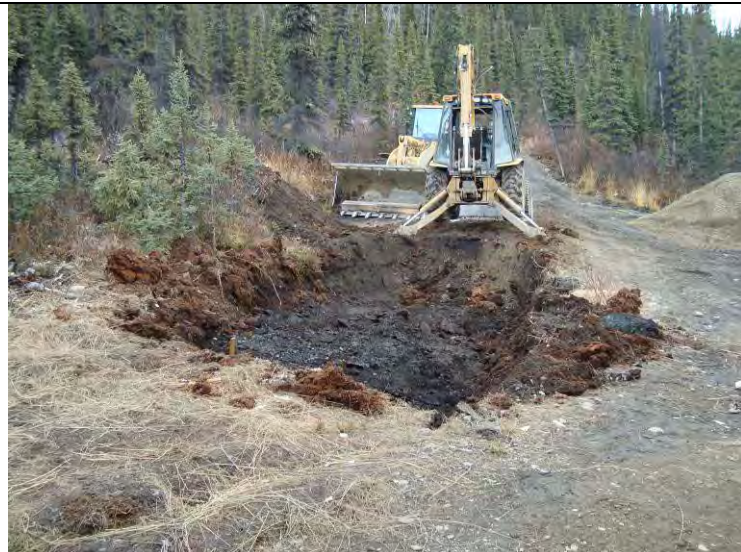
**10/03/08 Excavation of overburden (facing SE)**

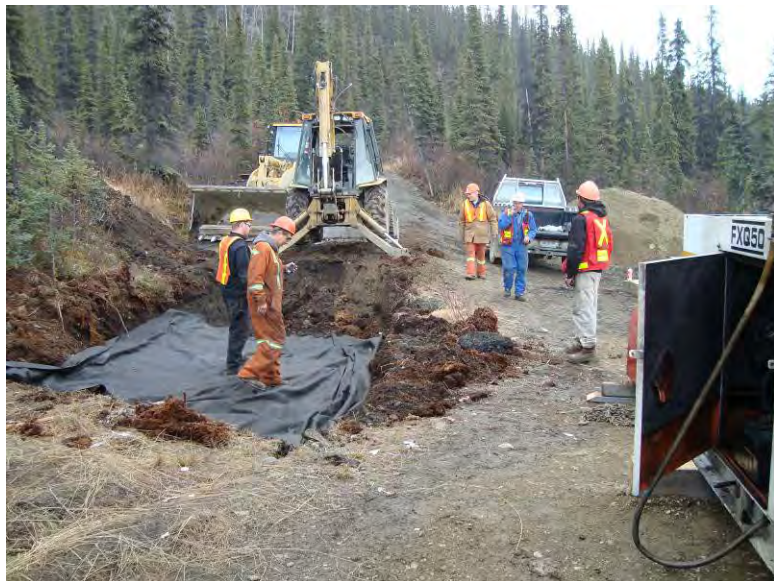
**10/03/08 Geotextile over permafrost that was found (facing SE)**

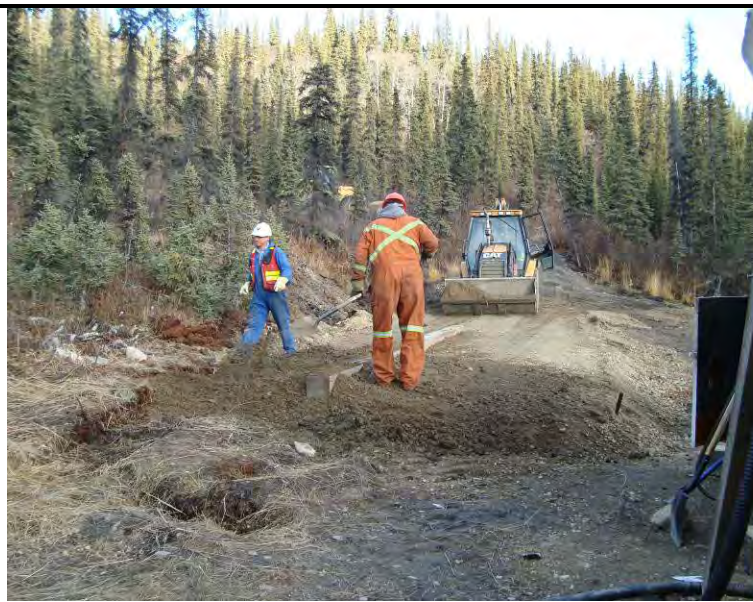
**10/03/08 Filling of excavated area (facing SE)**

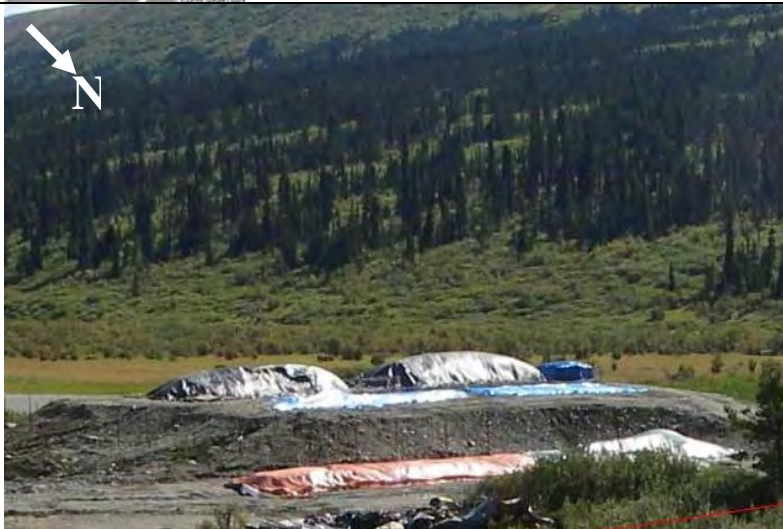
08/19/07 Cell 1 (blue tarp) prior to soil removal; tarped areas above and below of Cell 1 are the soil storage areas for soil that was moved to Cell 2 in September 2007.

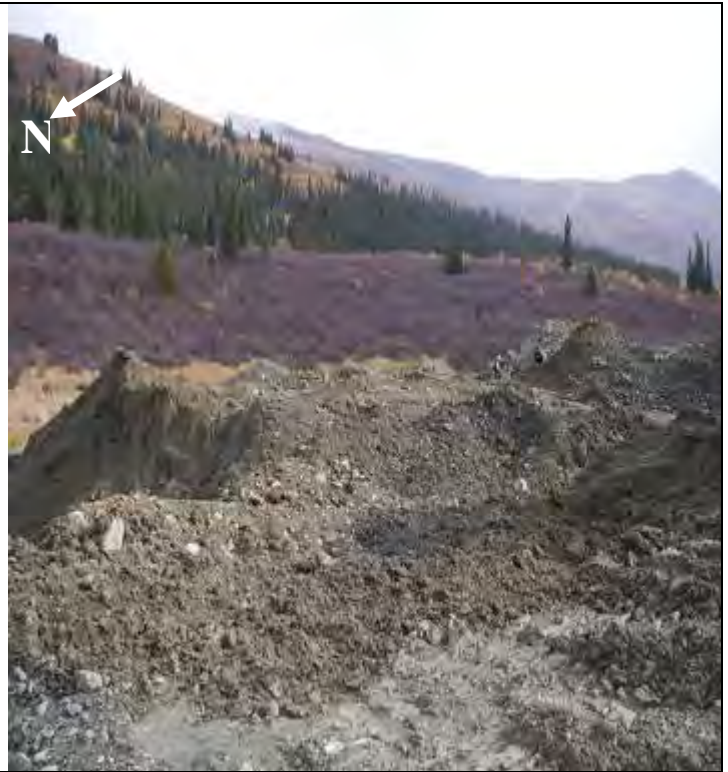
09/15/08 Excavation of underlying material

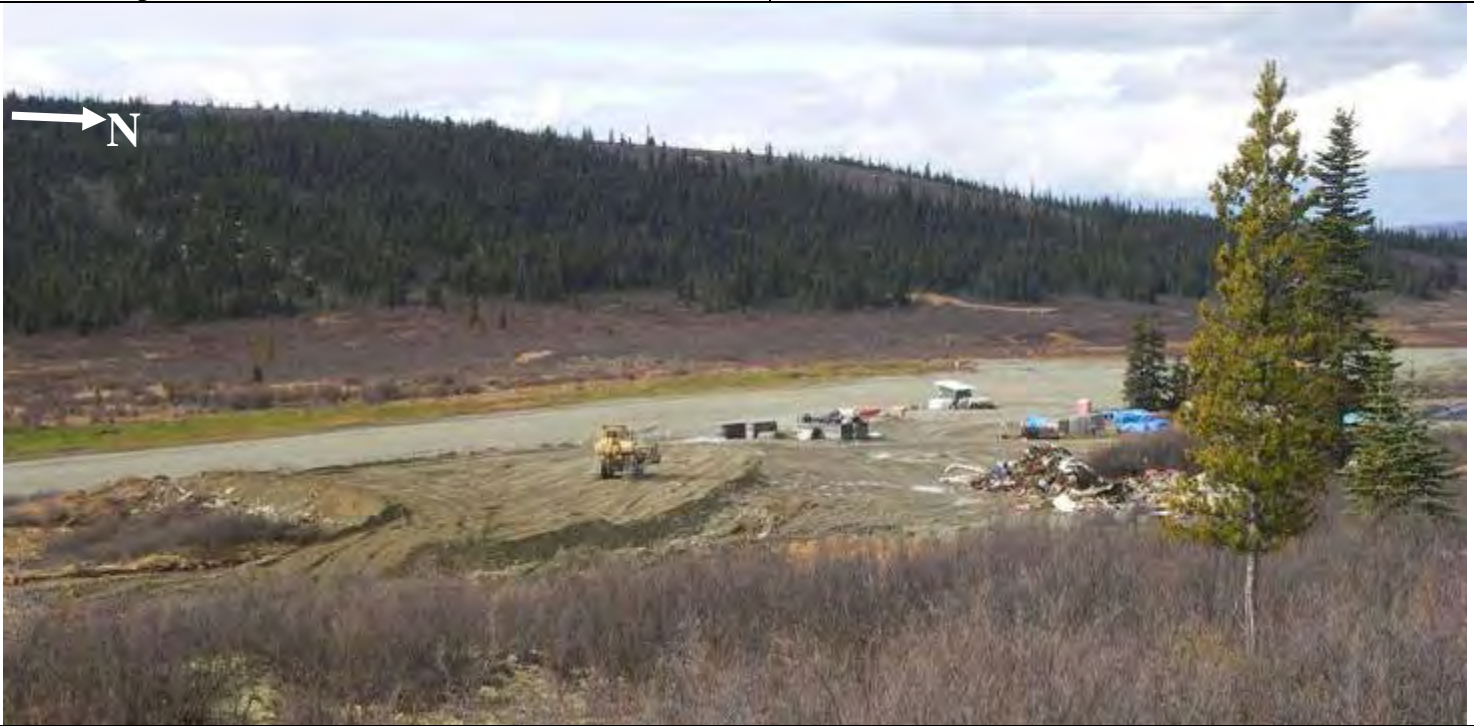
09/22/08 Cell 1 area following removal of cell material and underlying material.

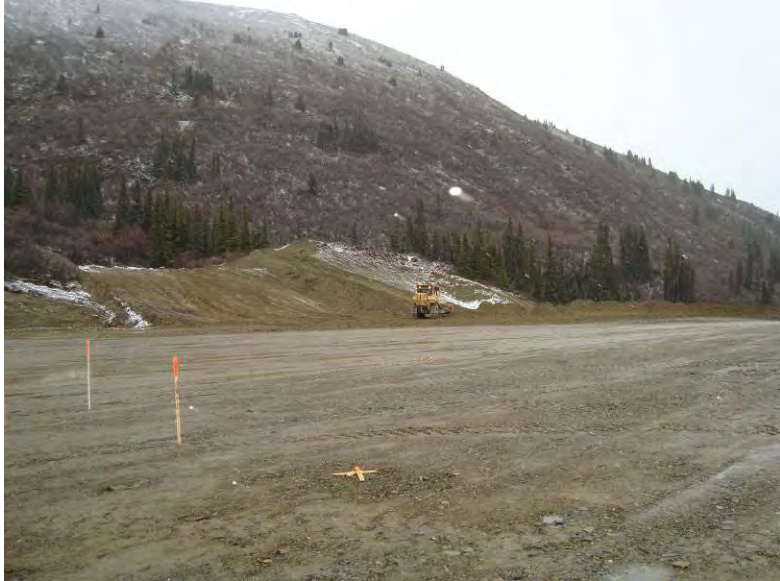
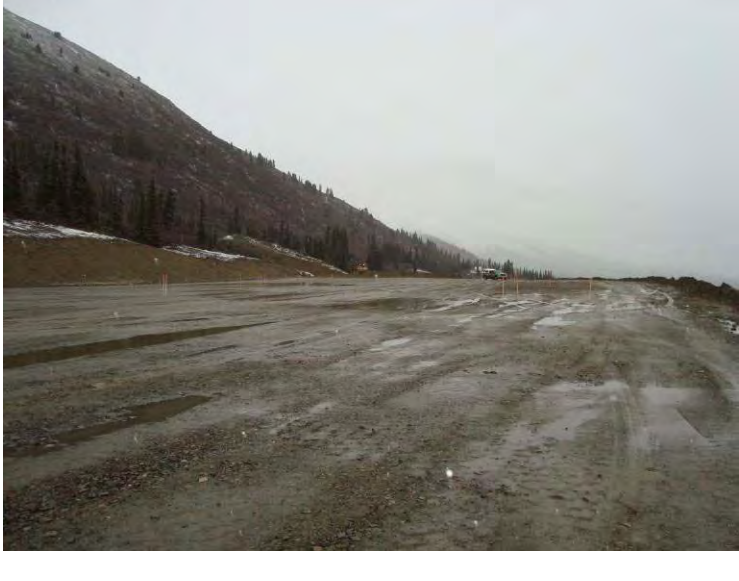
<b>10/05/08 Expansion of SE corner of pad, and staking of buried services layout (facing SE)</b>	<b>10/05/08 Camp pad (facing south)</b>

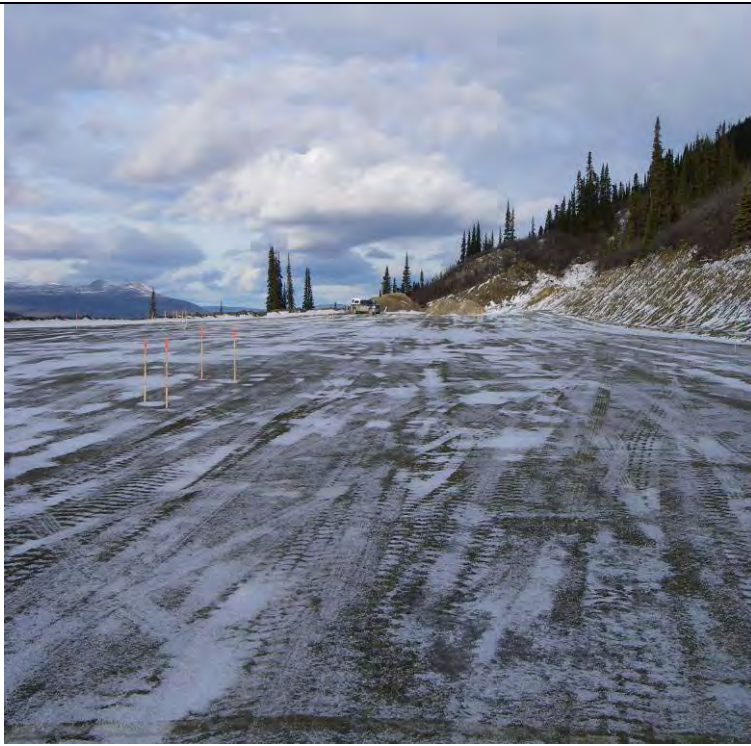
10\_12\_08 Looking North along Camp Pad some materials for services at end of pad

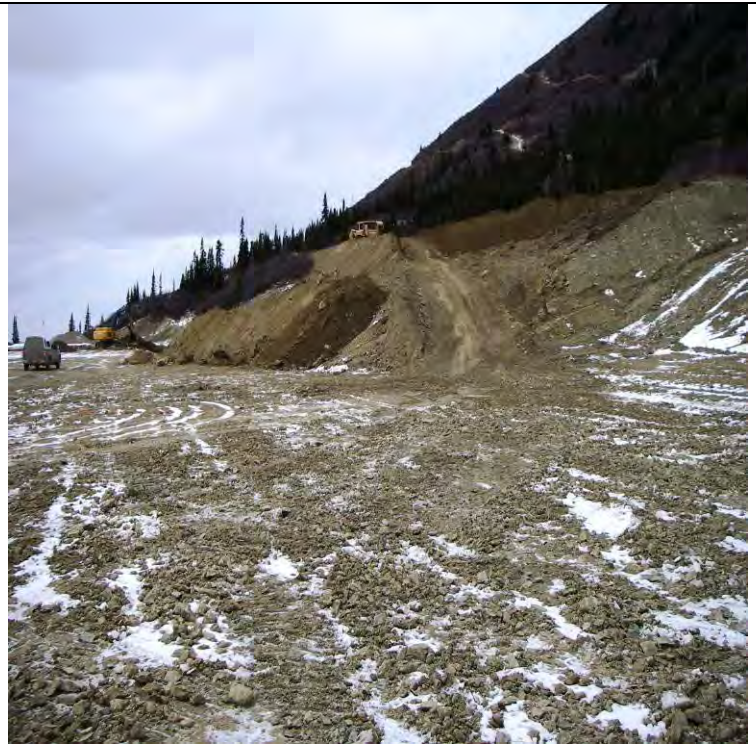
10\_15\_08 Looking North showing road to upper camp pad

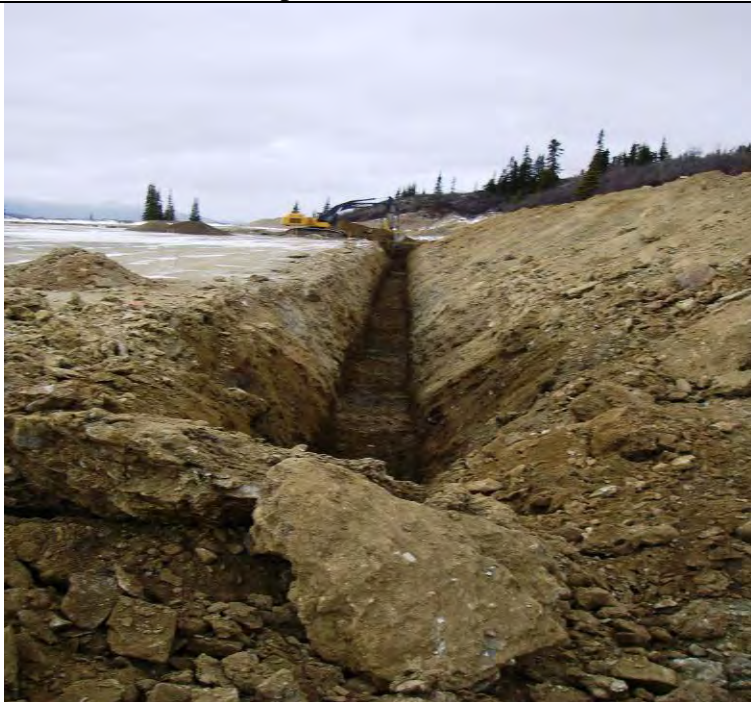
10\_15\_08 Facing North looking at eastern buried service trench

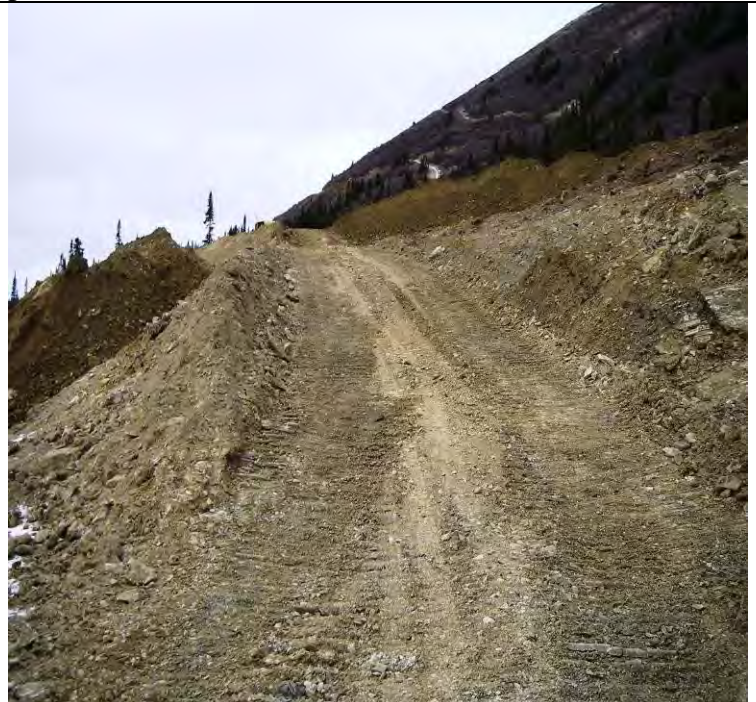
10\_15\_08 Looking North road to upper camp pad

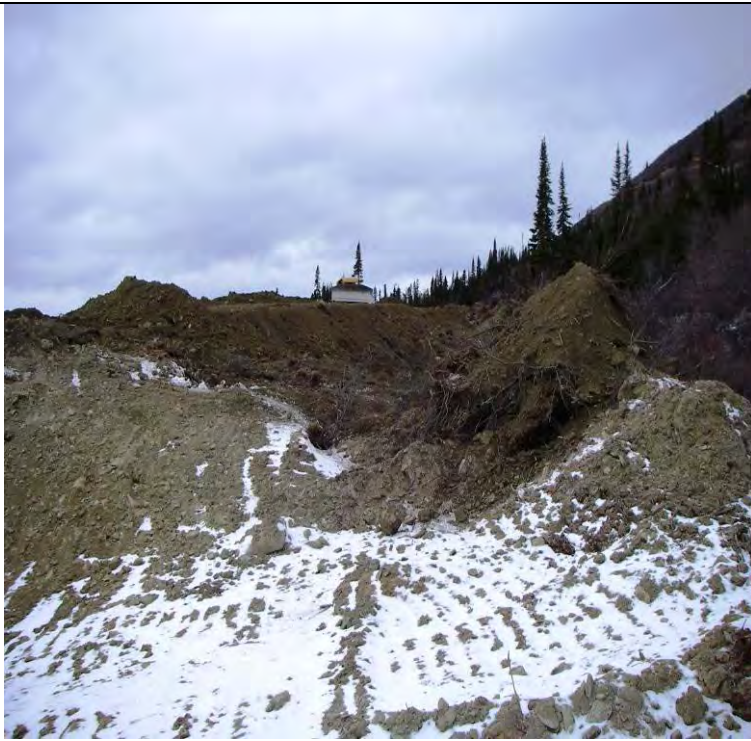
10\_15\_08 Looking North along upper pad with strippings windrowed towards eastern slope

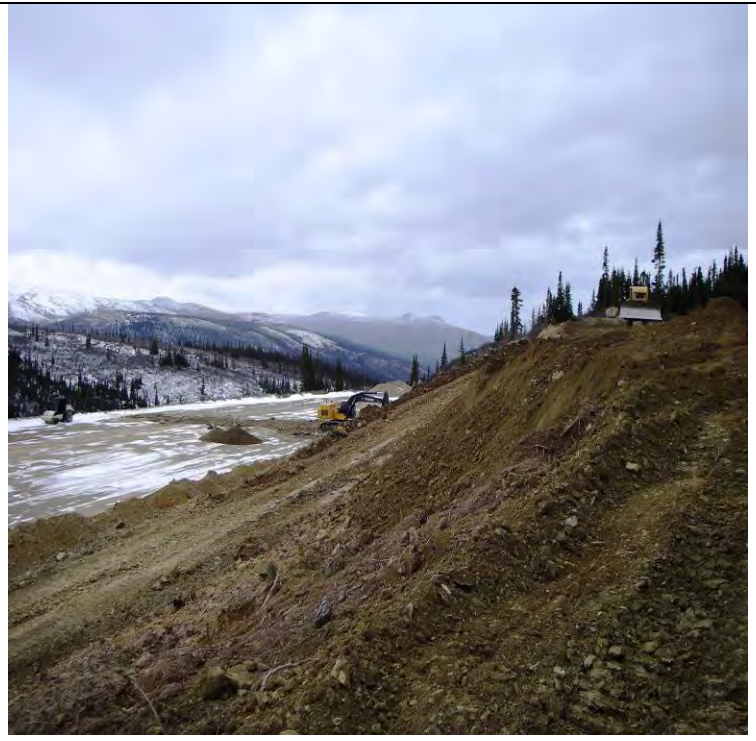
10\_15\_08 Looking North from water drill site down to lower camp pad

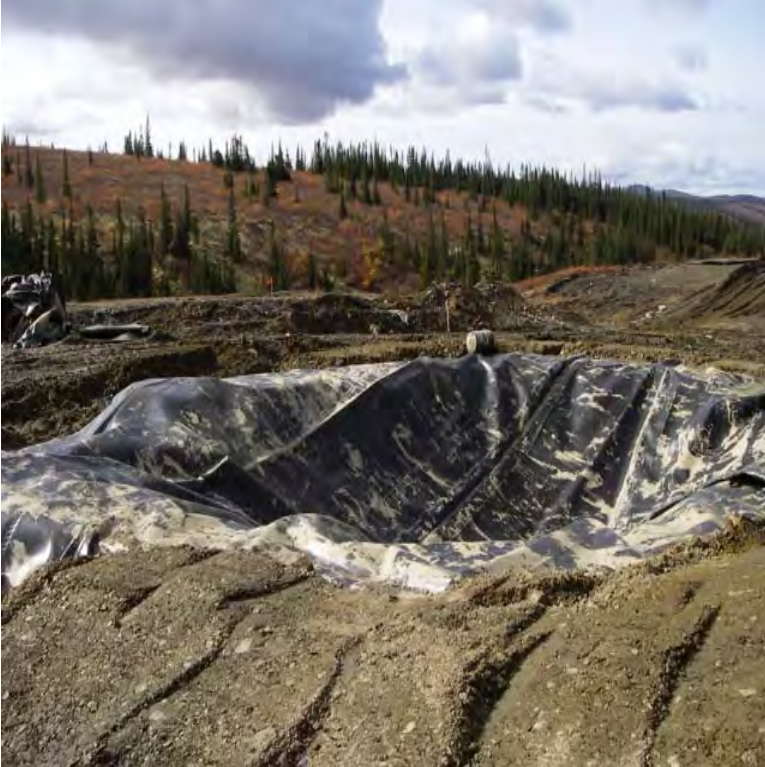
PortalPad\_09\_09\_08 Temporary Sump

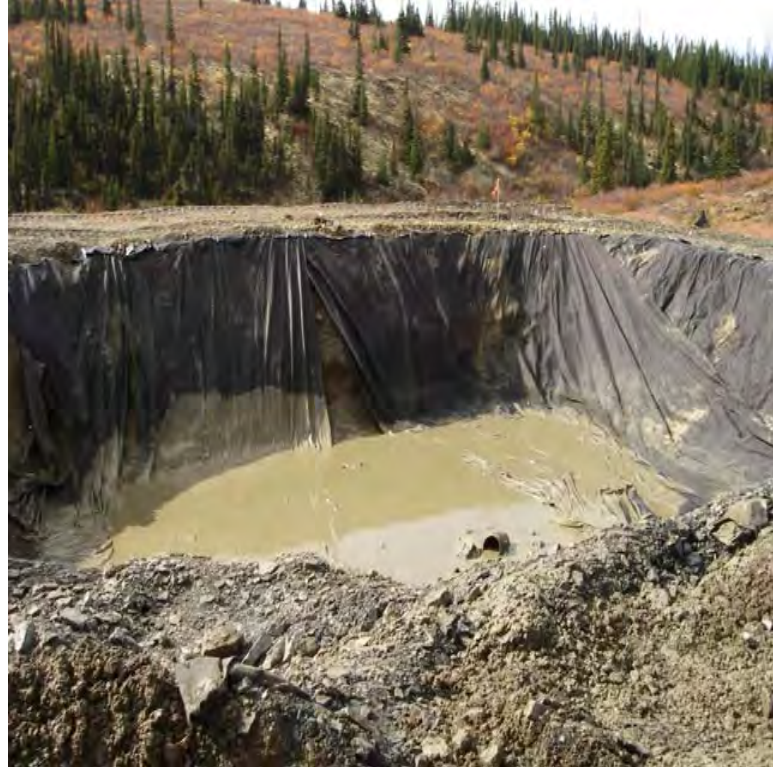
PortalPad\_09\_09\_08 Decommissioning PCS preparing to pump water to WRP before liner removal

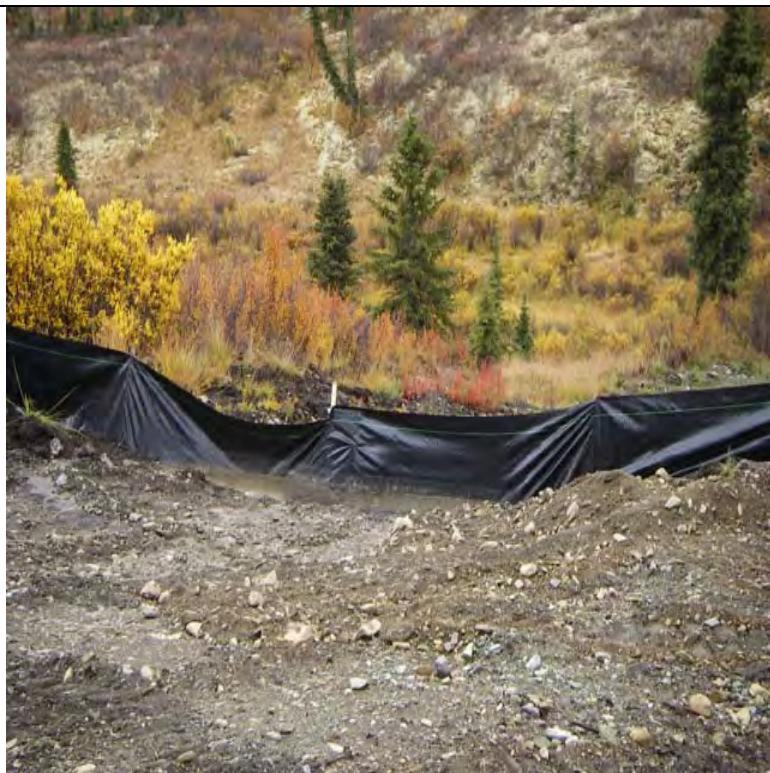
PortalPad\_09\_10\_08 Silt Fence at toe of pad

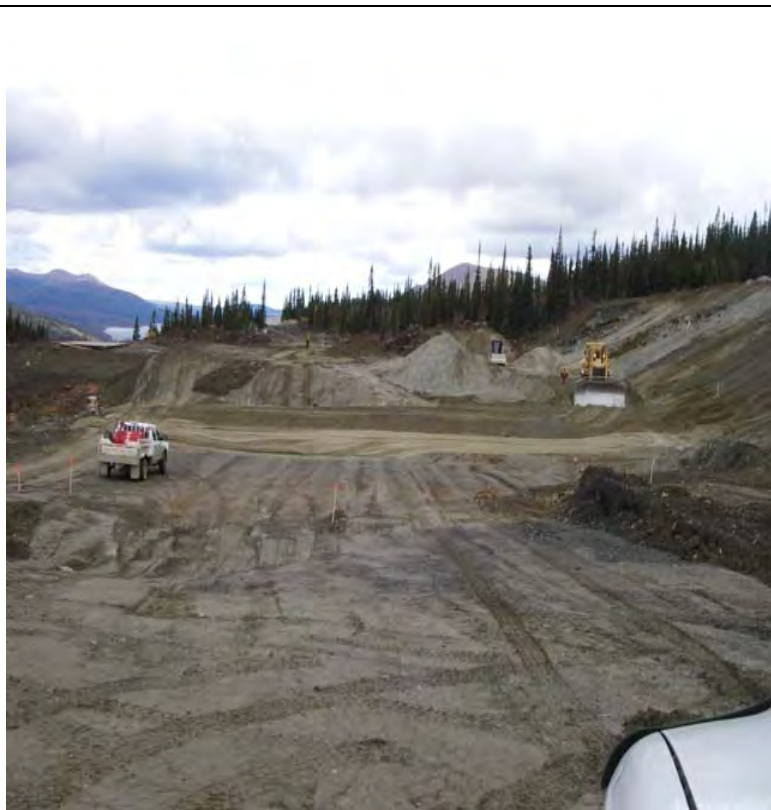
PortalPad\_09\_15\_08 Pad build up looking upchain

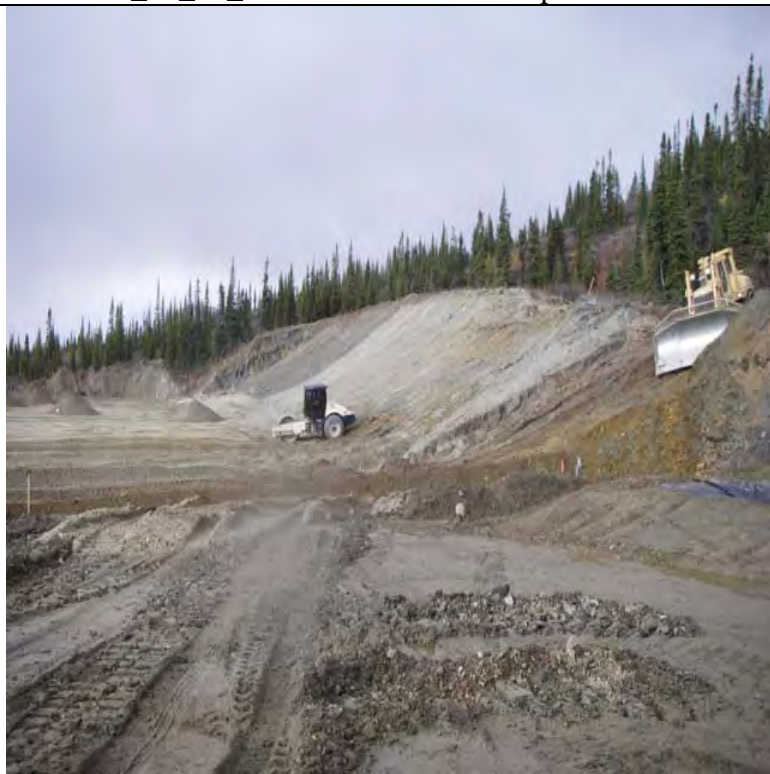
PortalPad\_09\_17\_08 Compacting the Portal Pad

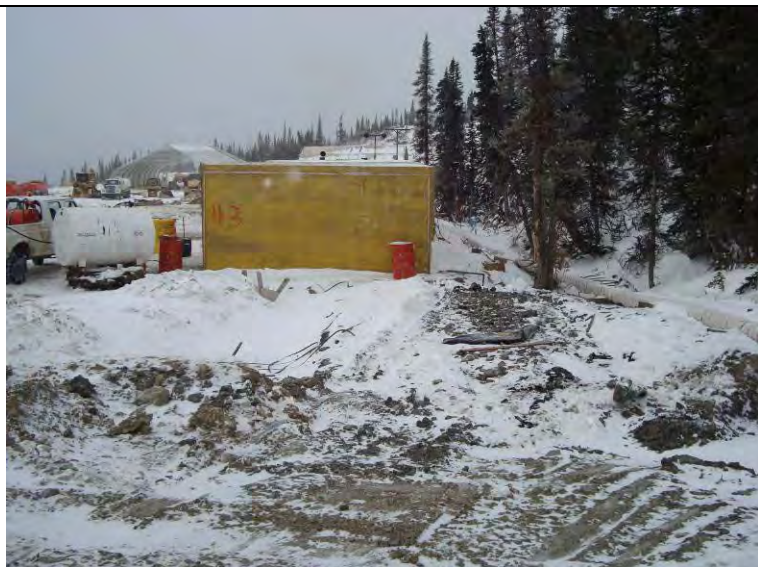
10-29-08 Old diesel tank location prior to leveling  
(facing WNW)

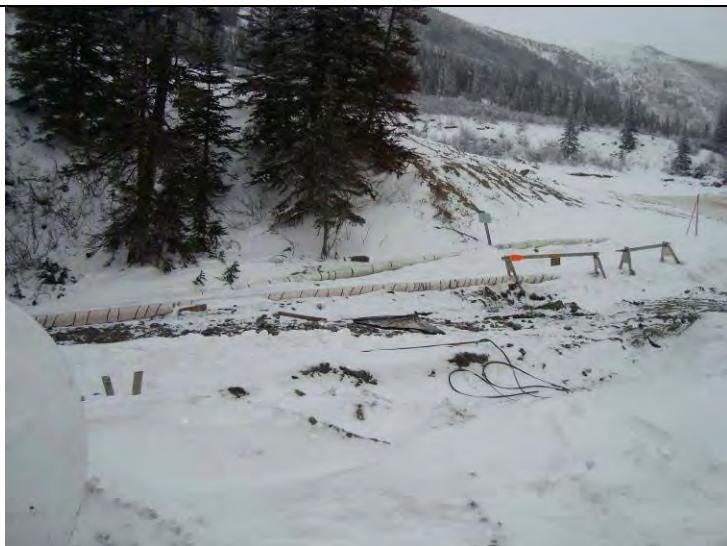
10-29-08 Old diesel tank location prior to leveling  
(facing E)

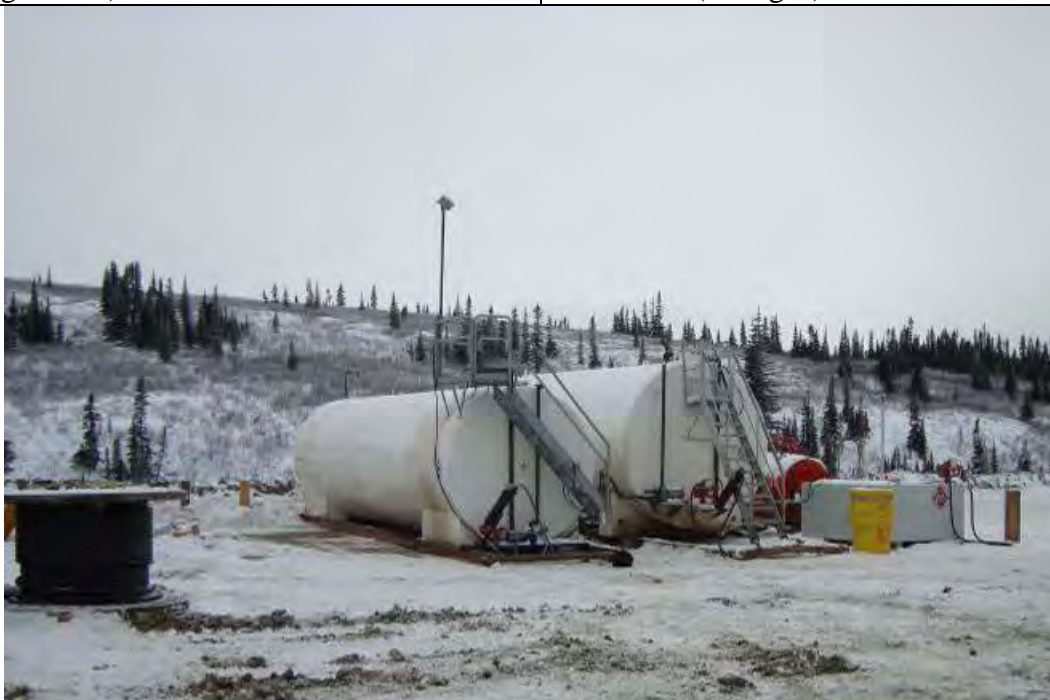
10-29-08 New diesel tank location (facing W)

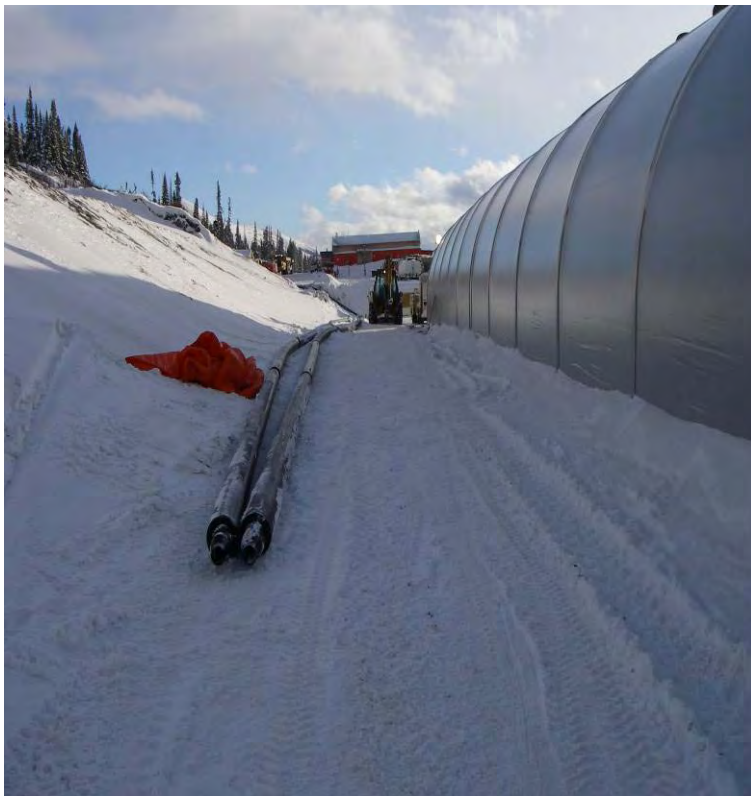
11-07-08 6" HDPE being run behind the new Sprung-facing S

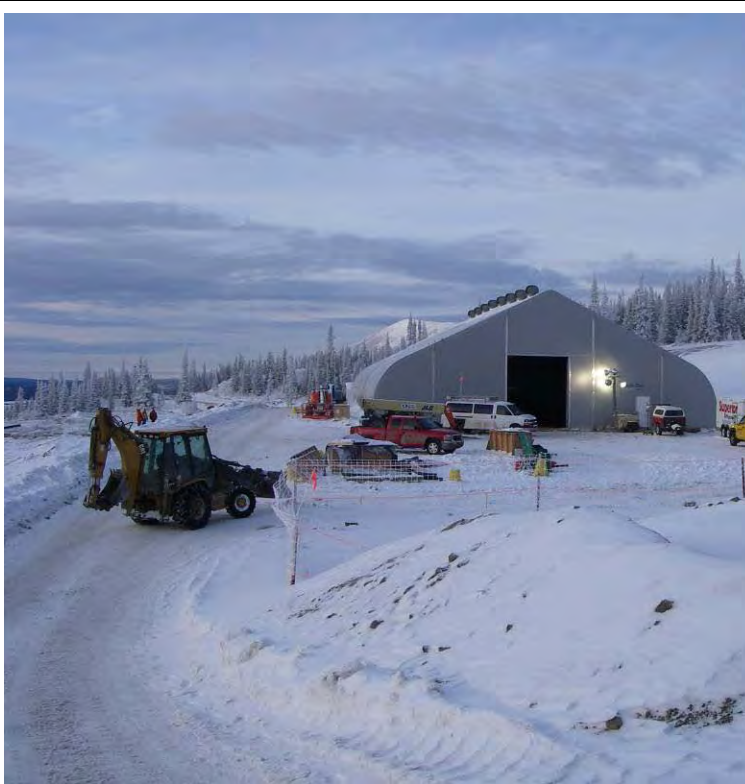
11-12-08 View of new Sprung installing door, temporary settlement pond in foreground with fencing ( facing N)

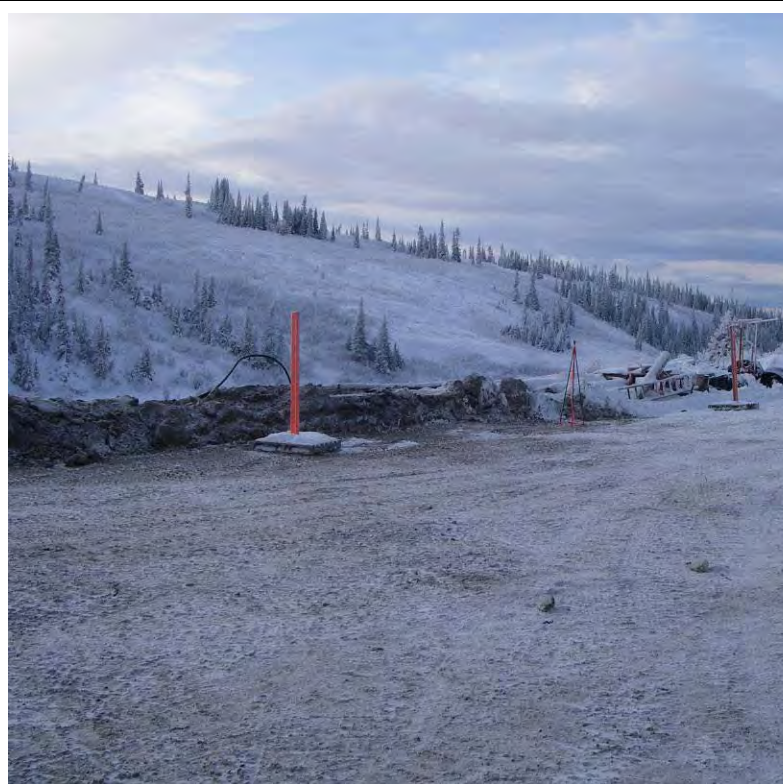
11-12-08 6" HDPE and electrical run protective barricades at lower portal area ( facing NW)

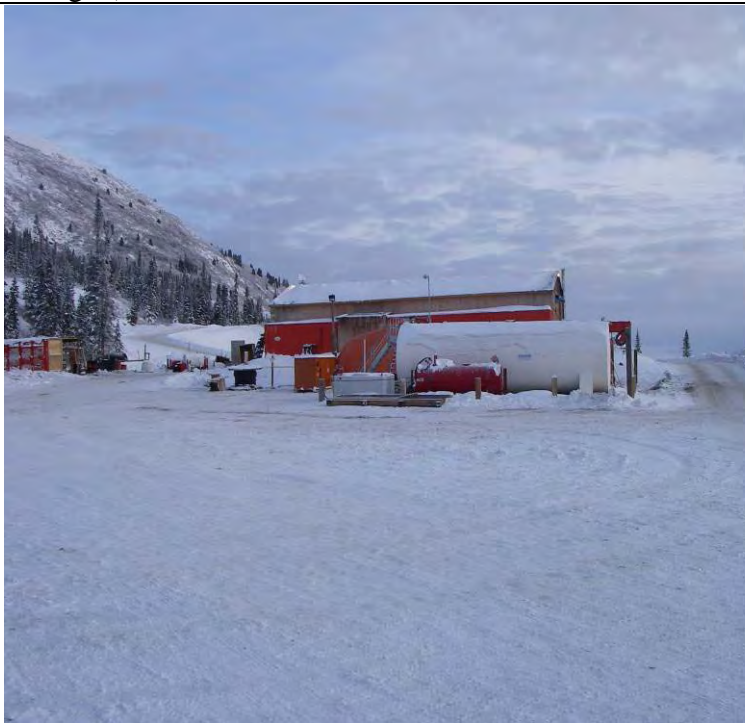
11-12-08 New location of fuel tanks and Gensets (facing S)

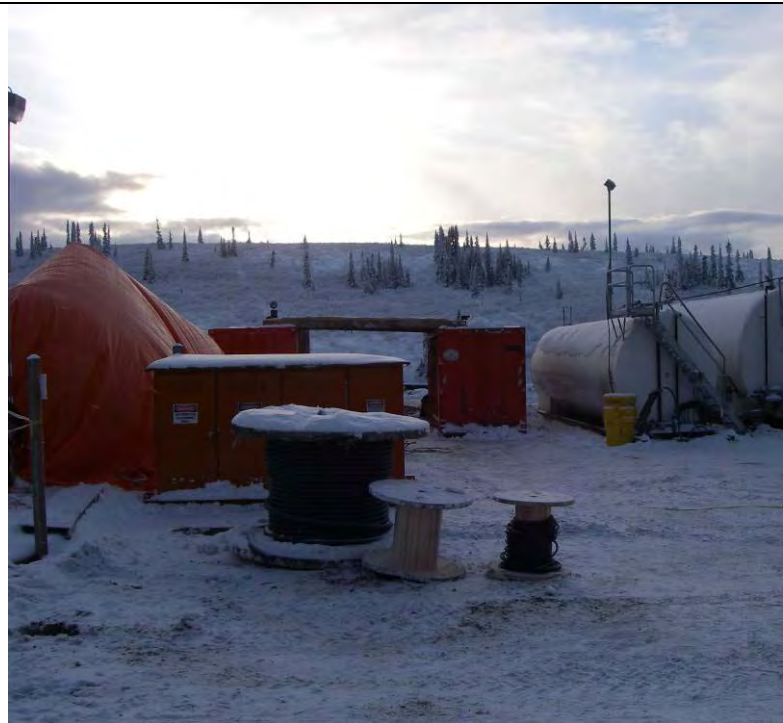
11-12-08 New location of fuel tanks and Gensets (facing W)

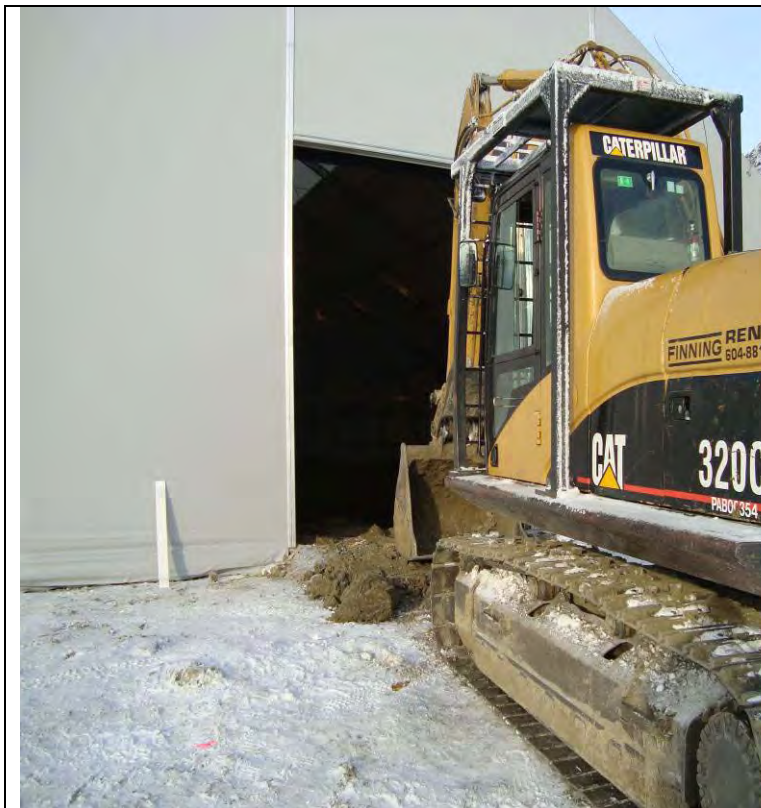
11-13-08 Pulling ramp and working on entrance for man-lift access– facing N

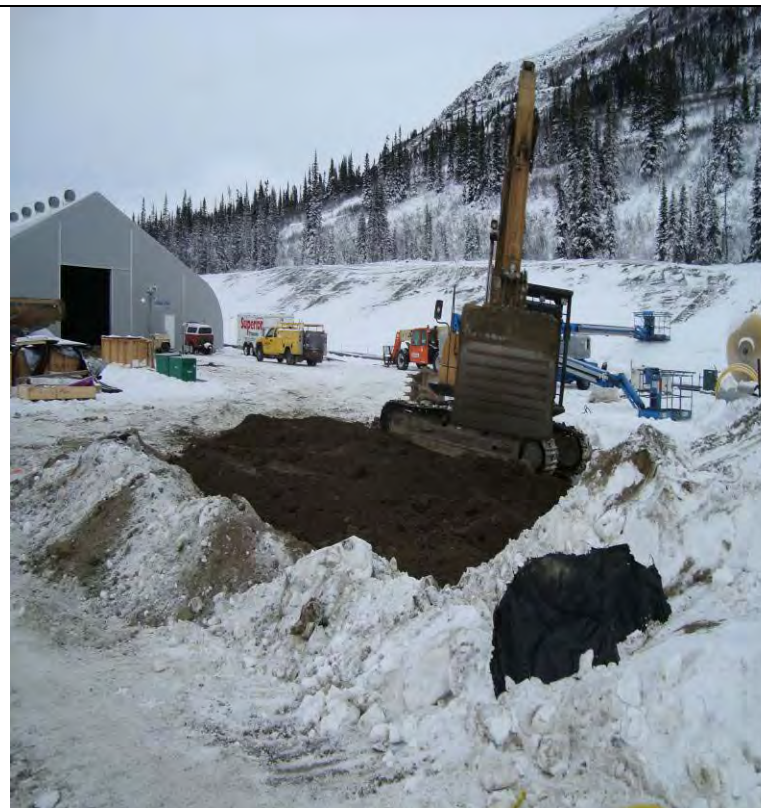
11-14-08 Backfilling the temporary sump – facing N
