## **Wolverine Project**

**QUARTZ MINING LICENSE QML-0006**

**2008 ANNUAL REPORT**

**Prepared by:  
Yukon Zinc Corporation  
Vancouver, British Columbia**

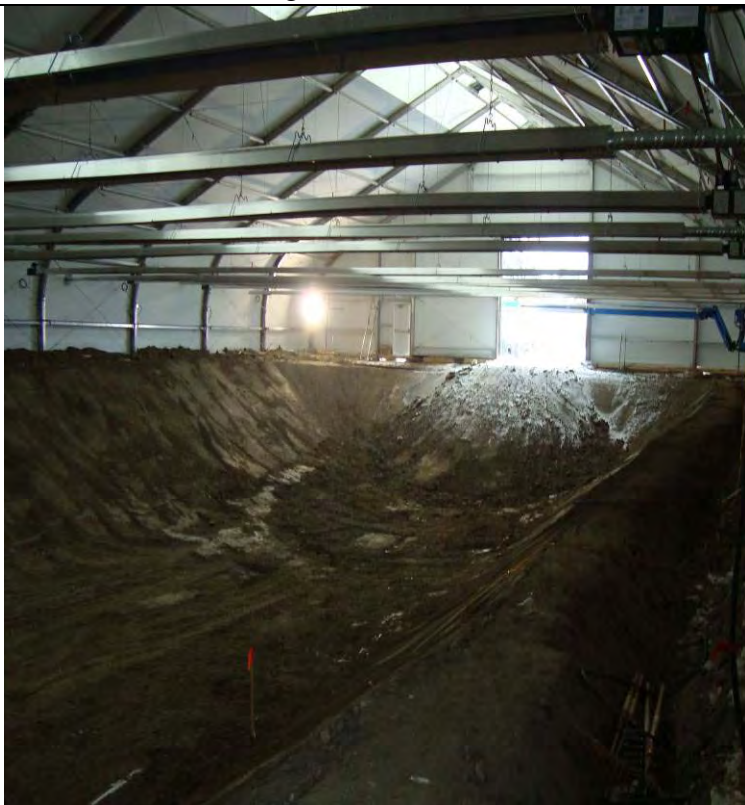
11-15-08 Sprung completed, lining of pond and internal piping to finish – facing S

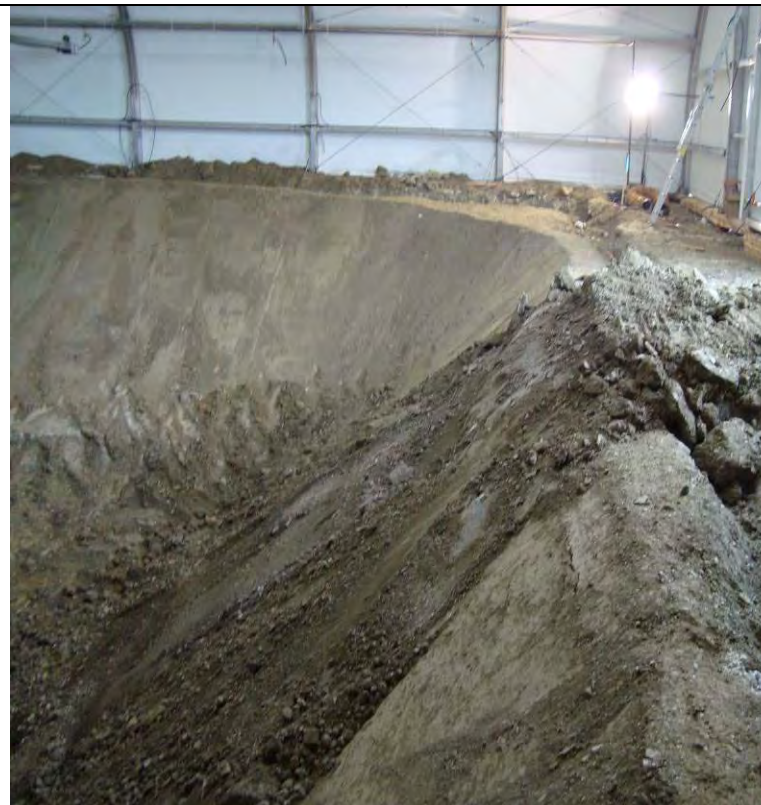
11-14-08 Excavation of the 2000 m<sup>3</sup> sump pulling the ramp - facing E

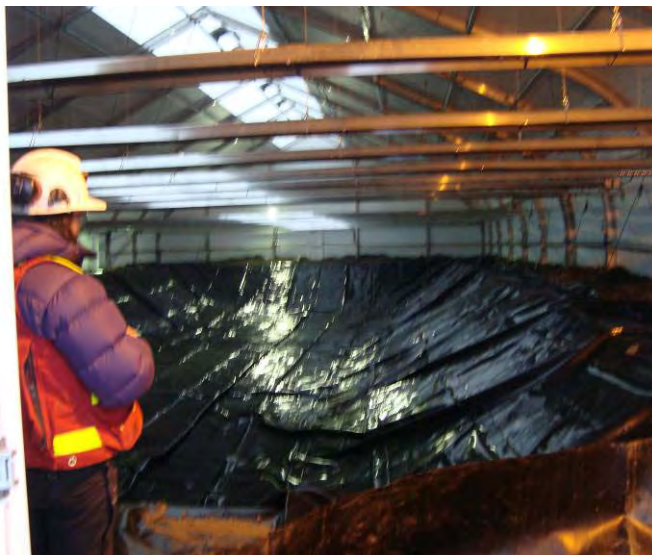
11-23-08 Finished liner install, still requires backfilling of lock trench

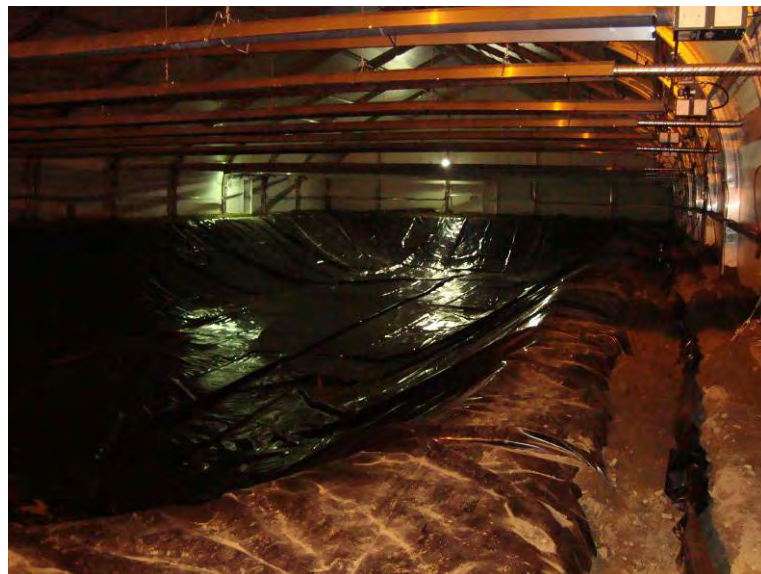
11-26-08 Geotextile lined sump, incomplete locktrench

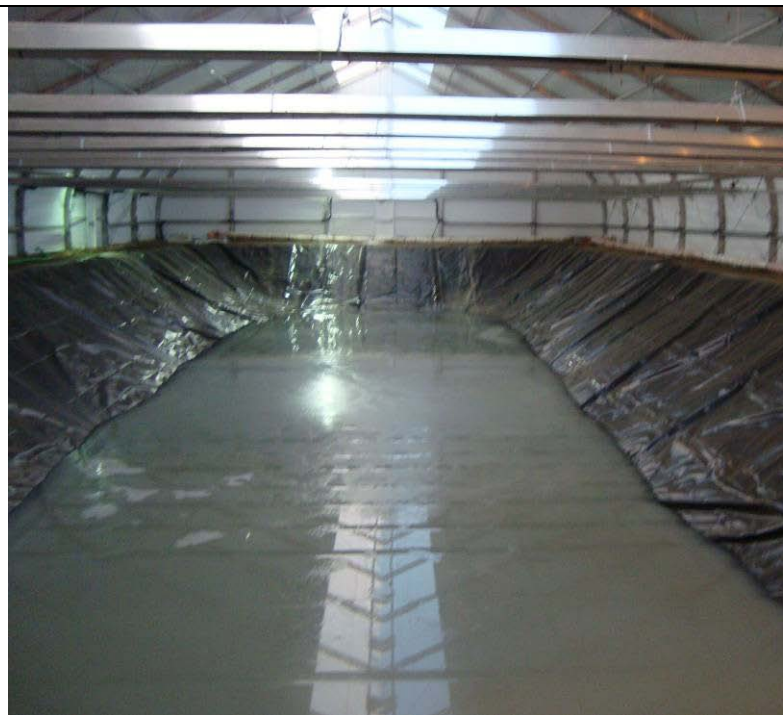
12-13-08 Pond #3 1/8 full with drill contacted water, milky suspended sediment ( facing N)

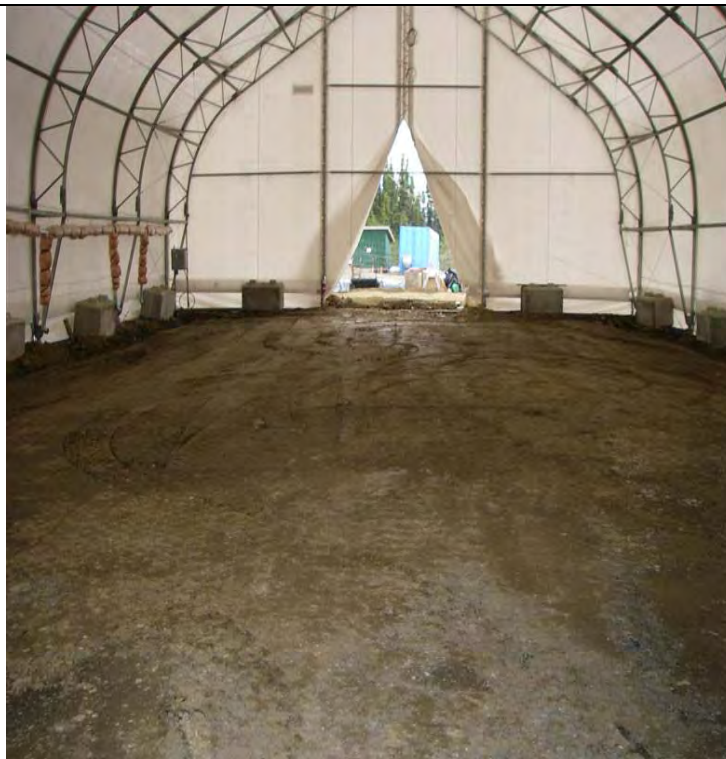
**Site Name: CDS**

**08/04/08 CDS filled and coverall graded looking SW**

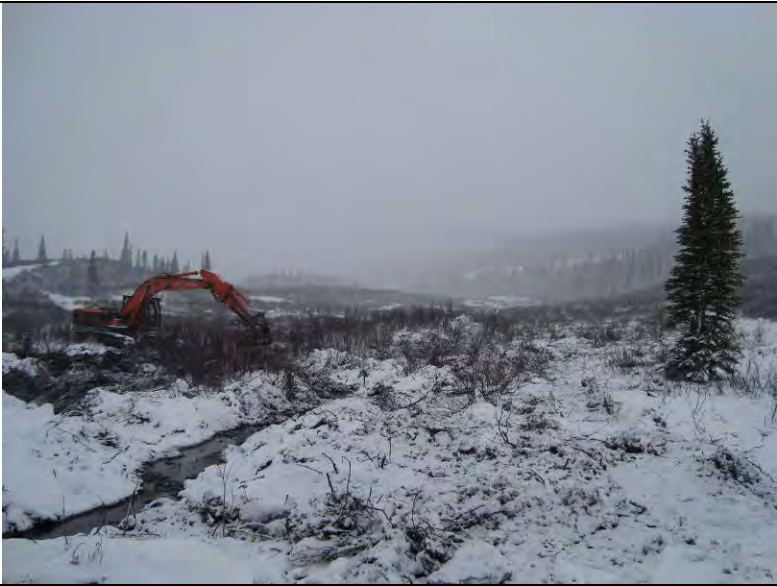
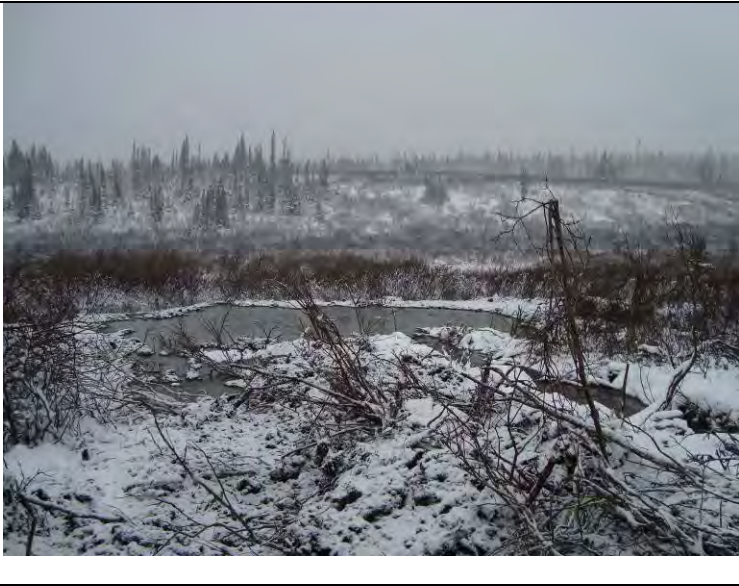
<p><b>10/23/08 South end central drainage (facing North from lower road)</b></p>	<p><b>10/23/08 Sediment control pool at south end of tailings area (facing south)</b></p>

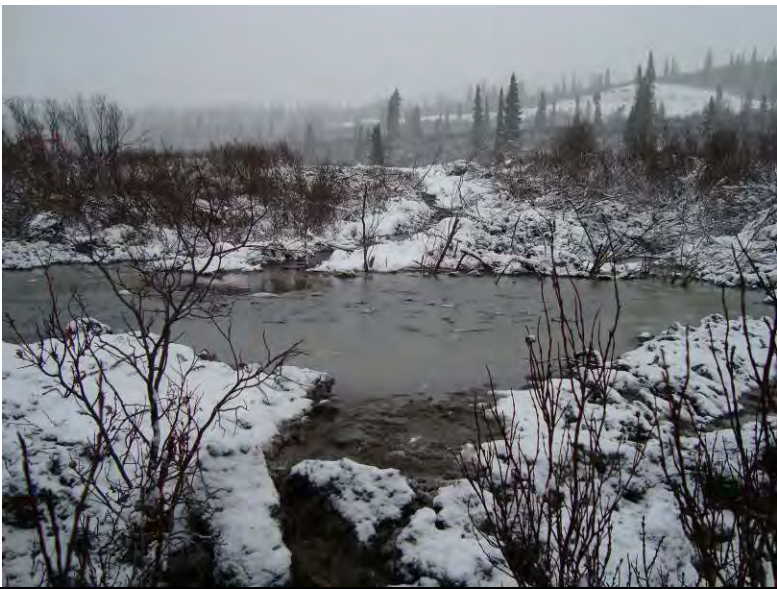
<p><b>10/23/08 Sediment control pool at south end of tailings area (facing North downstream of pool)</b></p>

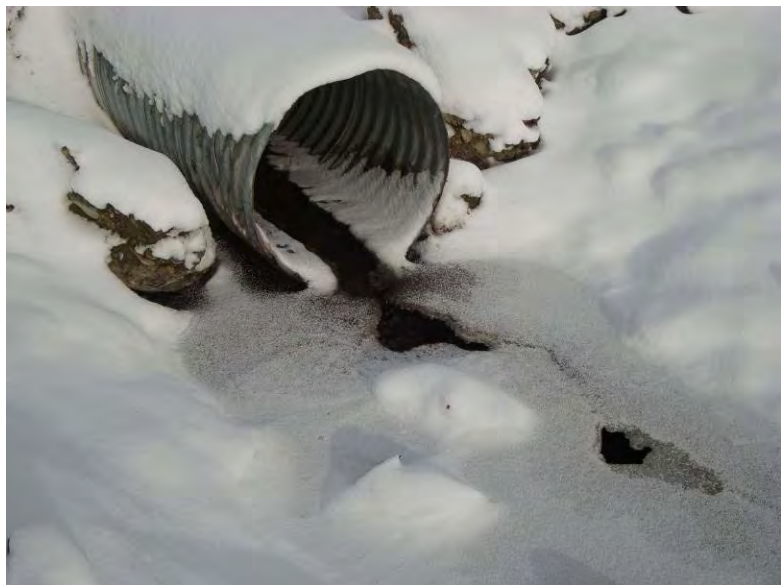
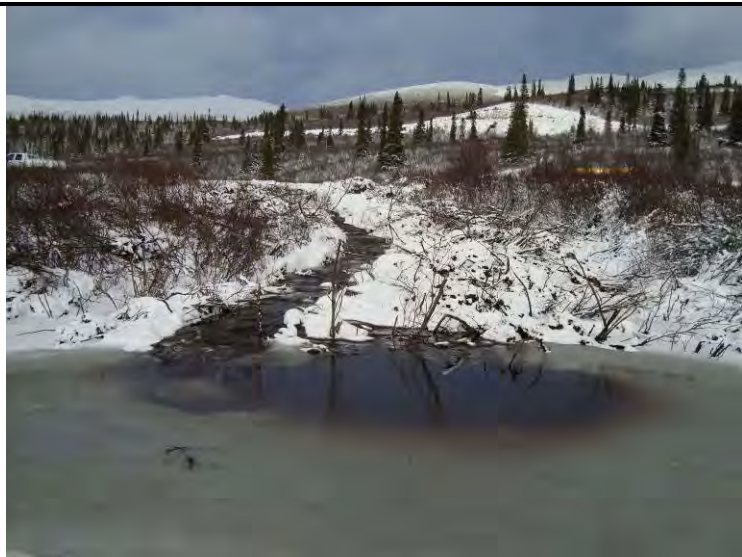
<p><b>10/24/08 sediment in water coming from southern culvert (downstream end)</b></p>	<p><b>10/24/08 Sediment trapping in sediment control pool (facing north)</b></p>

Samples Taken: none		
Additional Information Attached: none		
<b>Part 3 –Mitigation Requirements</b>		
Mitigation Required: Further mitigation to be determined once Ditch A diverts the majority of water source, may want to make adjustments to the sediment control sump or install silt fencing once flow has subsided		
Mitigation Condition: fair		
<b>Part 4 –Monitoring Requirements</b>		
Follow-up Monitoring: Monitor for sediment drainage into the wetland area and into Go Creek, monitor groundwater monitoring wells as per A-Licence (quarterly).		
Monitoring Frequency: Daily during periods of work on site		
Reporting Requirements: Weekly while construction/development continues

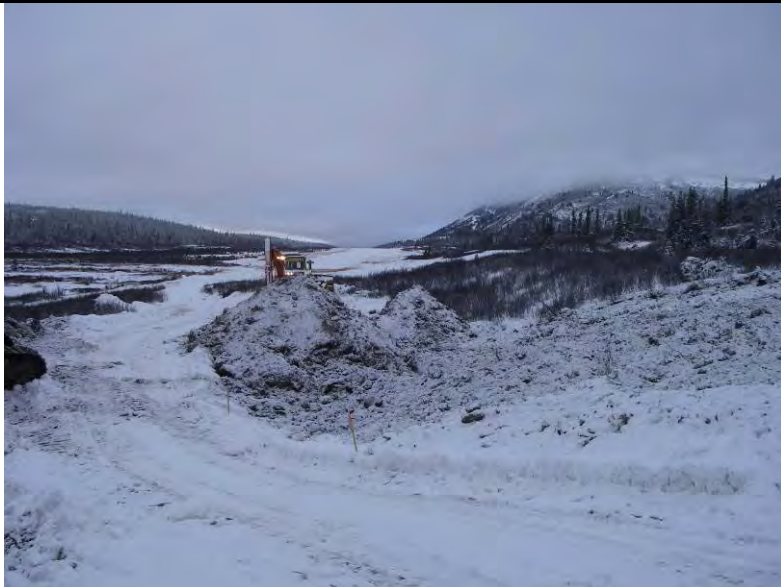
11-02-08 Stripping of Ditch A from 0+400 – 0+475 – facing N

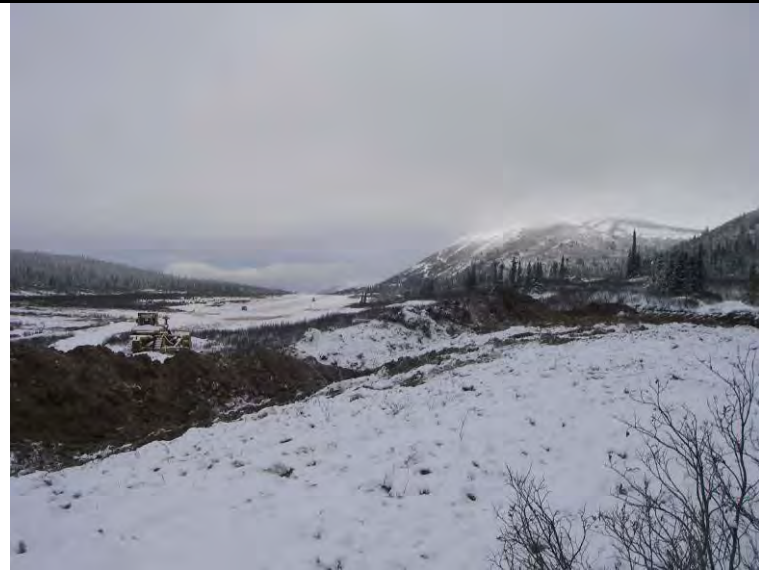
11-03-08 Stripping complete on Ditch A from 0+400 – 0+475 – facing NW

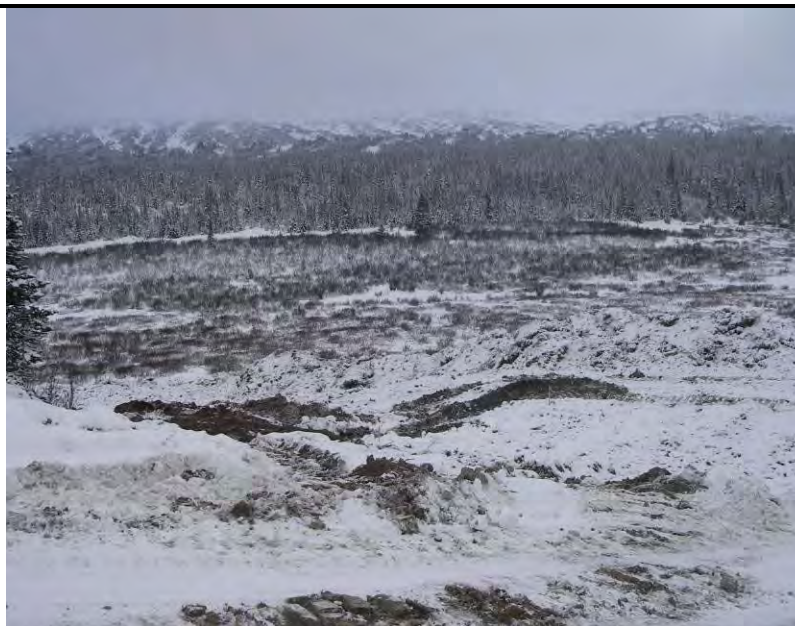
11-03-08 Stripping complete on Ditch A from 0+400 – 0+475 – facing SW

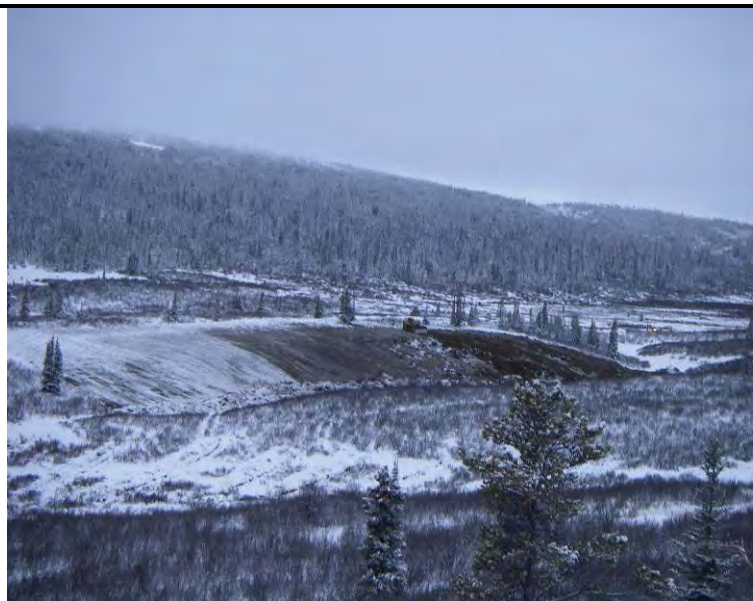
11-02-08 Stripping of tailings facility, upstream side – facing NW

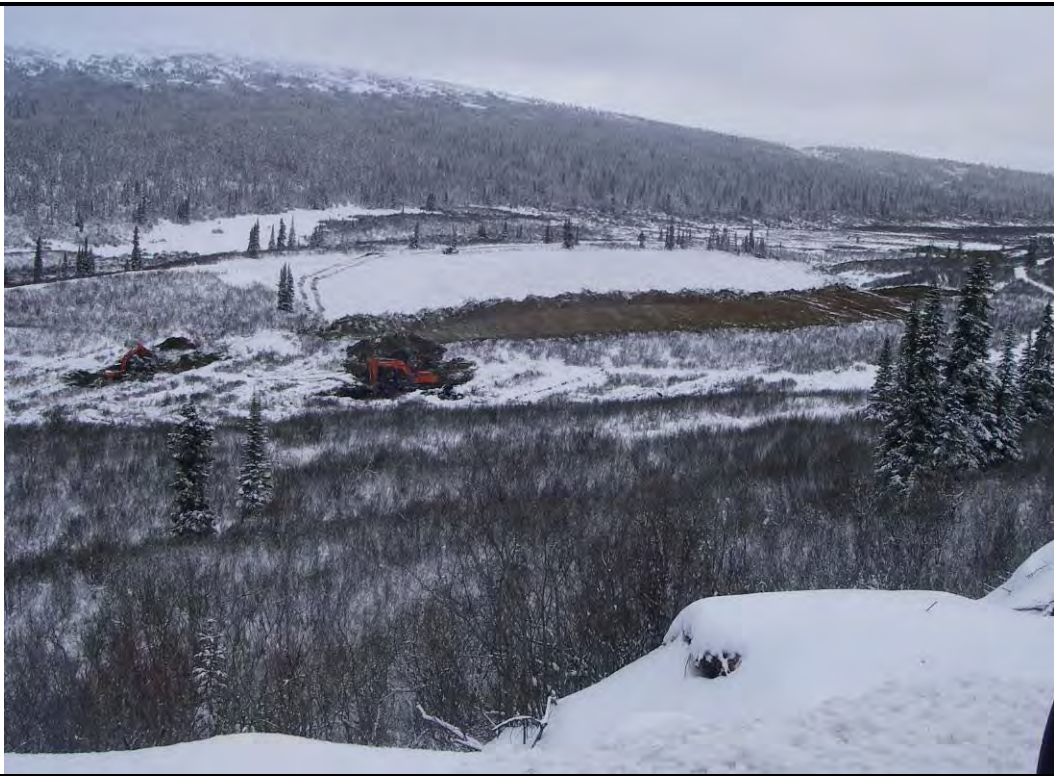
11-03-08 Stripping of tailings facility - facing W

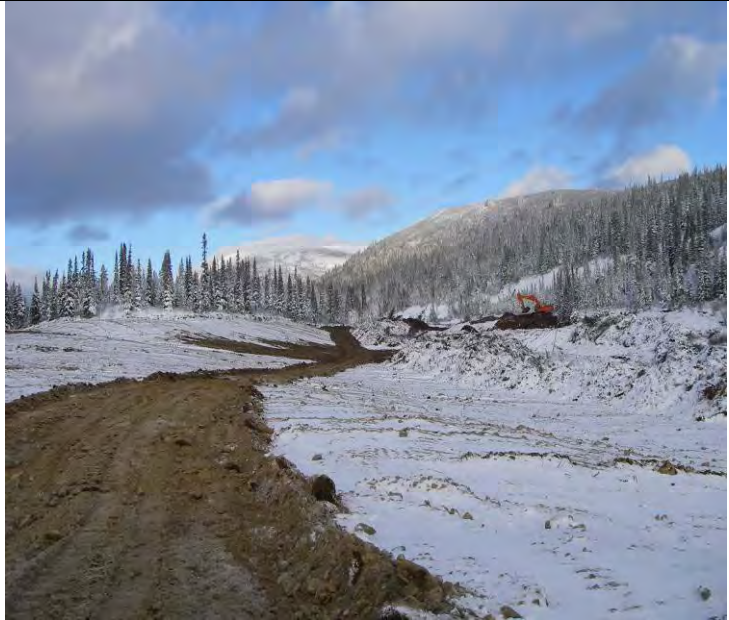
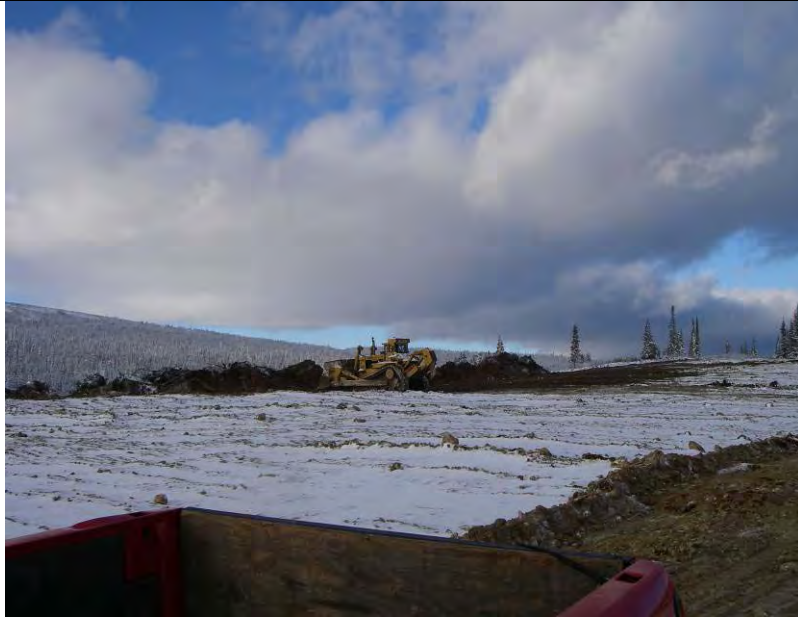
<p><b>11/07/08 Road access towards north end of tailings, 850 hoe casting strippings ( facing N)</b></p>	<p><b>11/07/08 Stripping west side of Tailings, building windrows for hauling (facing NW)</b></p>

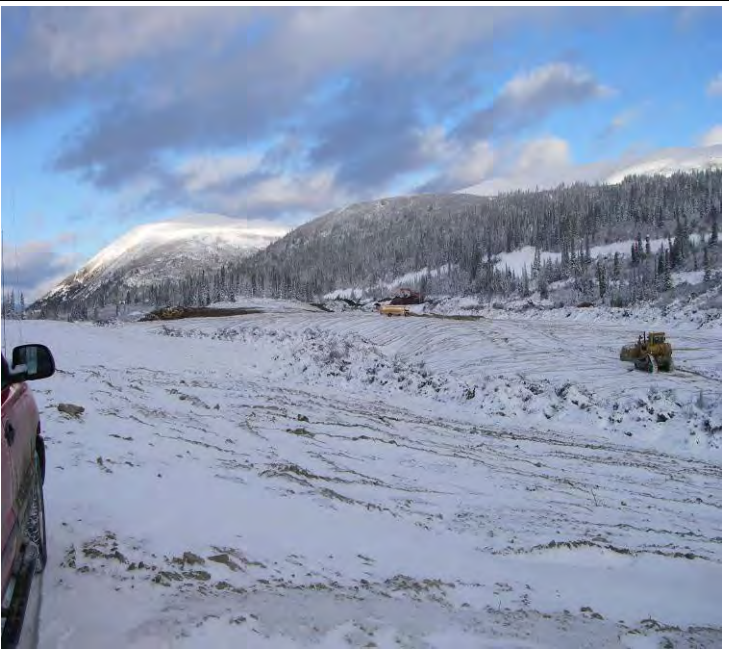
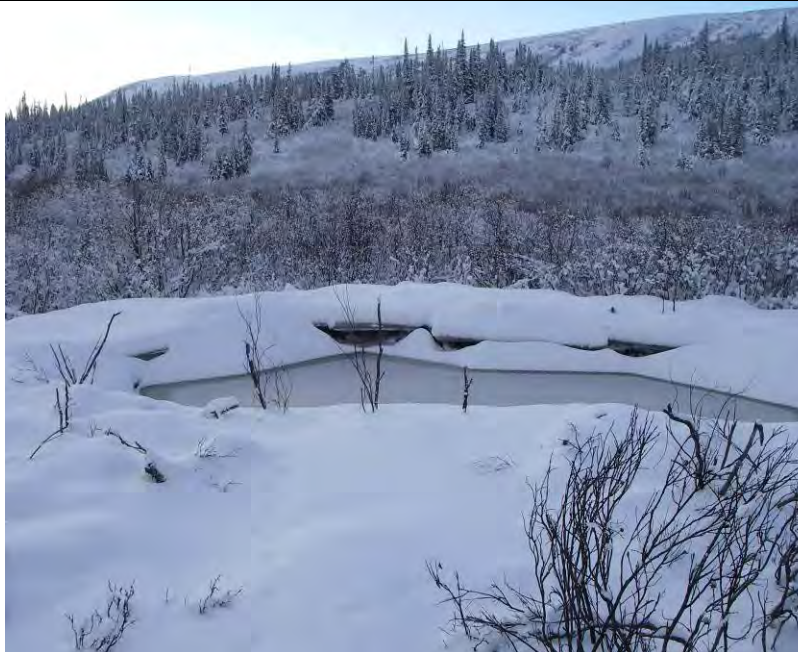
<p><b>11/07/08 Windrowed stippings at valley bottom for hauling to organic stockpiles</b></p>	<p><b>11/07/08 Sediment control pool at south end of tailings area, water beneath ice running clear (facing south)</b></p>

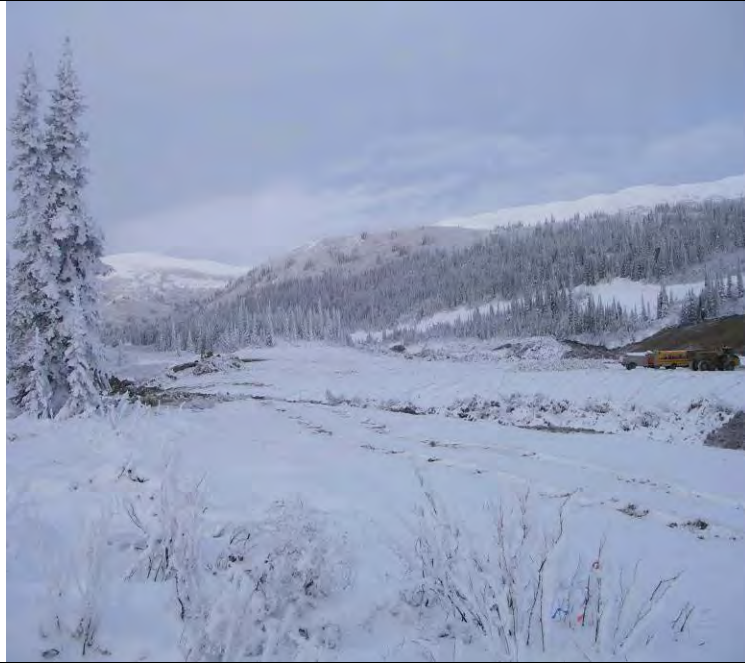
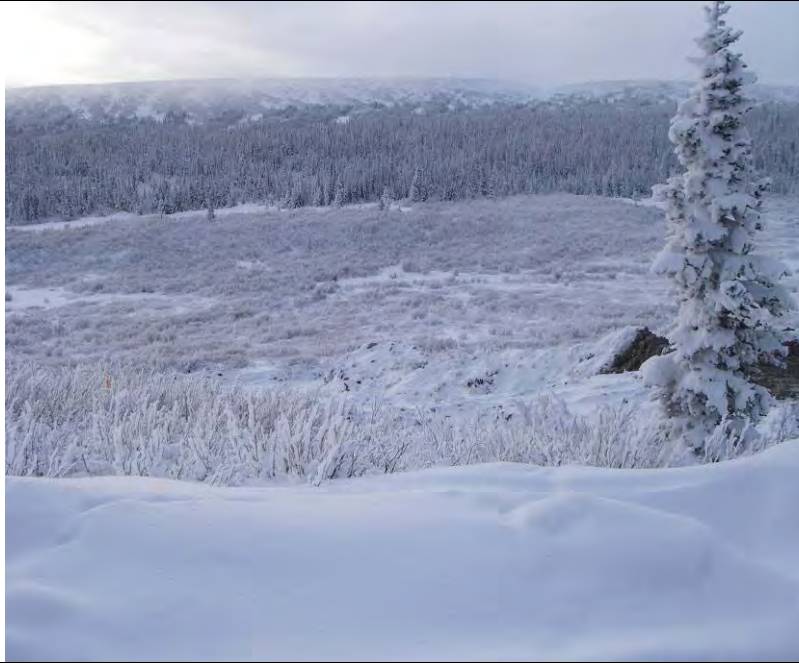
<b>11/11/08 Road access towards north end of tailings ( facing SE)</b>	<b>11/11/08 Northern Strippings location west side of Tailings, (facing NW)</b>

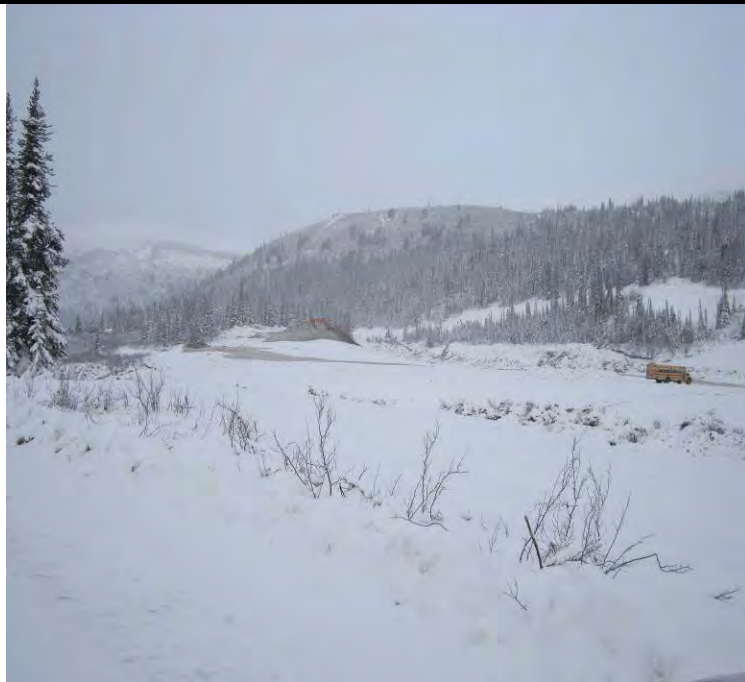
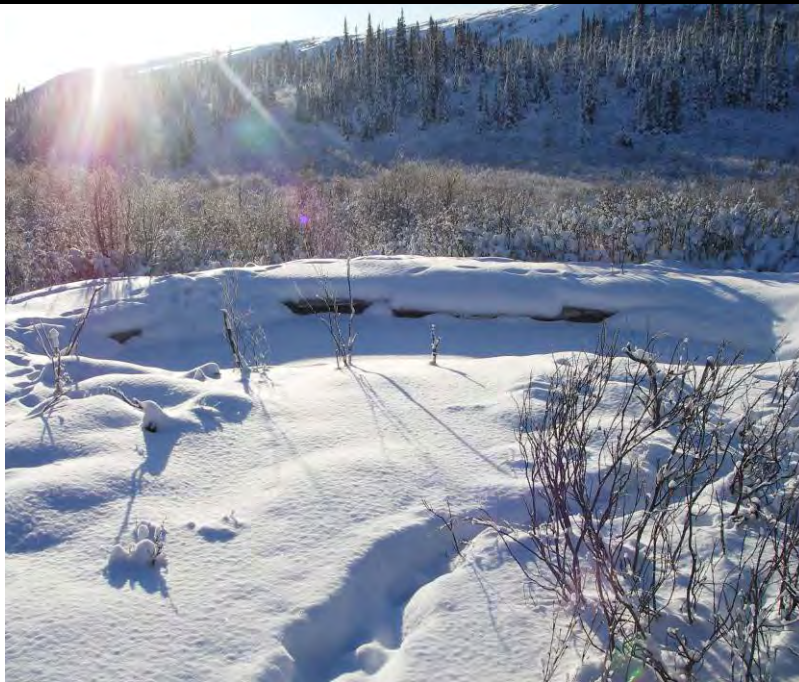
<b>11/15/08 Windrowed stippings at valley bottom for hauling to organic stockpiles, 850 Hoe in background starting on Ditch A (facing NE)</b>	<b>11/16/08 Sediment control pool at south end of tailings area (facing SW)</b>

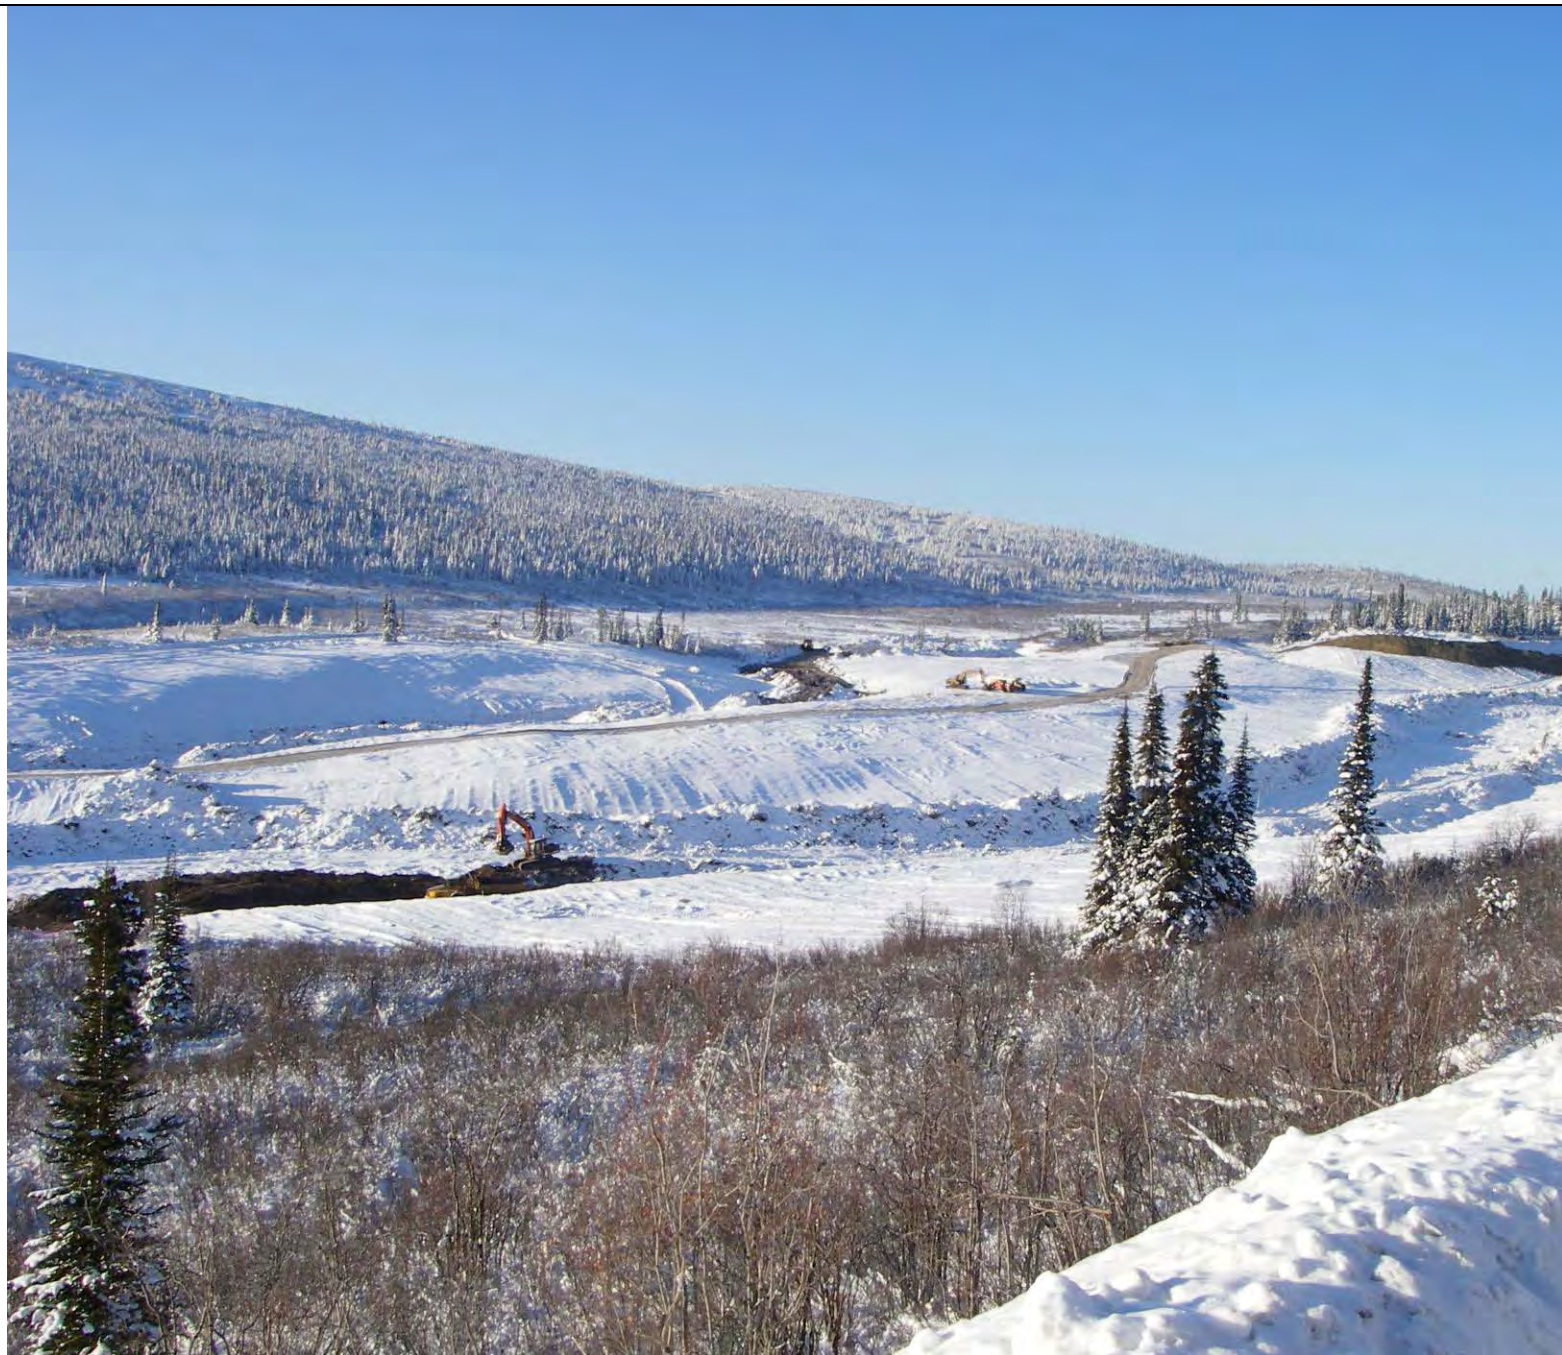
**11/16/08 Overall layout of Tailings, Ditch A work to far right, Northern Stockpile hauling in center background with Northern Stockpile hauling in foreground to the left. Notice windrows of strippings (facing SE)**

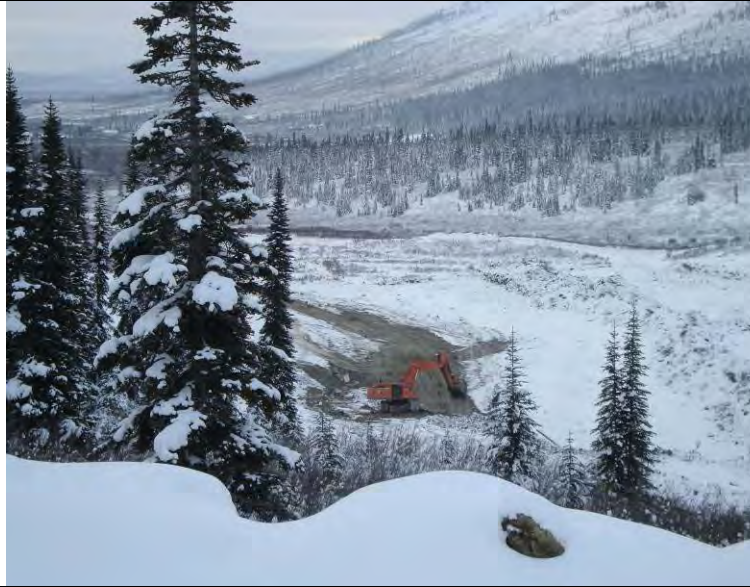
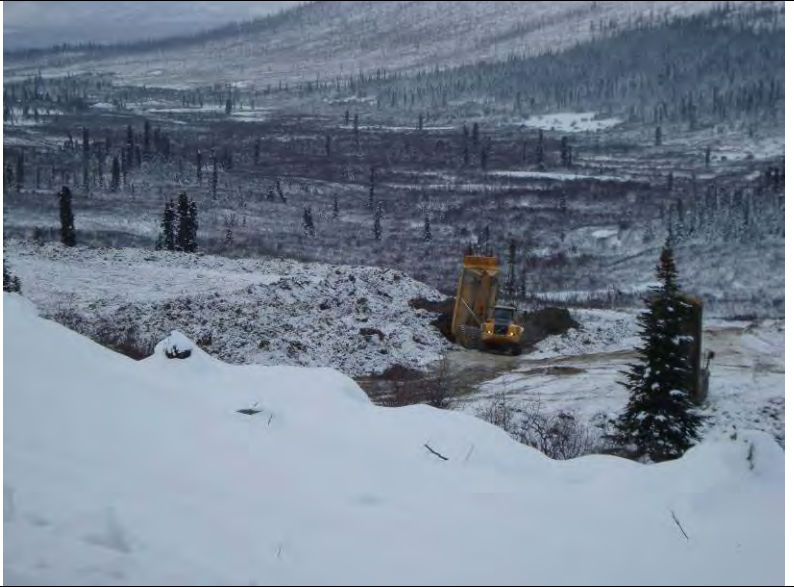
<b>11/21/08 Hoe piling organics for hauling ( facing South)</b>	<b>11/21/08 South strippings stockpile (facing SW)</b>

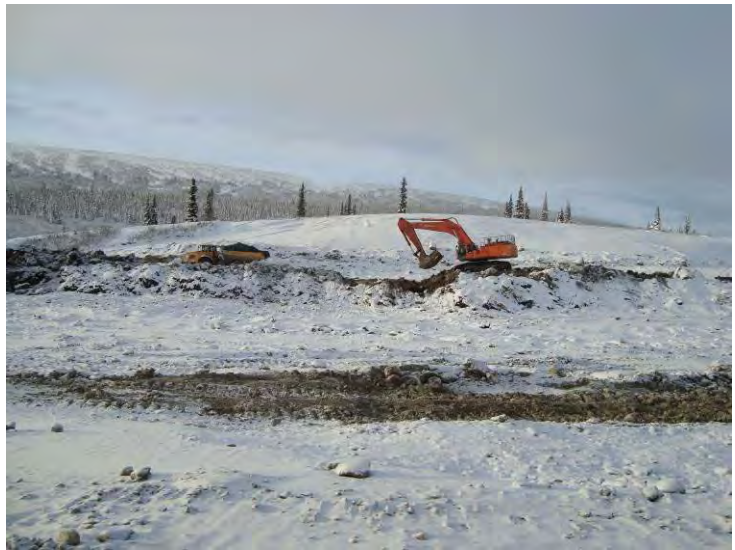
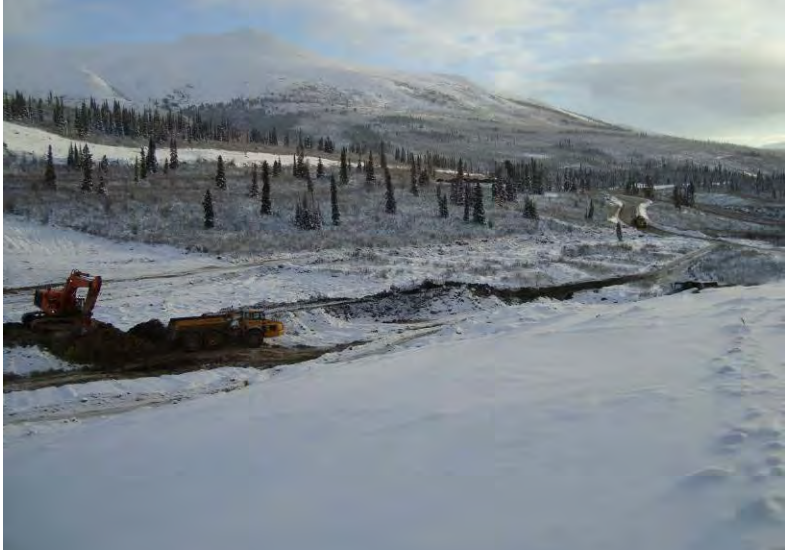
<b>11/22/08 Loading of rock trucks for organics haul (facing West)</b>	<b>11/22/08 Left side of picture showing loading, haul road along right hand side (facing SE)</b>

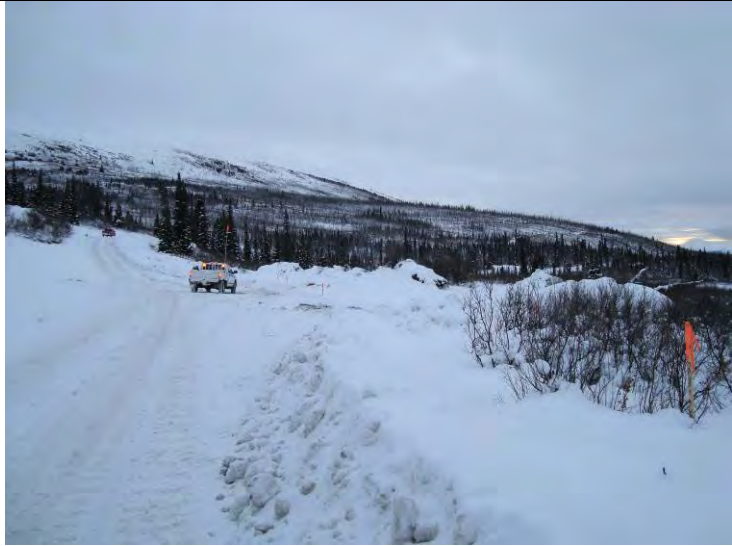
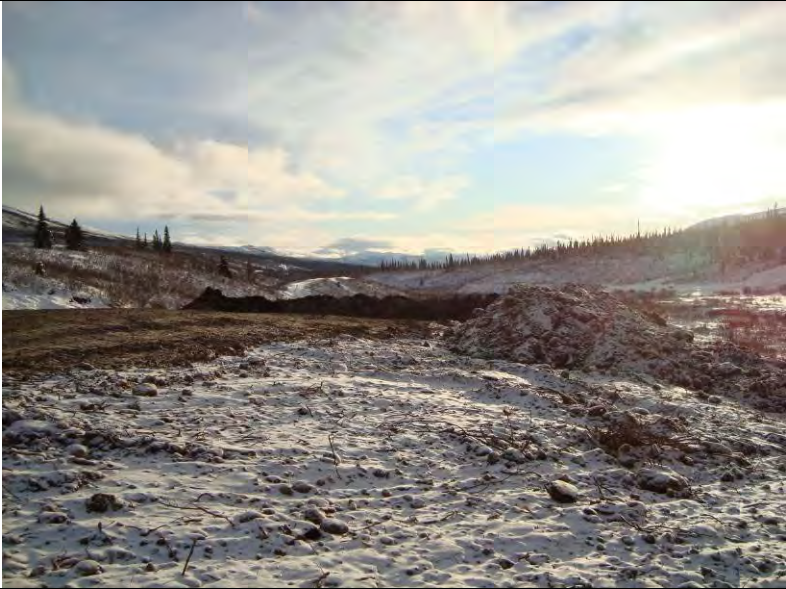
<p><b>11/27/08    Flagging showing alignment of access road into the tailings from south ( facing SE)</b></p>	<p><b>11/27/08    North strippings stockpile (facing S)</b></p>

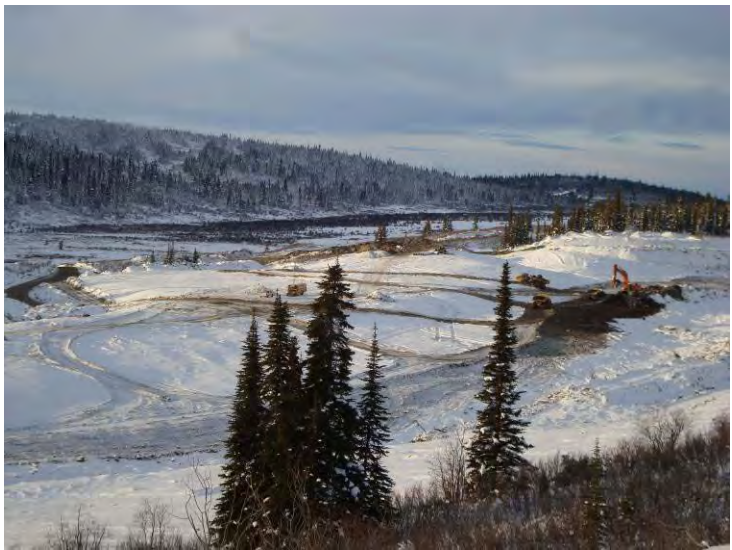
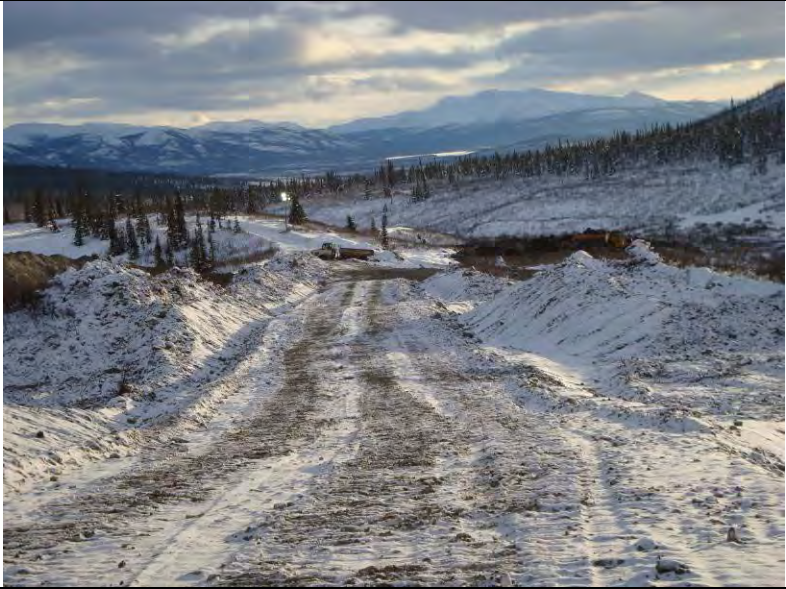
<p><b>11/29/08    Loading of rock trucks for organics haul (facing NW)</b></p>	<p><b>11/29/08    Northern Ditch A access road from Arctic Camp (facing S)</b></p>

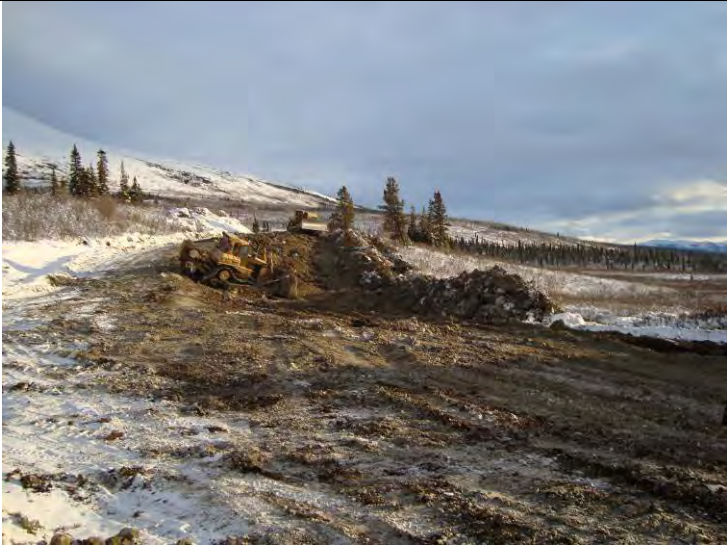
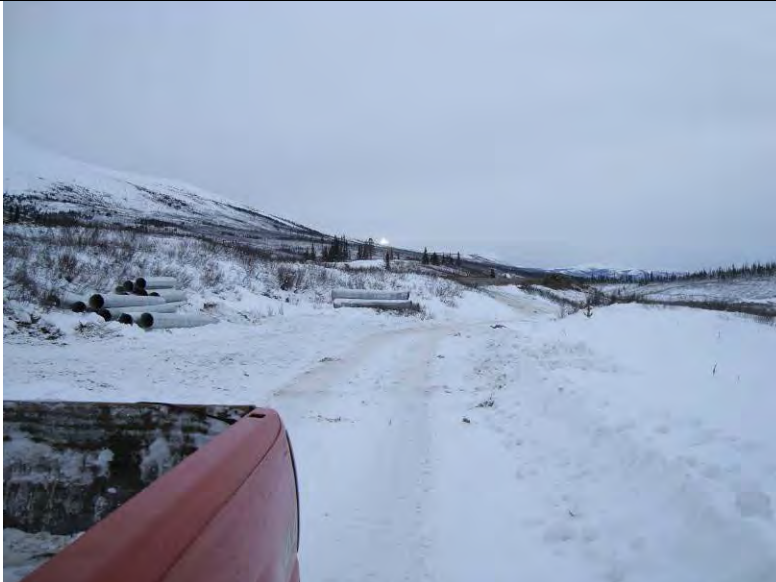
<b>11/29/08 Stripping of southern tailings access road (facing SE)</b>	<b>11/30/08 Culverts where proposed 3<sup>rd</sup> stockpile location if needed (facing S)</b>

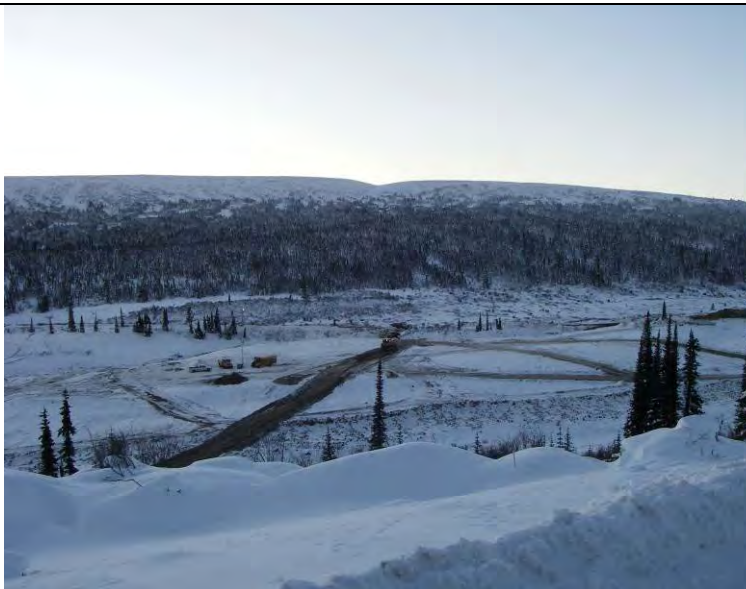
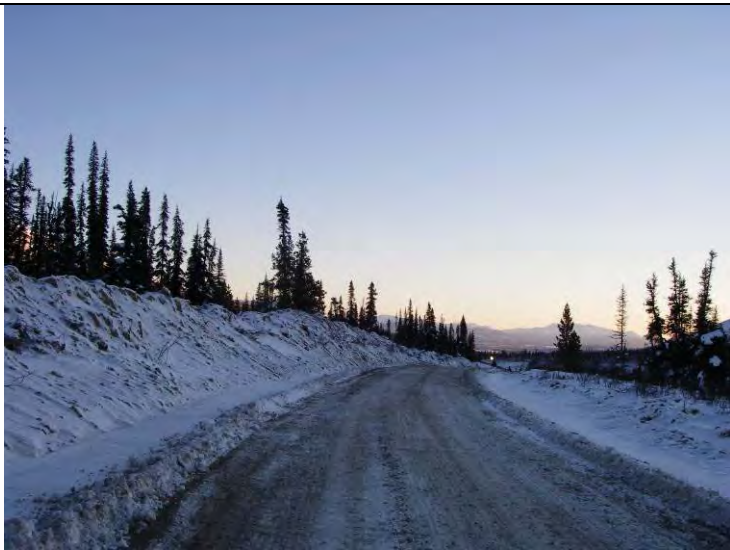
<p><b>12/02/08 Load and haul for organics haul to north stockpile (facing NW)</b></p>	<p><b>12/02/08 Construction access road to Ditch A (facing S)</b></p>

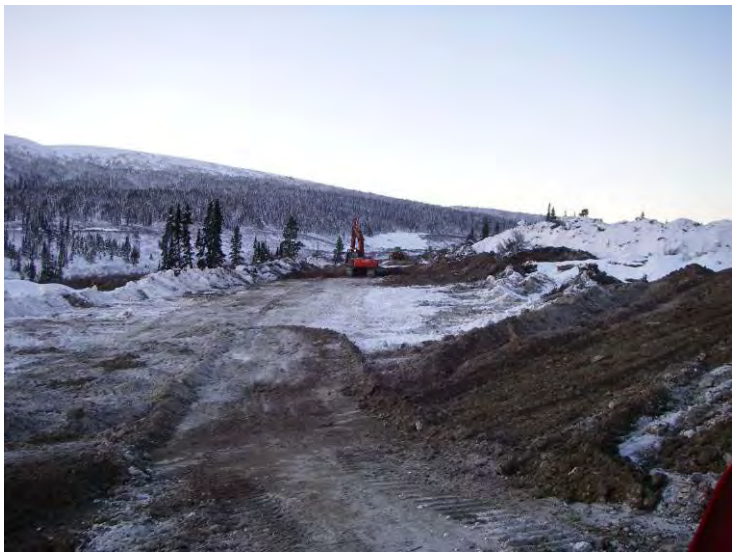
<p><b>12/02/08 Clearing for southern access road 23+000-23+800 (facing NW)</b></p>	<p><b>12/02/08 Stockpile N1 (facing S)</b></p>

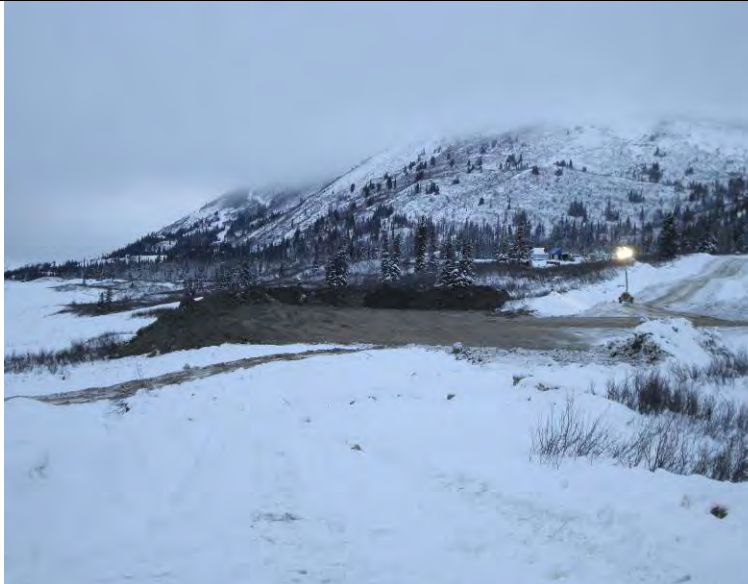
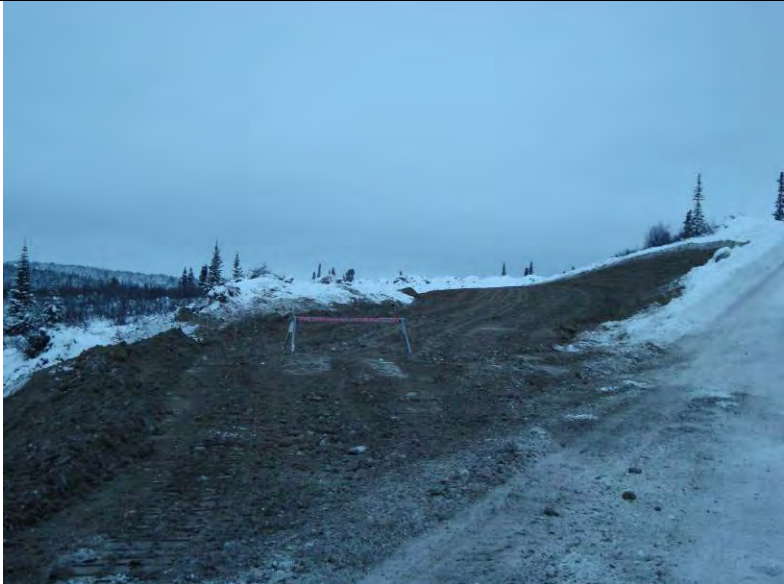
<b>12/06/08 Third stockpile for organics (facing N) Arctic construction camp in back right</b>	<b>12/06/08 southern access road (facing NW)</b>

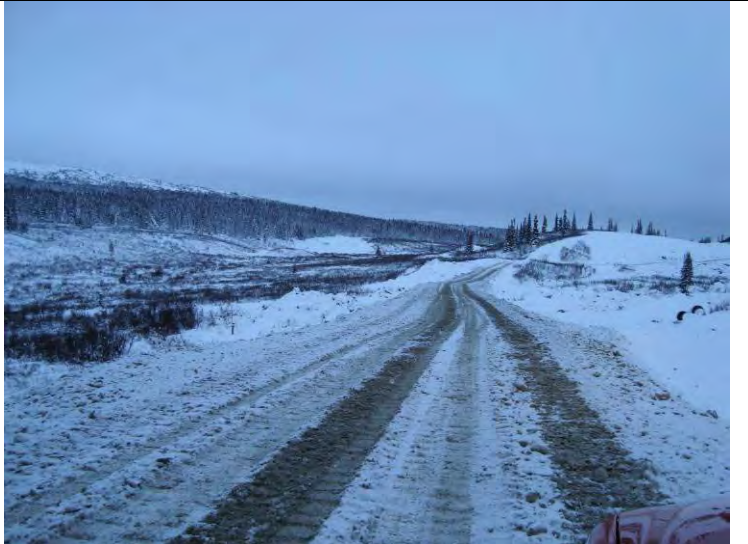
<b>12/06/08 southern access road (facing NW)</b>
