## **Wolverine Project**

**QUARTZ MINING LICENSE QML-0006**

**2008 ANNUAL REPORT**

**Prepared by:  
Yukon Zinc Corporation  
Vancouver, British Columbia**

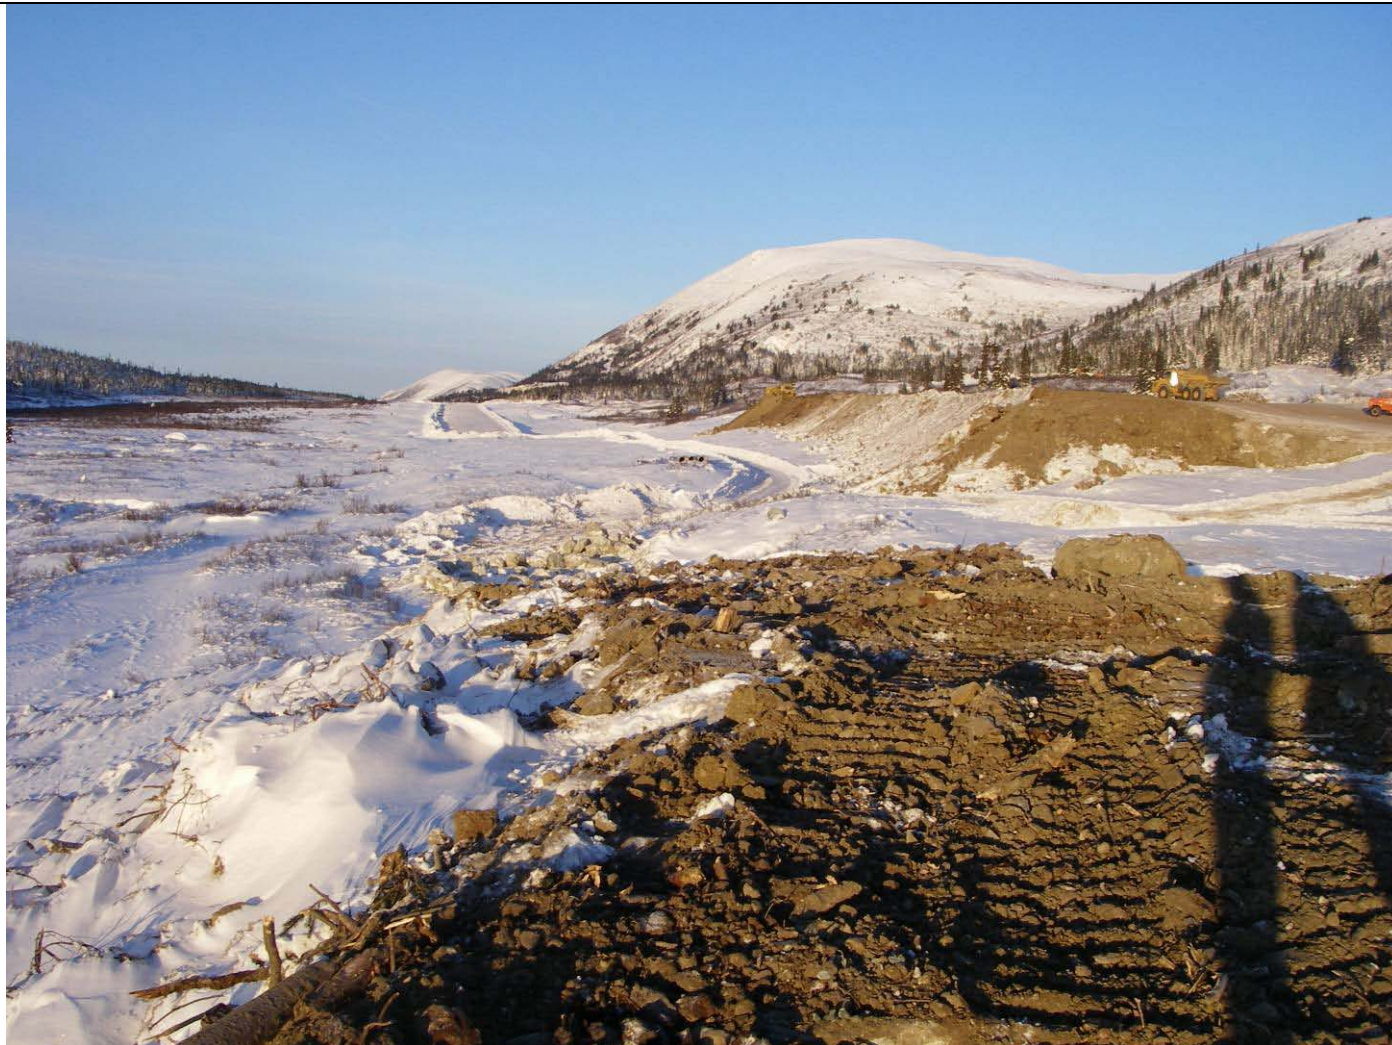
**12/15/08 End of Northern Stockpile Limit at location C, extended Dec 11, 2008. Slopes will be rounded slightly and sloped back. (Facing N)**

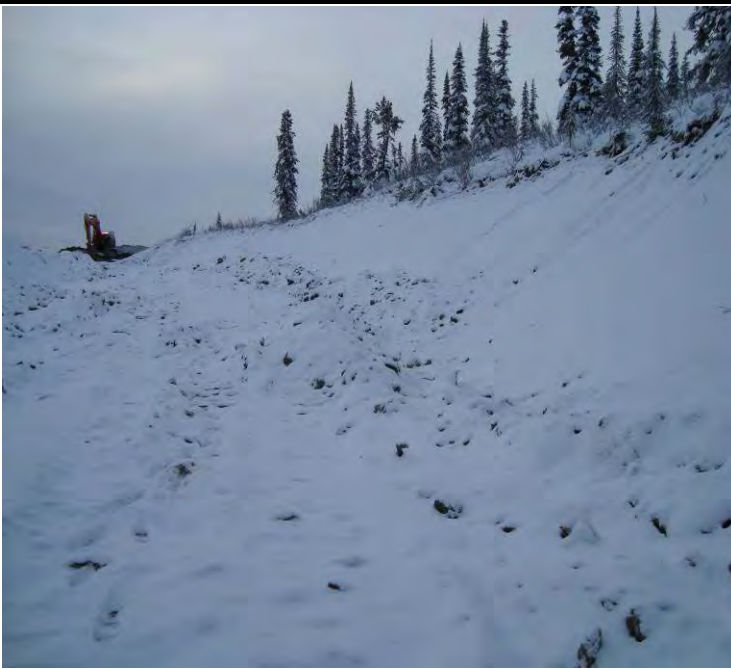
<p><b>11/15/08 Rough grading of ditch A at 0+150m (facing SW)</b></p>	<p><b>11/16/08 View of Ditch A work up to 0+200m, large piles stockpiled for dam material (facing W)</b></p>

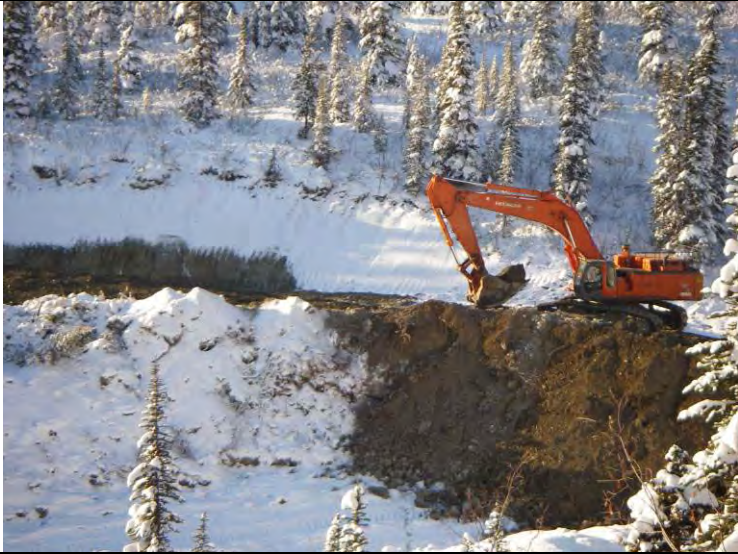
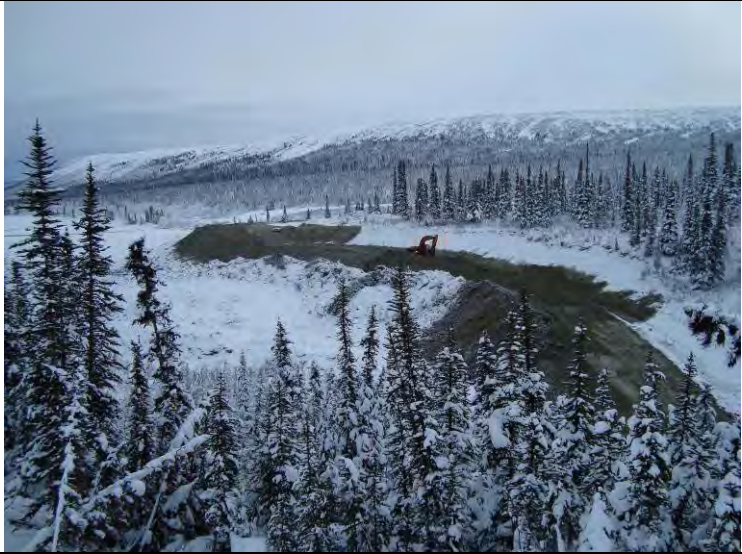
<p><b>11/16/08 850 Hoe working on fine ditch work at 0+050m (facing NE)</b></p>	<p><b>11/17/08 Ditch A rough grading up to 0+225m (facing W)</b></p>

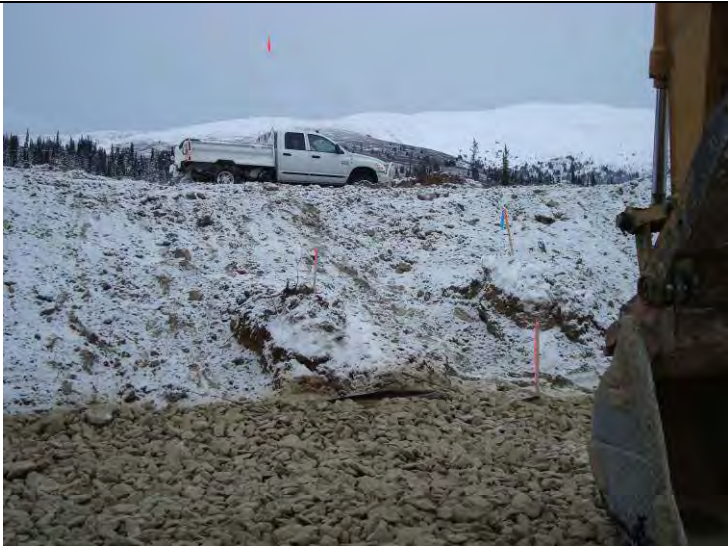
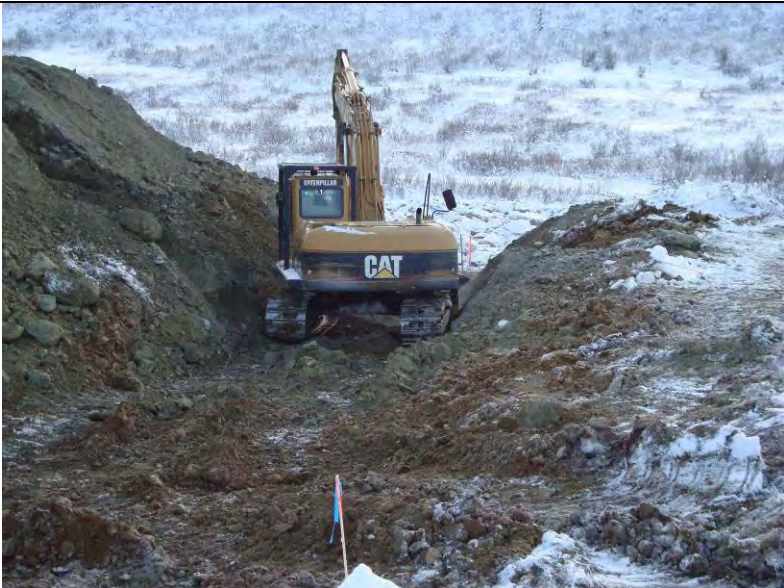
<b>11/23/08</b> Stakes on bank indicating where culvert will enter the stilling basin (facing E)	<b>11/24/08</b> Start of ditching for culvert install at SW end of Ditch A (facing W)

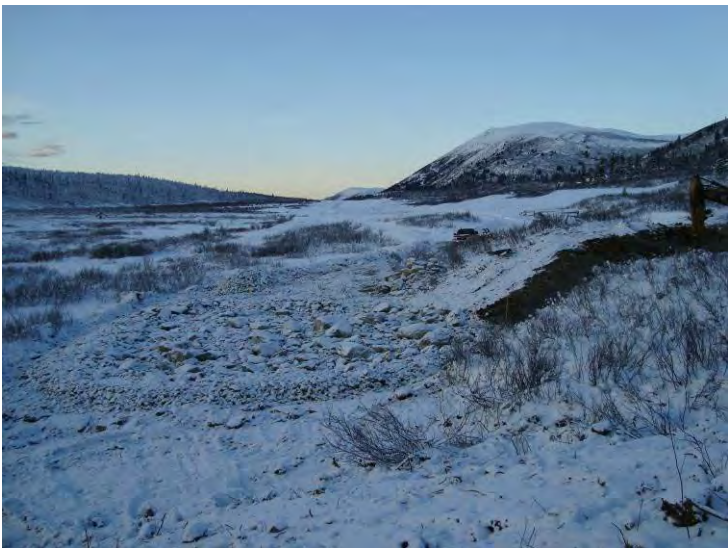
<b>11/24/08</b> Completed stilling basin (facing N)	<b>11/24/08</b> Start of ditch A access road from Arctic camp approx. 200m (Facing S)

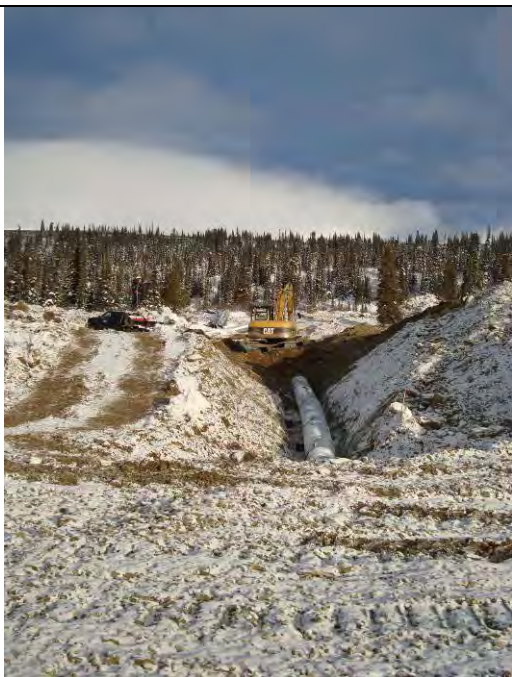
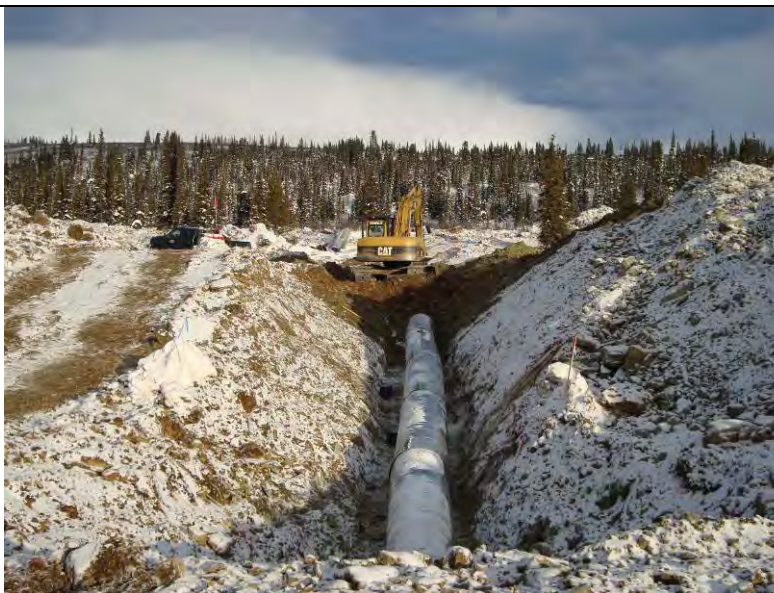
<p><b>Site Name: Ditch A</b></p>

<p><b>11/27/08 Ditching and culvert installation (facing E)</b></p>	<p><b>11/27/08 Ditching and culvert installation (facing E)</b></p>

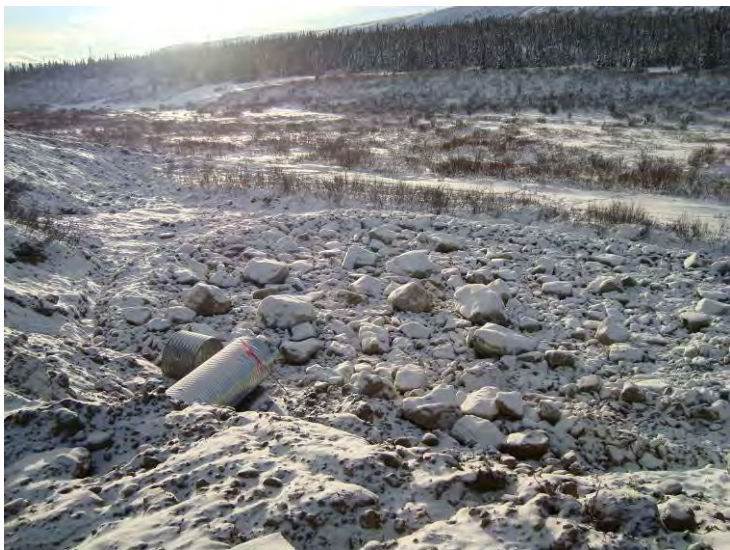
<p><b>11/27/08 Completed stilling basin with culvert opening (Facing SW)</b></p>	<p><b>12/01/08 NE culvert opening (upslope end) from open ditch (Facing E)</b></p>

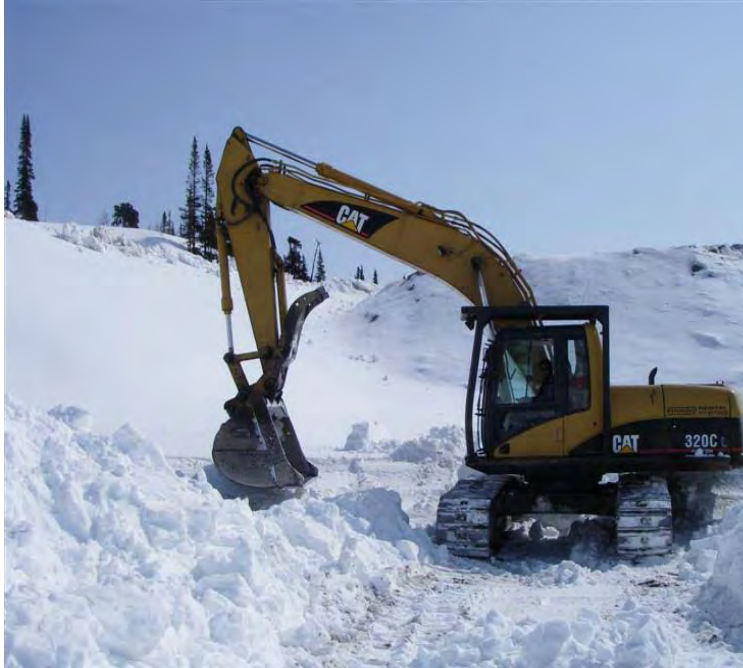
04/24/08 WRP snow clearing for berm placement

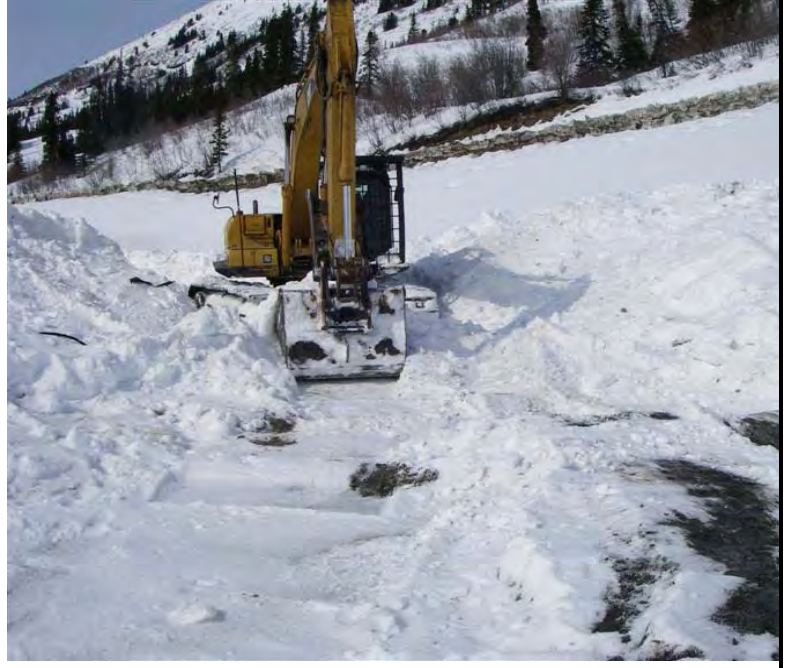
04/24/08 WRP snow clearing for berm placement

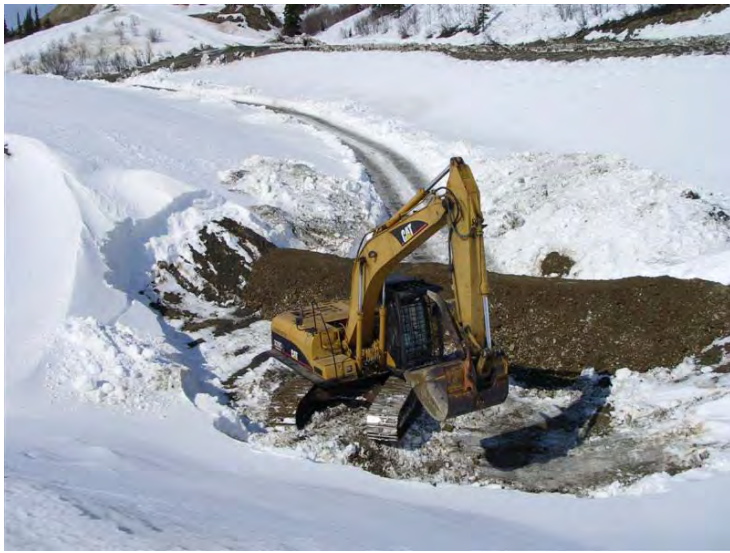
04/24/08 WRP berm being compacted and shaped

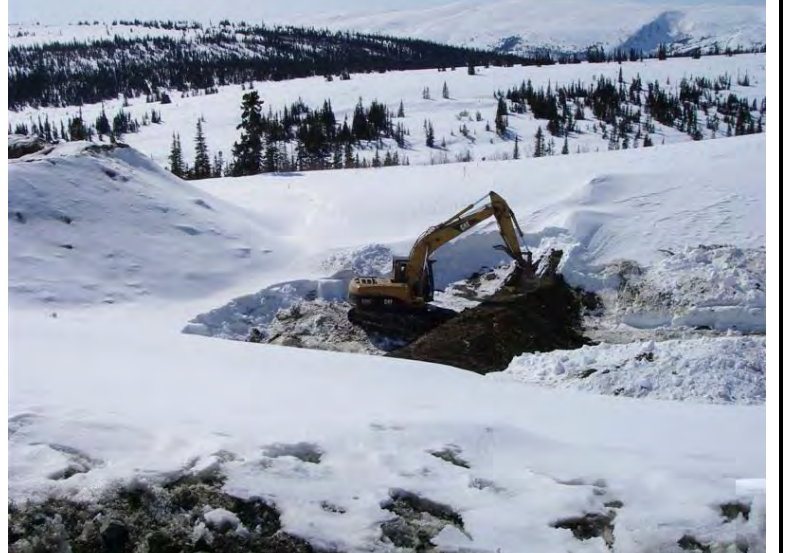
04/24/08 WRP berm being compacted and shaped

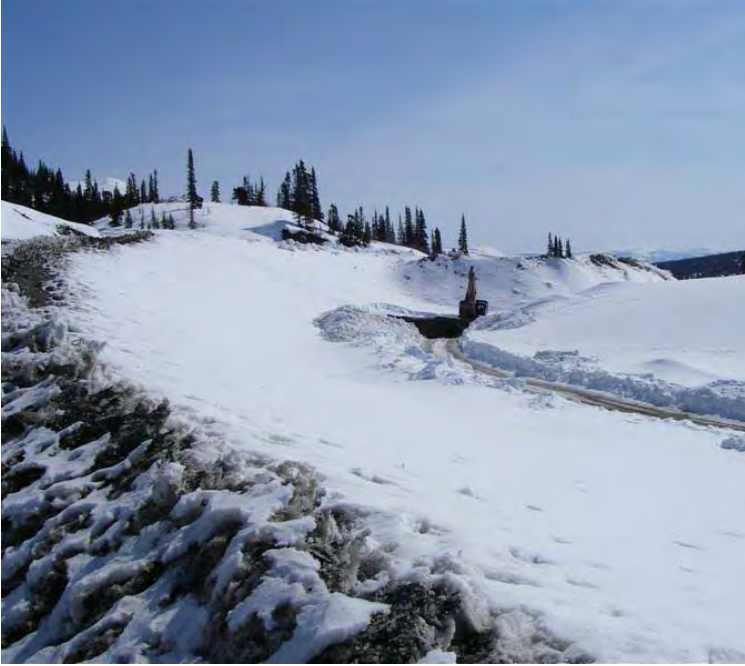
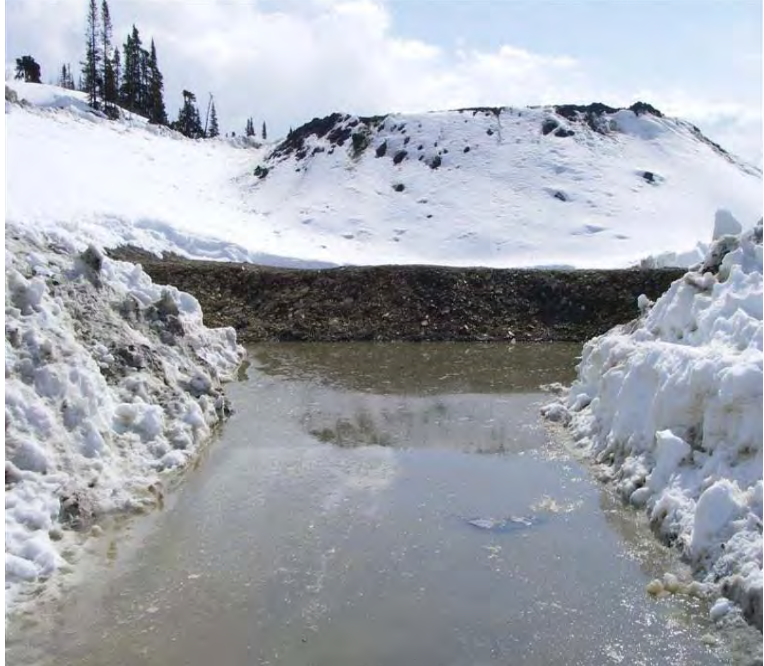
Site Name: WRP

04/24/08 WRP berm building	04/28/08 WRP berm complete separating Impacted and non – impacted water

Mitigation Required: Pump out water to water truck and to ponds for treatment if test results show water is contaminated. If water meets discharge requirements then we will discharge to the vegetation over the western edge of the WRP.	
Mitigation Condition: F	
<b>Part 4 –Monitoring Requirements</b>	
Follow-up Monitoring: Watch for slumping of earthen dyke and watch water levels	
Monitoring Frequency: Daily, during rain events or when mitigation applied	
Reporting Requirements: QMLU-0006, QZ01-051

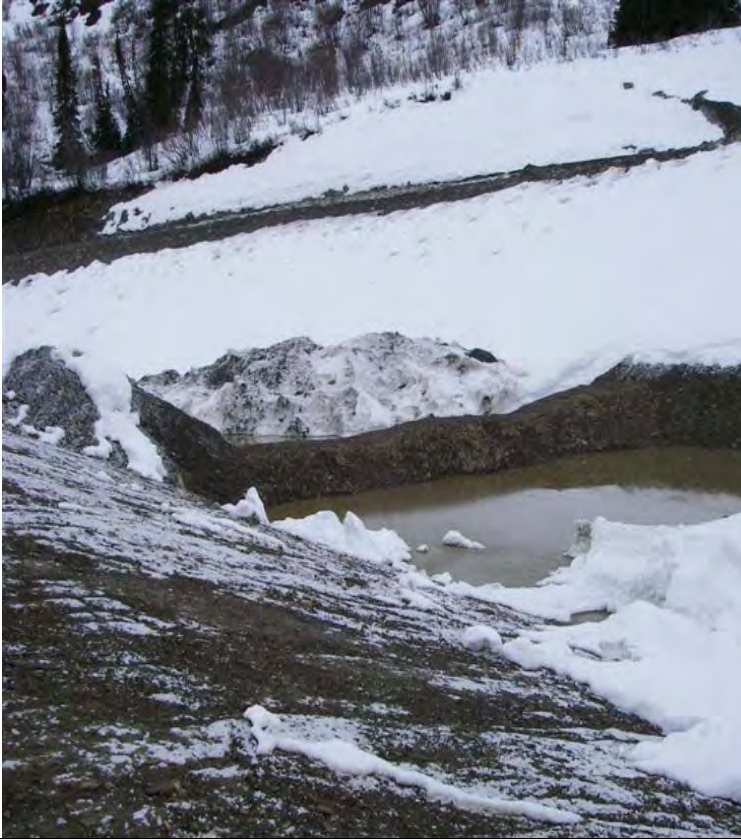
05/01/08 WRP looking Northeast

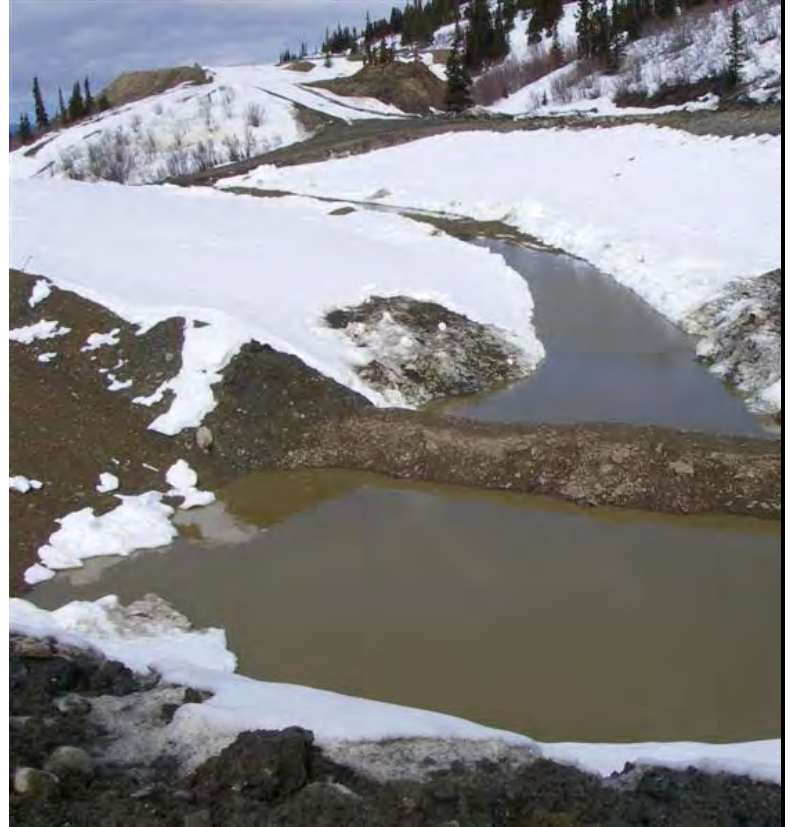
05/02/08 WRP berm looking North

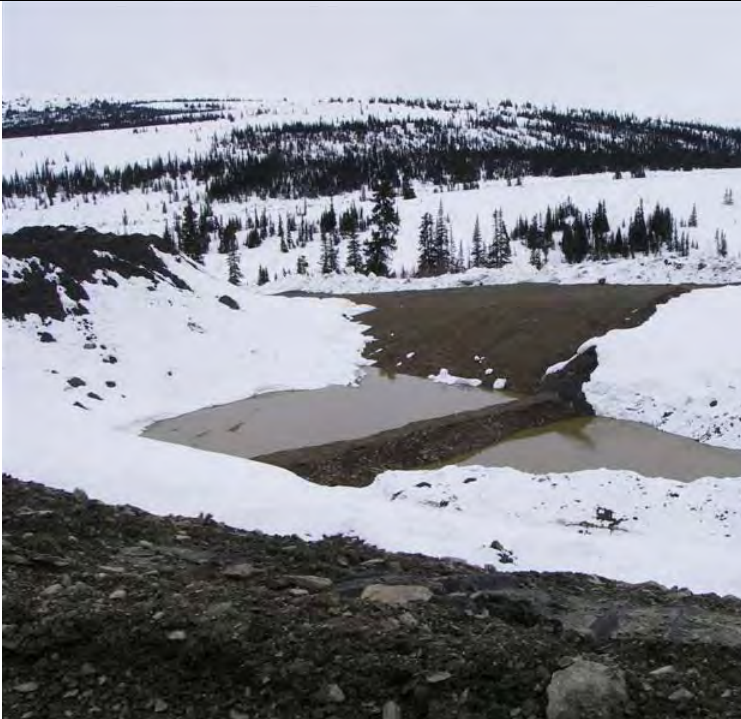
05/03/08 WRP berm looking west

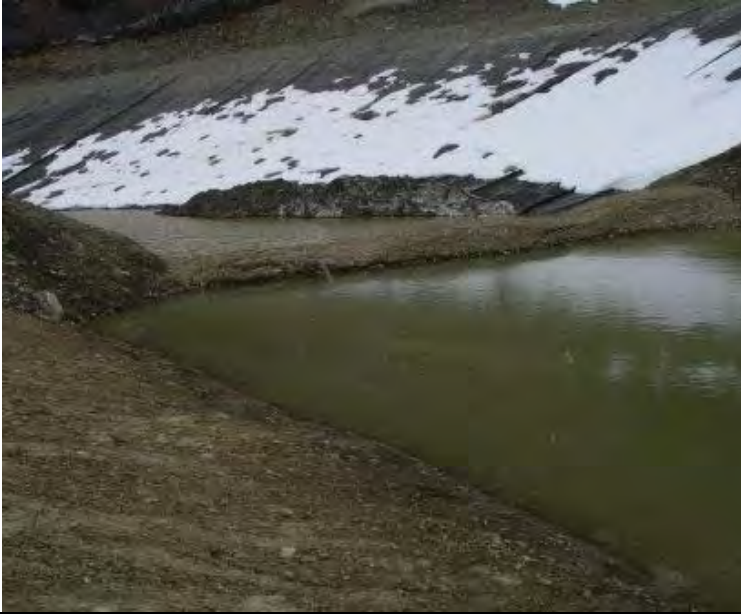
05/15/08 WRP looking Northeast

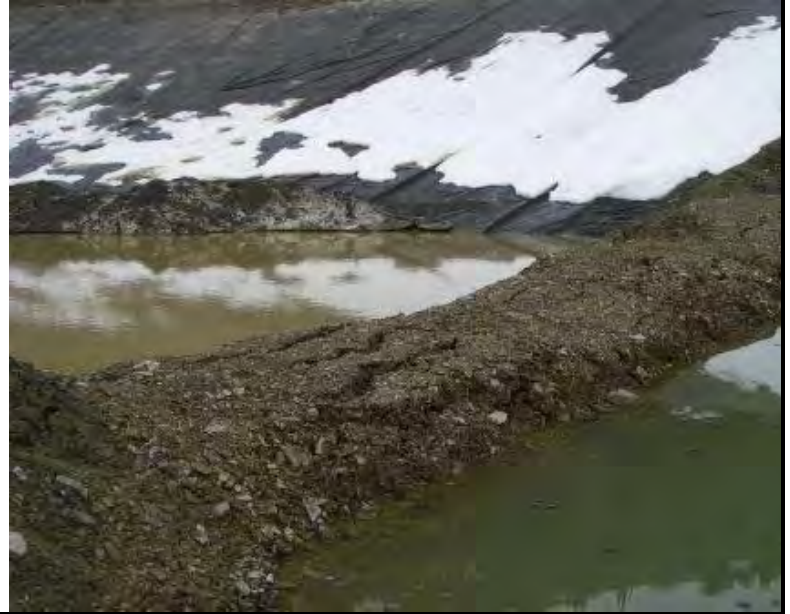
05/17/08 WRP berm looking Northeast

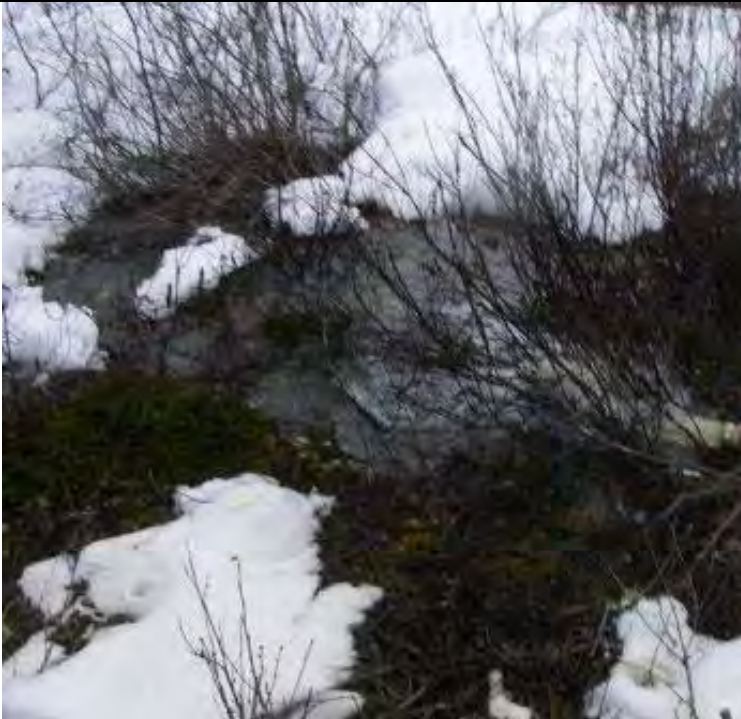
05/18/08 Disposal of WRSS1B into vegetation

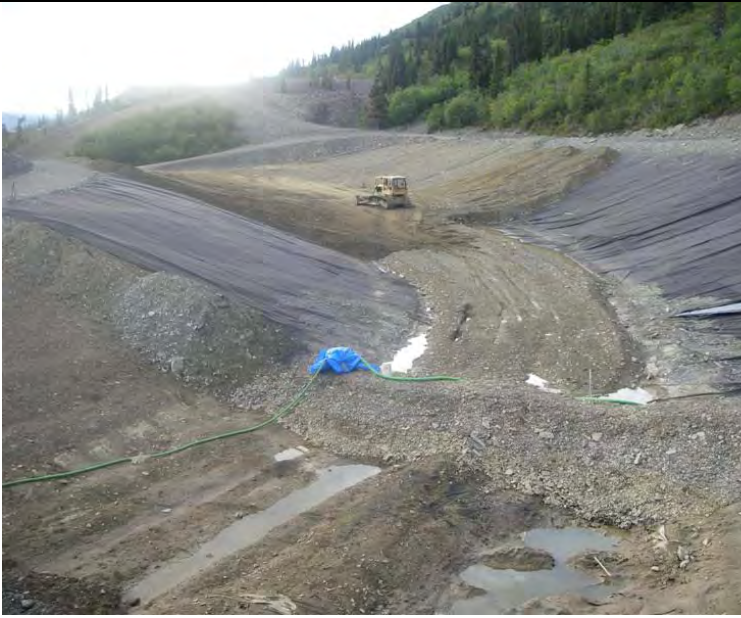
08/14/08 Looking NW

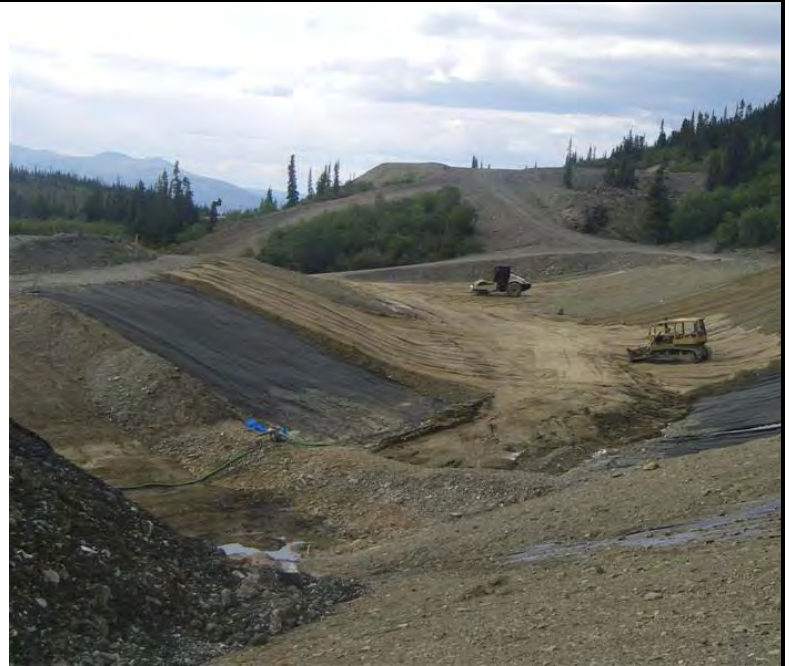
08/15/08 Looking NW

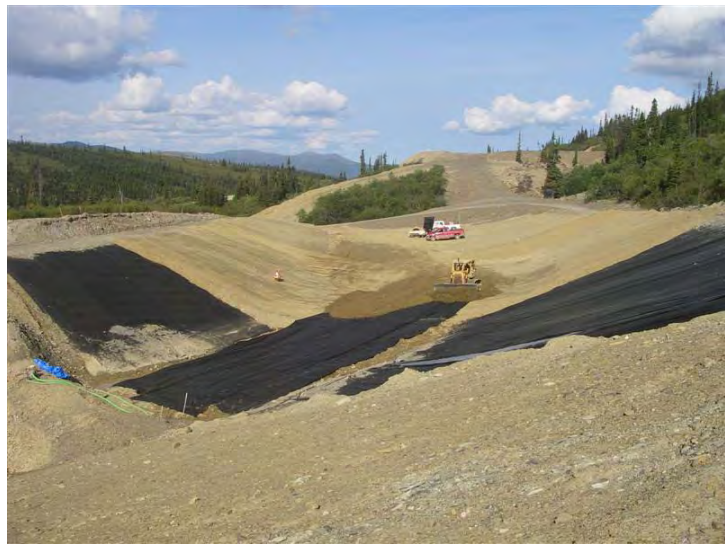
08/16/08 Looking NW

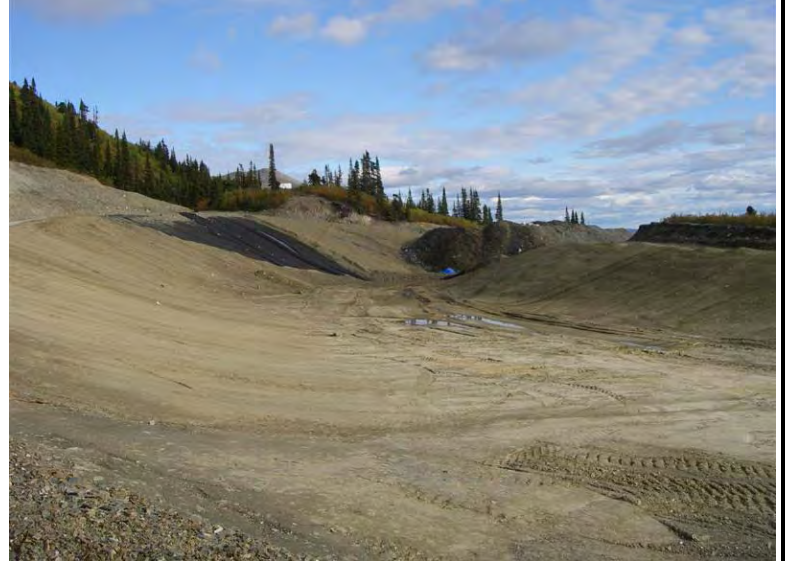
09/01/08 section not lined looking SE

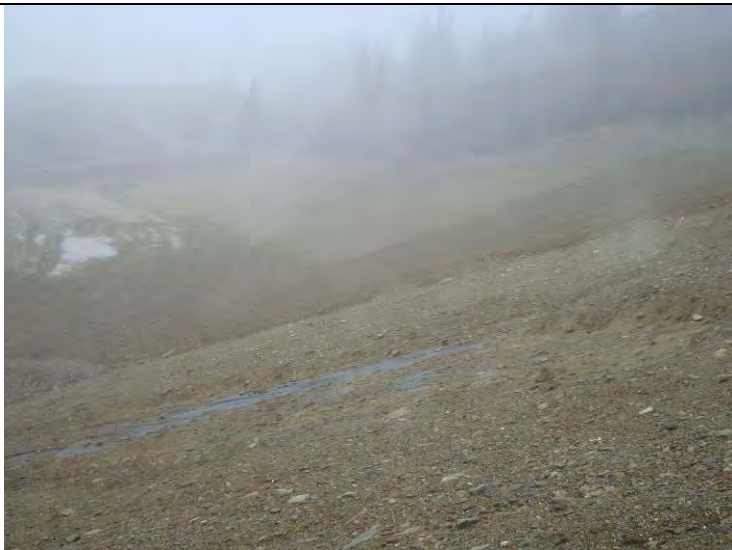
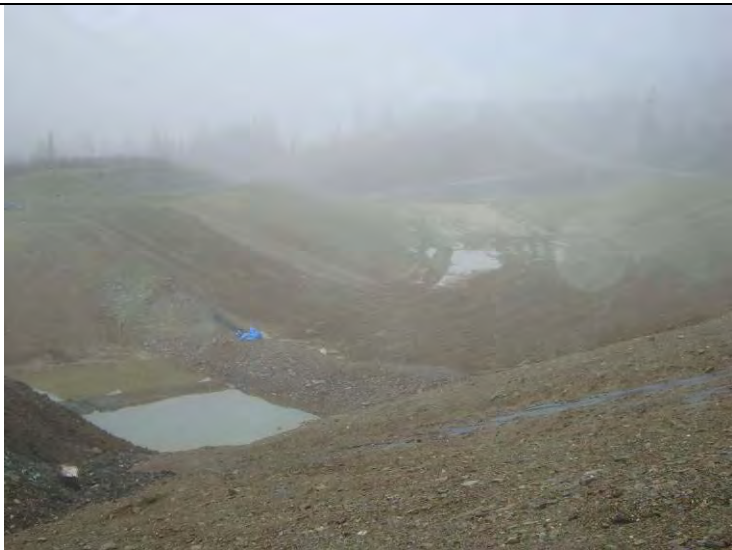
09/29/08 Completed Phase II lining (Facing NW) 942	09/29/08 Completed Phase II lining (Facing NW) 943

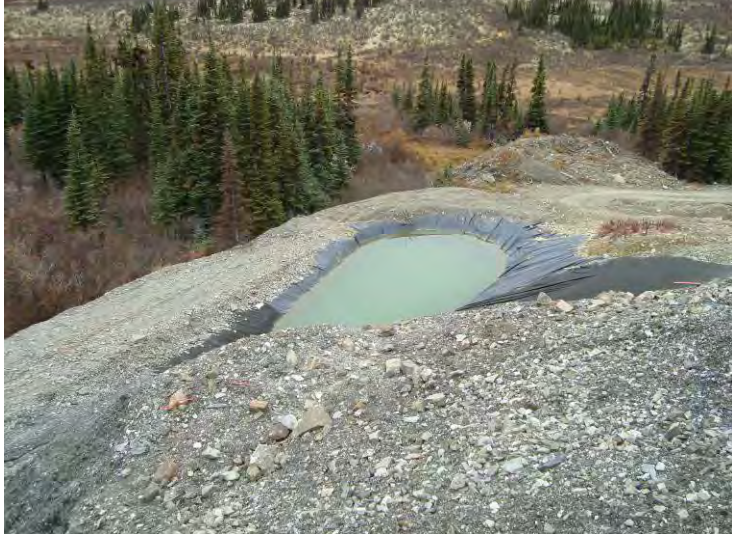
09/29/08 Packing clay liner, completed Phase I repairs (Facing NW) 1615	09/29/08 Waste rock Sump 1615

Repairs to Phase I			
<ul style="list-style-type: none"> <li>- Material put on portion of slope that had sloughed down liner</li> </ul>			
No additional water was removed from the pad before clay lining			
Site Description:			
Clay lining complete on both Phase I & II			
Clay berm remains separating both phases, and may be moved closer to toe of the waste rock pile before winter drill program commences.			
Assessed Risk: Low			
Photos Attached: WRP			
Samples Taken: none			
Additional Information Attached: none			
<b>Part 3 –Mitigation Requirements</b>			
Mitigation Required: Water that was removed to the waste rock sump needs to be taken to the water treatment sumps for mixing and discharge			
Mitigation Condition: G			
<b>Part 4 –Monitoring Requirements</b>			
Follow-up Monitoring: Watch for slumping of earthen dyke and watch water levels			
Monitoring Frequency: during rain events or when mitigation applied

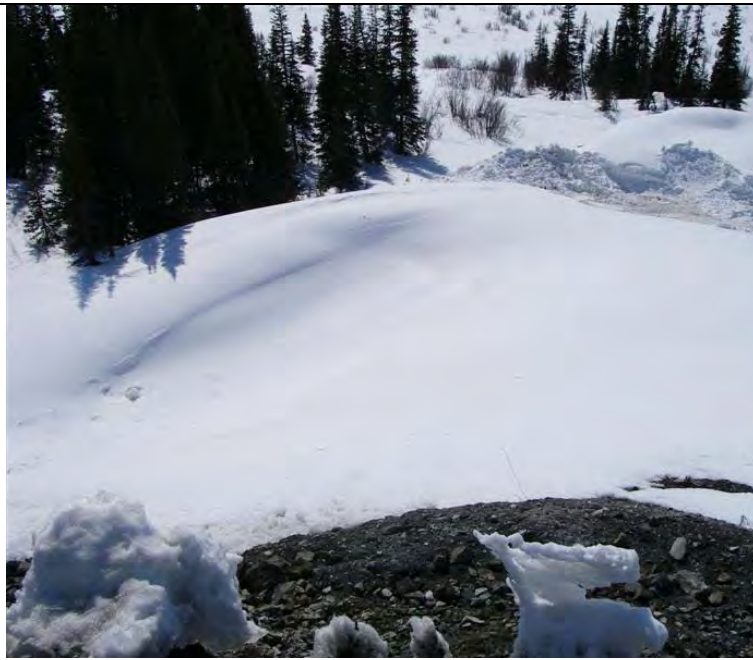
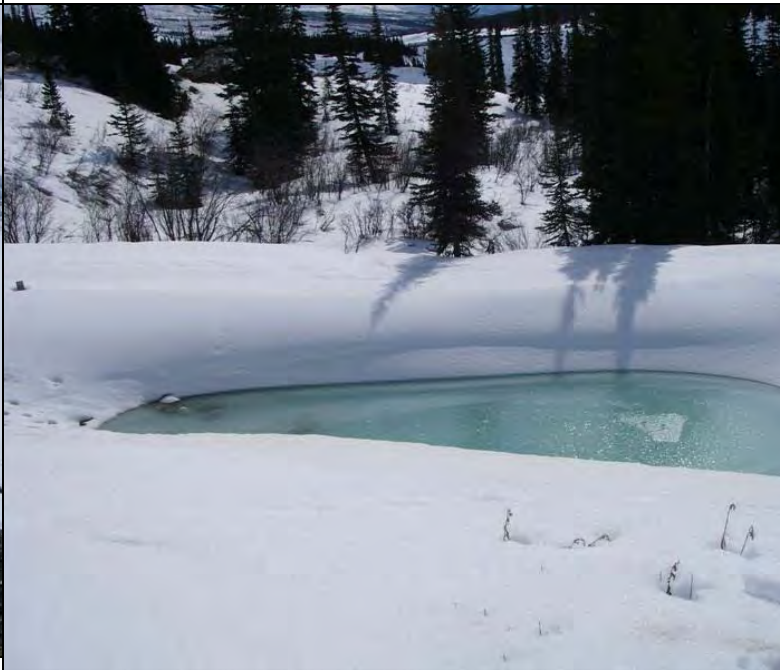
<b>Site Name: WRS</b>

<b>04/25/07    West WRS</b>	<b>04/28/07    West WRS</b>

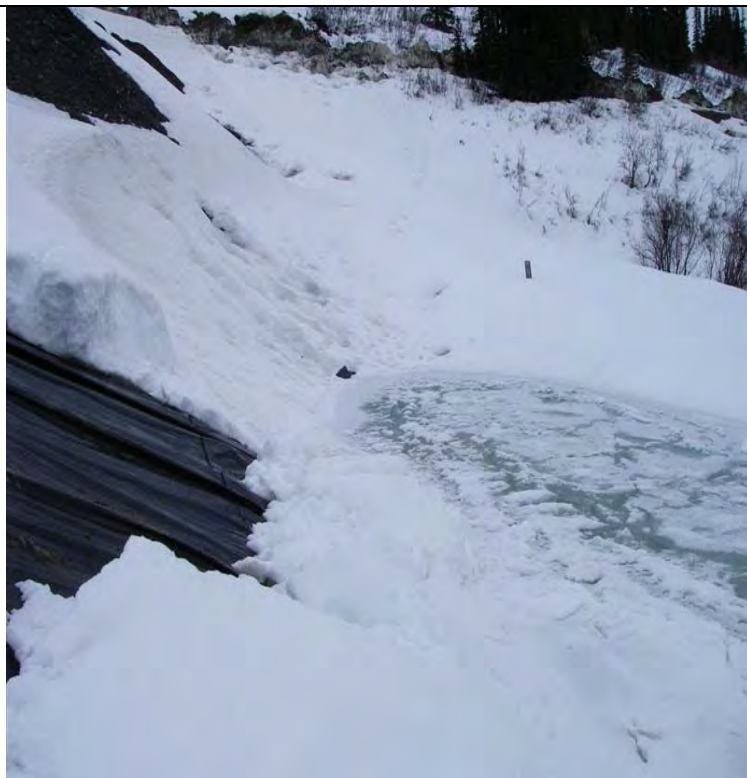
**05/01/08 WRS looking East**

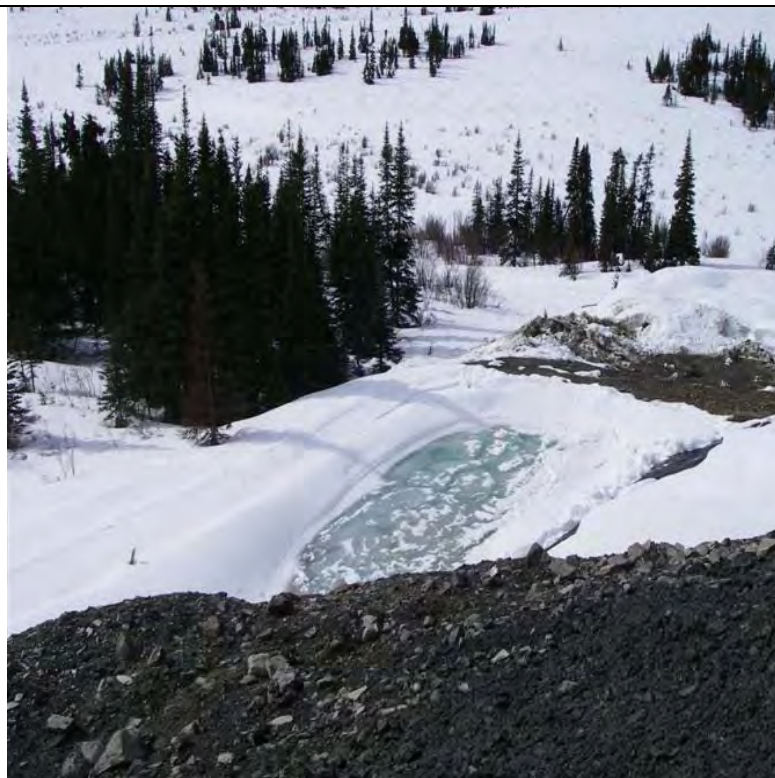
**05/02/08 WRS looking West**

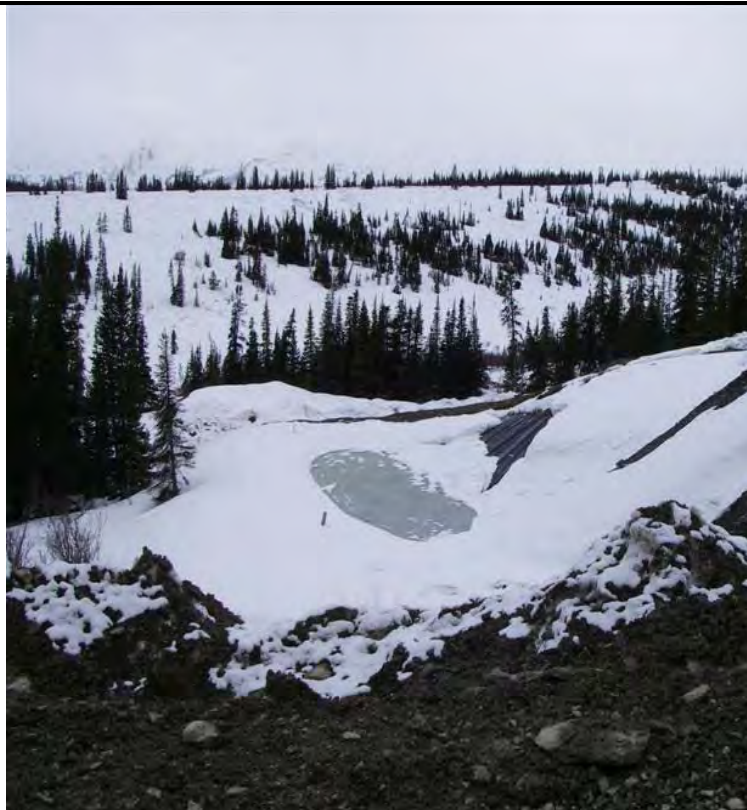
**05/02/08 WRS looking West**

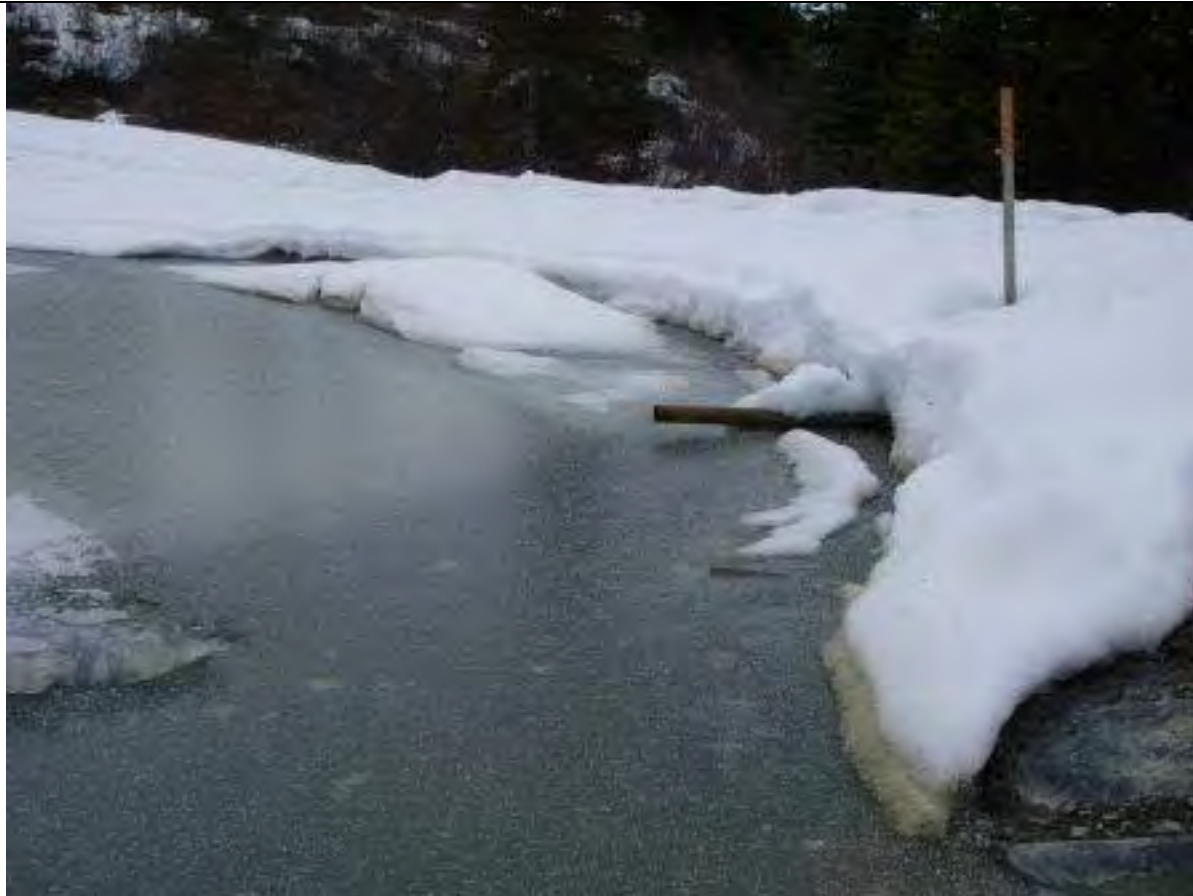
**Site Name: WRS**

**05/15/08 WRS looking South**
