## WOLVERINE MINE

# QUARTZ MINING LICENSE QML-0006

# 2010 ANNUAL REPORT

Prepared by: Yukon Zinc Corporation Vancouver, British Columbia

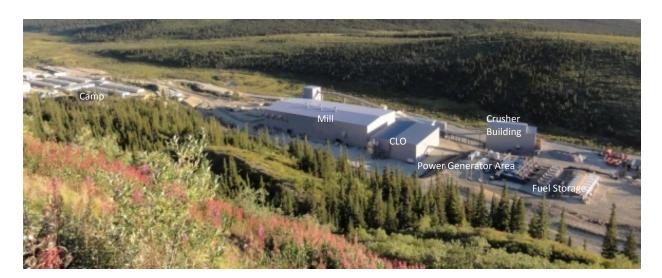
Picture 2-1: Overview of industrial complex area including camp, mill, concentrate load-out (CLO), crusher buildings, as well as power generator area and fuel storage areas.

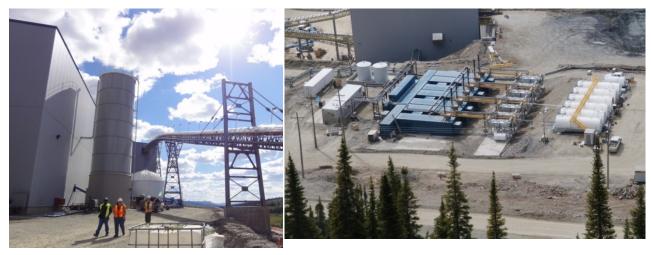
Picture 2-2: Mill building, cement silo and conveyor.

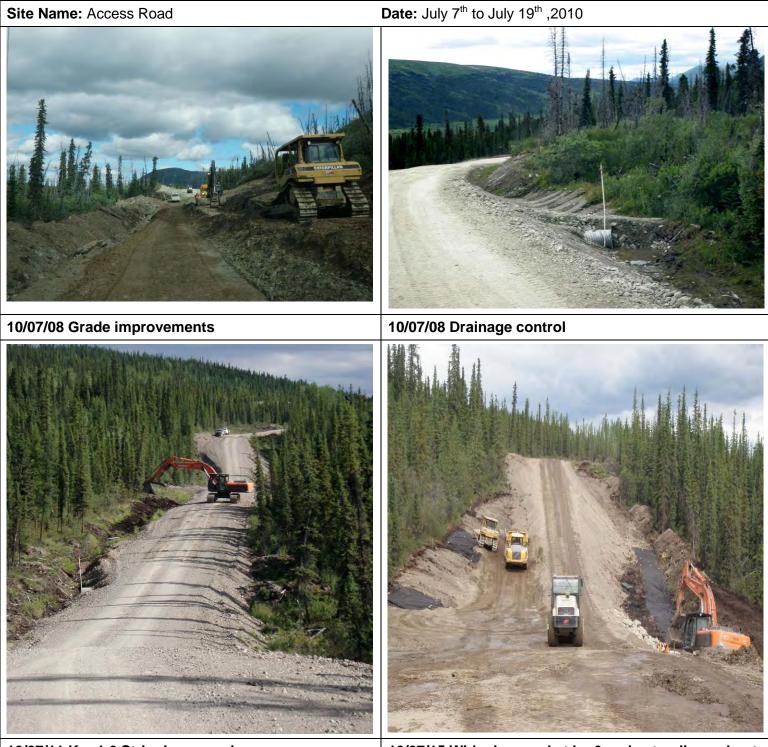
10/07/15 Widening road at km6 and extending culvert

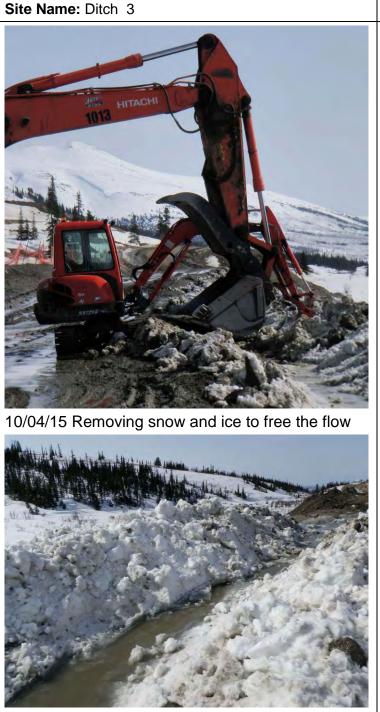
10/04/15 Snow and ice moved a side water starting to floe freely

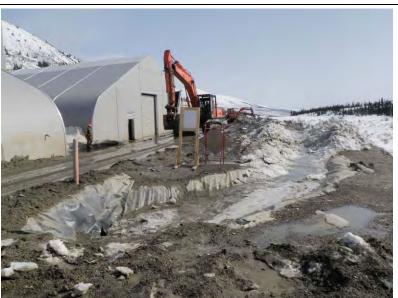
10/04/15 Some sediment built up near the culvert

Mitigation Required: holes will need to repaired and sediment removed

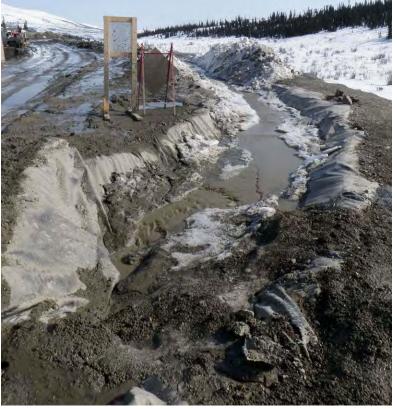
10/04/16 water is flowing at a steady rate into sump 2

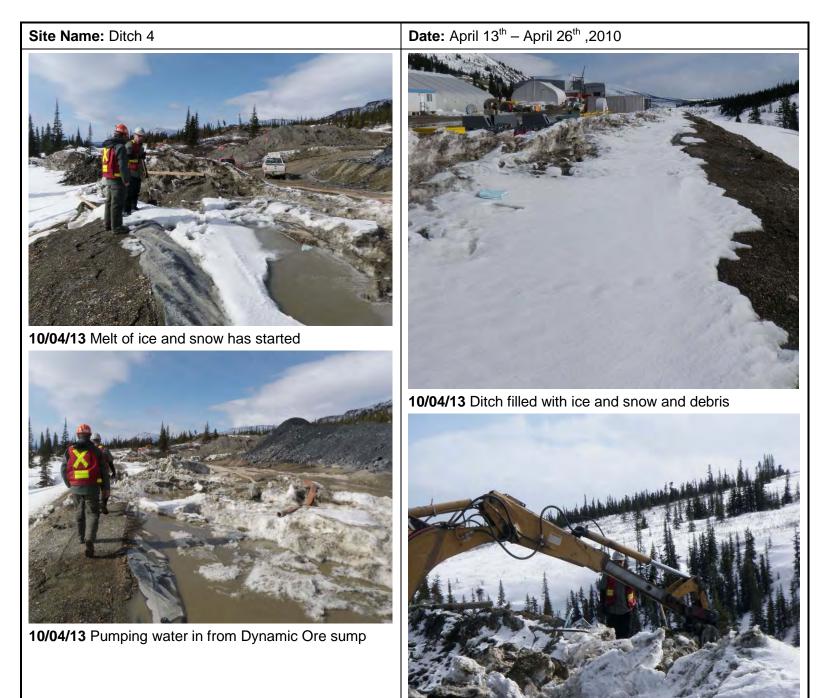
10/04/13 Removing snow and debris from ditch to allow flow

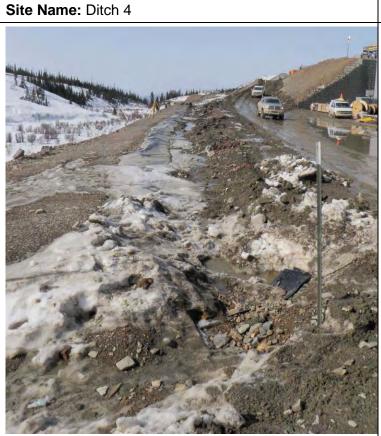
10/04/15 The ditch is full of debris, ice and snow.

Mitigation Required: Debris and ice needs to removed, holes in the liner need to repaired, sides need to built up

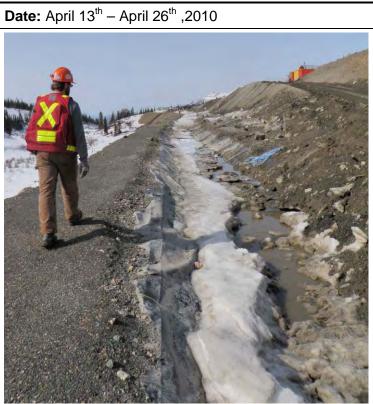
10/04/15 Ice built up along the ditch blocking flow

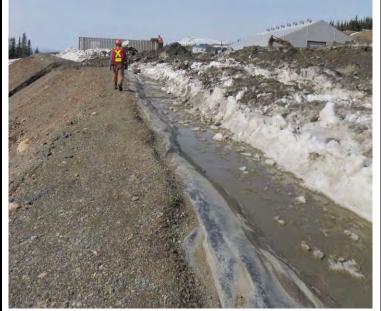
**10/04/15** Starting to break up all the ice and snow to all water to flow through

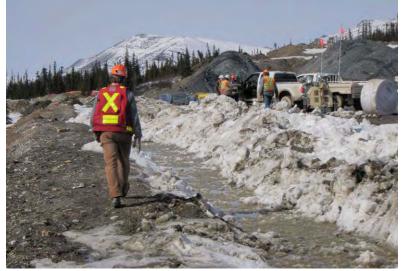
**10/04/15** Guys working on the ditch to get it flowing and stop the over flowing where it is damming up.

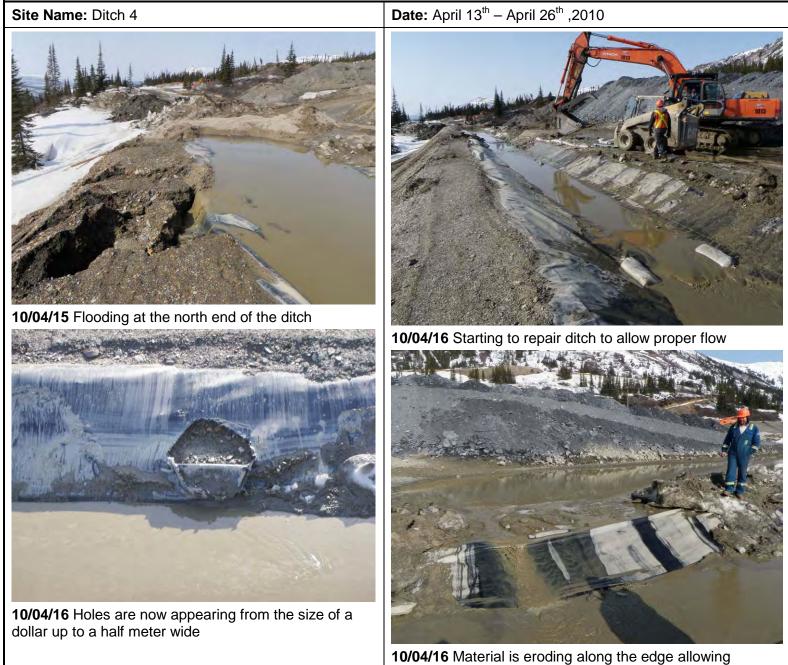
sediment to build up in the ditch

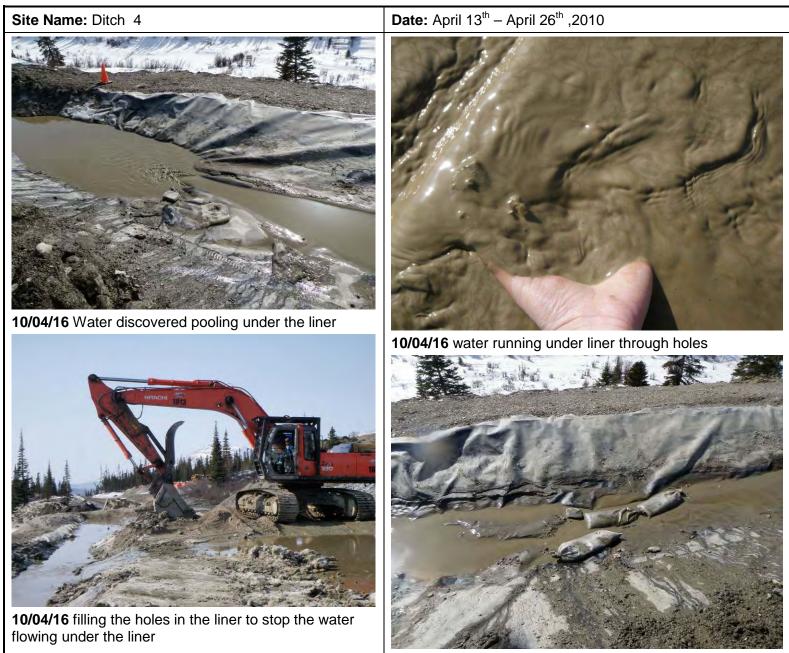
10/04/18 The water under the liner has dissipated.

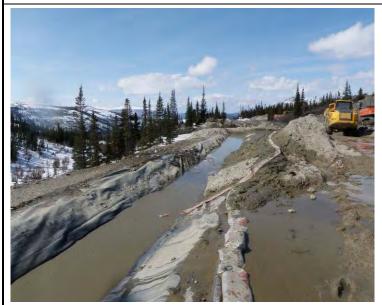
**10/04/18** Water is flowing at a steady pace. No more ice and debris damming it up. There is a lot of sediment building up that needs to be removed.

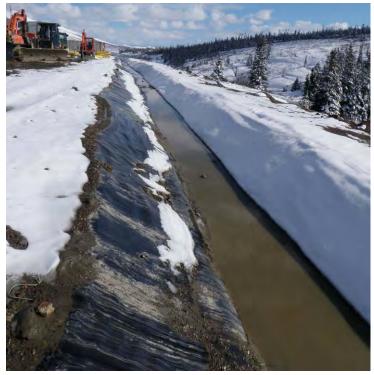
10/04/21 Ditch is clear and is flowing steady. Snow fall and rain have increased the flow significantly.

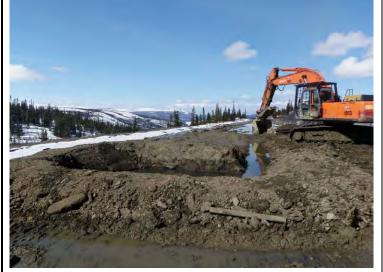
10/04/22 A sump has been built to collect water pooling above ditch 4. This water is then pumped into ditch 4 or taken via truck to tailings facility

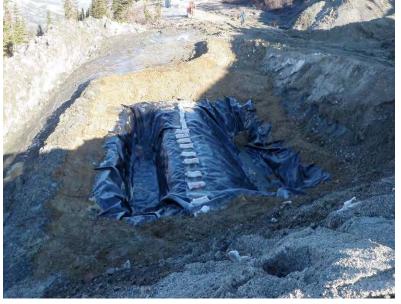
10/04/24 Sump built below north end of ditch 4 to catch runoff from dynamic waste rock pile. This water will then be pumped into ditch 4 or to tailings

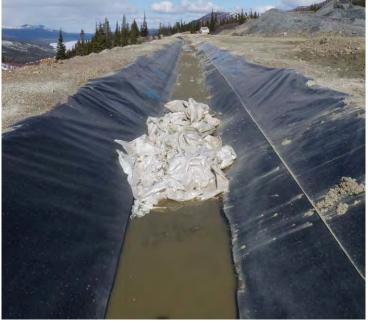
10/05/13 Debris in ditch (North end)

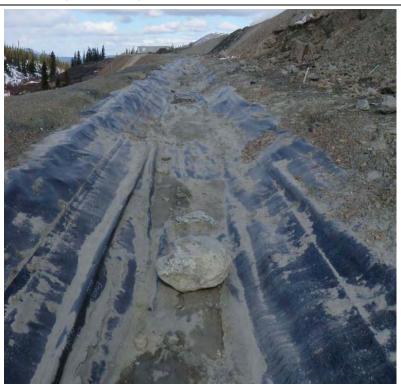
10/05/13 There is no water flowing (looking north)

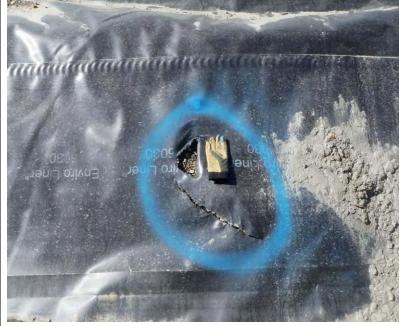
10/05/13 Holes marked with blue paint (Various sizes)

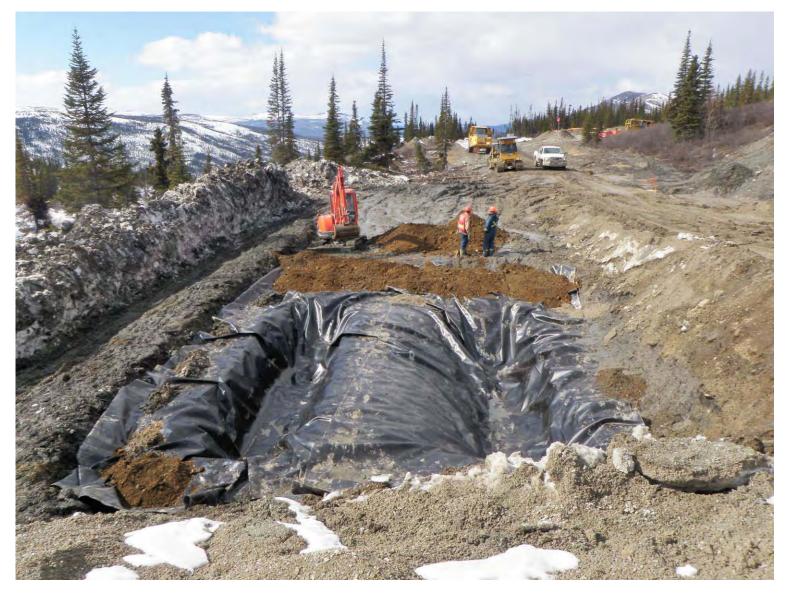
#### 10/04/23

Sump installed at the end of ditch 4 to capture any runoff from the dynamic ore pile and industrial complex. This water will then be pumped into ditch 4.

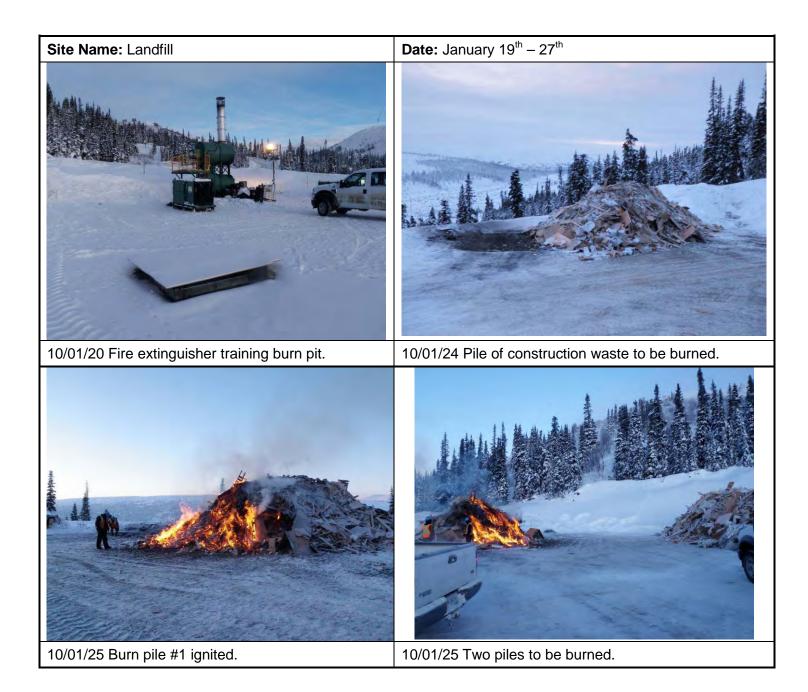
Site Name: Landfill	Date: January 19 <sup>th</sup> – 27 <sup>th</sup>
10/01/26 Burn pile #2.	10/01/26 Burn pile #2 after burning all day.
10/01/27 Burn pile #2 after burning over night.

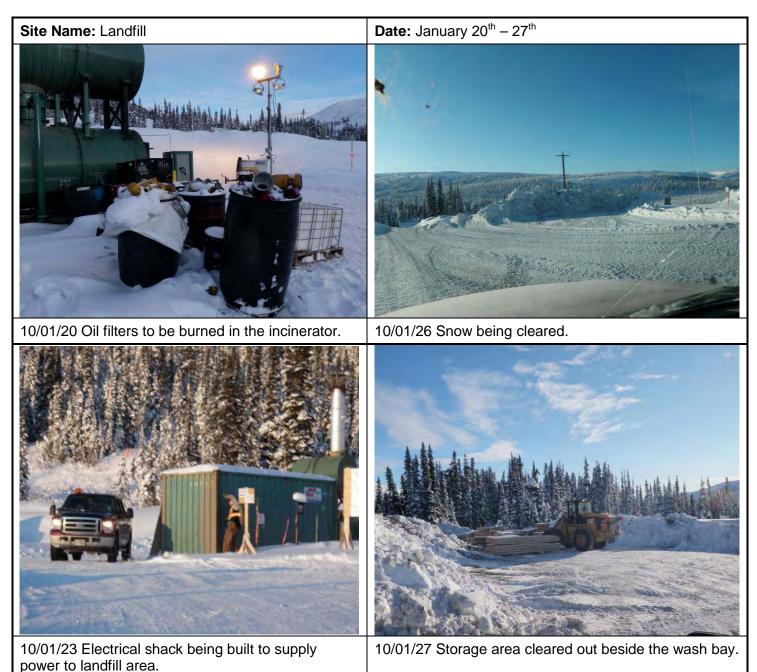
- Incinerator area looks well maintained
- Sign for wood/metal areas fallen down, needs to be repaired and stabilized
- Wooden crate (painted "Garbage") left in wood storage area, mixed garbage (plastics, drink bottles and boxes, metals, aerosols, etc.) at least 15-20 ravens rummaging around

Mitigation Required: Wood/Metal sign to be repaired, garbage crate to be cleaned up, contractors to be notified of proper waste management protocols.

Mitigation Condition: Site services notified about sign and conditions, "Garbage crate" removed, Robin preparing one page overview of waste management for contractors.

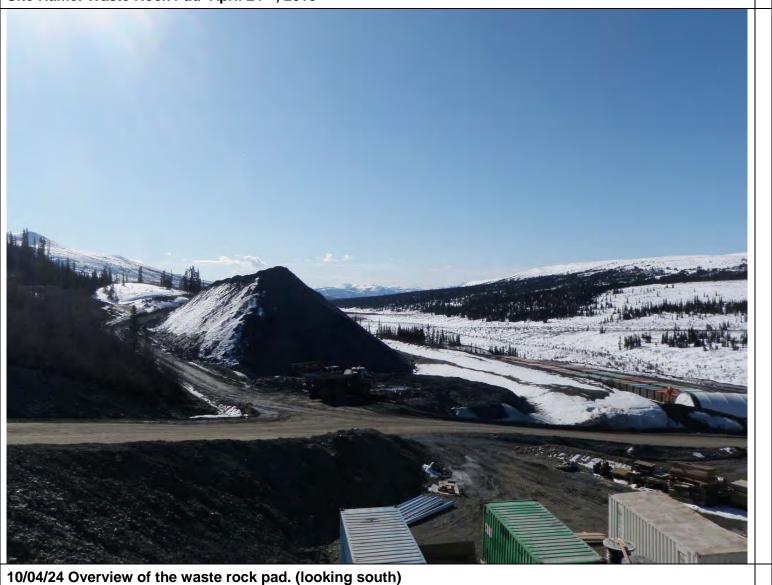
Site Name: Waste Rock Pad April 24<sup>th</sup> , 2010

Part 1 – Site Description	Part 1 – Site Description	
Date: April 24th ,2010	Inspector(s): Jaymie Skidmore	
Site Name: Waste Rock Pad – Waste Rock Sump	Location/Co-ordinates: Waste Rock Pad and Sump ~ Km 27.2	
Site Location Description: The waste rock pad is located in an area which is lined and bermed with a large earthen/clay dyke to contain water drainage from the waste rock stored in this area. The waste rock sump is approximately 221m3 and is also lined. This sump is designed to collect contaminated water runoff from the waste rock pile.		
Weather Conditions: Typical spring weather with temperatures ranging from 0 to 15C with periods of snow, rain and sun. Spring melt is in effect.		
Part 2 – Site Assessment		
Activity:		
-Pumped waste rock sump-6 water truck loads pumped and discharged into the tailings facility		
-Ditching the area around the ore pile ramp to divert runoff back into the lined area

Site Description: Waste rock sump is now empty; the waste rock pile is increasing daily. Ditching and seepage prevention is ongoing.		
Assessed Risk: Low		
Photos Attached: Yes (2)		
Samples Taken: No none needed		
Additional Information Attached: none		
Part 3 –Mitigation Requirements		
Mitigation Required: Pump out waste rock sump and ditch around waste rock pile.		
Mitigation Condition: good		
Part 4 –Monitoring Requirements		
Follow-up Monitoring: Monitor ditches to insure efficiency during melt and rain		
Monitoring Frequency: Daily, during rain events or when mitigation applied		
Reporting Requirements: As conditions change

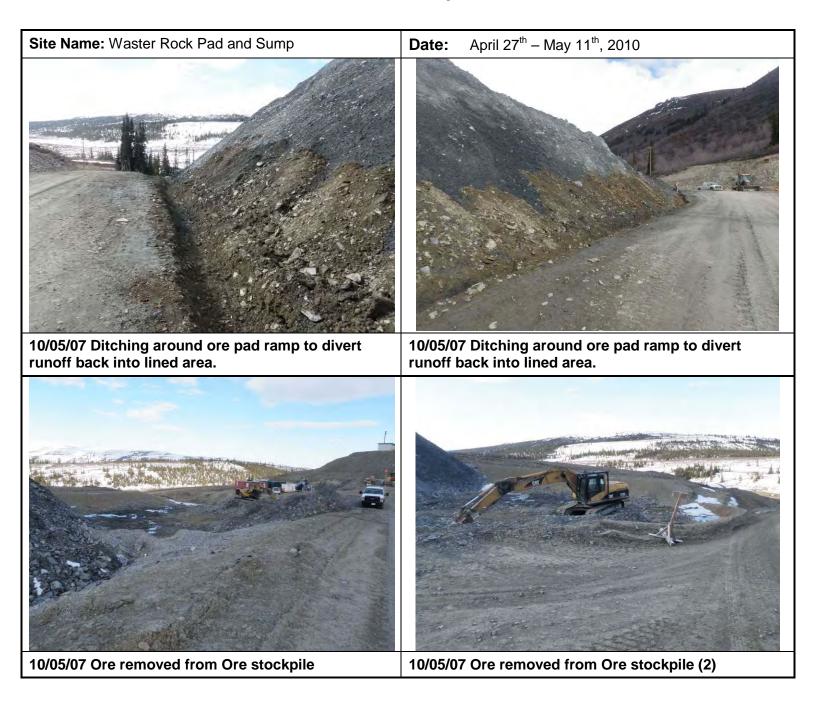
Site Name: Waste Rock Pad April 23th , 2010 10/04/23 Ditching around ore pad ramp to divert runoff back into lined area.

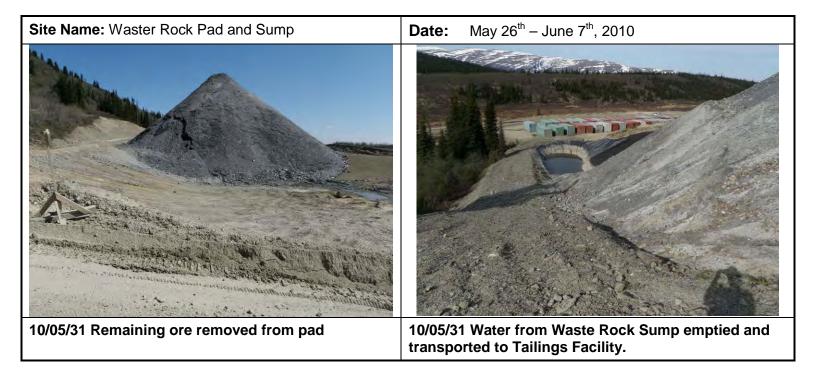
Part 1 – Site Description	
Date: May 26 <sup>th</sup> – June 7 <sup>th</sup> , 2010	Inspector(s): Robin McCall
Site Name: Waste Rock Pad – Waste Rock Sump	Location/Co-ordinates: Waste Rock Pad and Sump ~ Km 27.2
Site Location Description: The waste rock pad is located in an area which is lined and bermed with a large earthen/clay dyke to contain water drainage from the waste rock stored in this area. The waste rock sump is approximately 221m3 and is also lined. This sump is designed to collect contaminated water runoff from the waste rock pile.	
Weather Conditions: Spring weather with temperatures ranging from 0C to 15C with periods of rain and sun.	
Part 2 – Site Assessment	
Activity:	
-Waste rock sump was emptied and discharged into the	tailings facility
-Remaining Ore removed from Waste Rock Pad	
Site Description: No ore remains on the pad, sump level does not pose risk of runoff	
Assessed Risk: Low

Photos Attached: Yes (2)	
Samples Taken: No	
Additional Information Attached: none	
Part 3 – Mitigation Requirements	
Mitigation Required: Pump out waste rock sump as required	
Mitigation Condition: good	
Part 4 – Monitoring Requirements	
Follow-up Monitoring: Monitor ditches and any potential seepage from the facility	
Monitoring Frequency: Daily, during rain events or when mitigation applied	
Reporting Requirements: As conditions change
